## **Report of the Damage caused by the Mid-North Iwate Earthquake of September 3, 1998**

Kazuo KONAGAI, Atsushi MIKAMI, Toshihiko KATAGIRI, Raquib AHSAN  
and Daisuke MARUYAMA

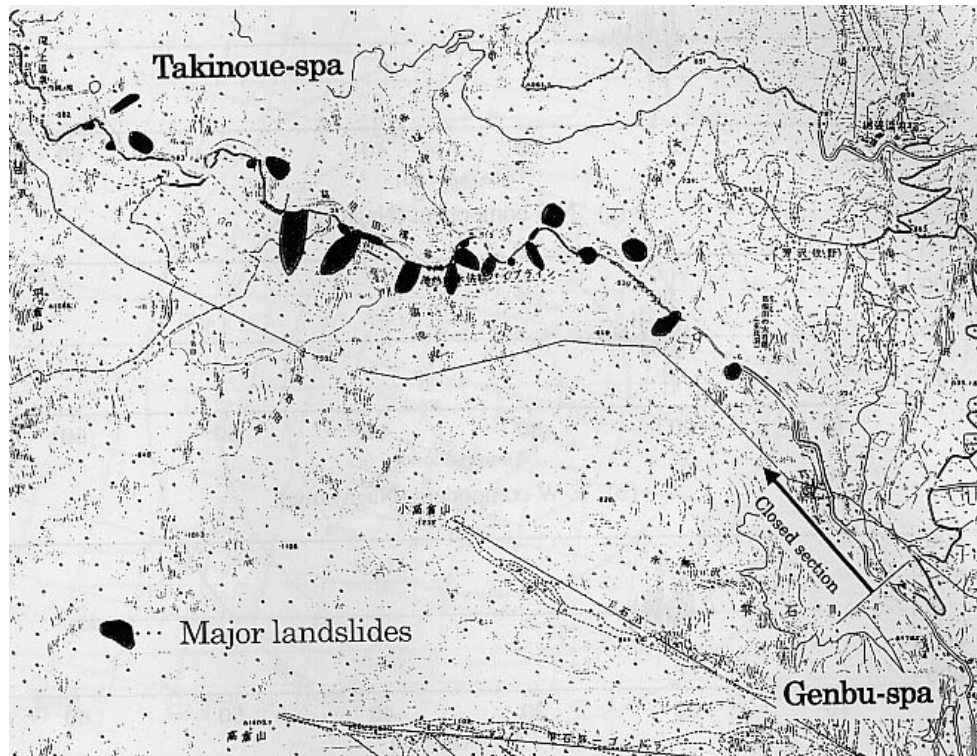
Fig. 4 Location of major landslides

Traffic on the prefectural route 100, called Nishiyama-Obonai Line, was suspended by a number of earthquake-induced landslides along the Kakkonda glen, causing about 100 people at Takinoue Spa to be held up for a night. Total 55 landslides took place between Takinoue and Genbu spas. Locations of major landslides are shown in **Fig. 4** along with a pair of photographs of a typical slide (**Photo 6**). When the photographs are viewed side by side through a stereoscope, they are perceived as a single image in three-dimensional space. When used to focusing both eyes on these photographs, these separate perceptions of the two eyes can be combined and interpreted in terms of depth even without a stereoscope. On the visualized 3D

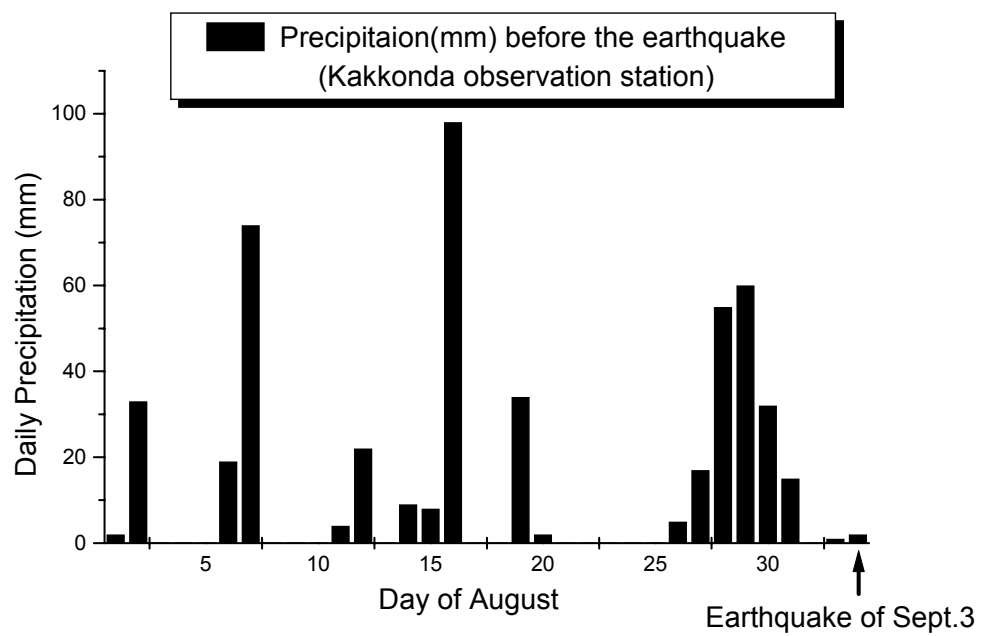
Fig.5 Precipitation record (Kakkonda meteorological observatory)

Needless to say, slope failures and precipitation closely correlate to each other. **Fig. 5** shows the precipitation record at Kakkonda meteorological observatory, which is very close to the dislocated fault planes. It is clear from this figure that a spell of 6 days rain was followed by the earthquake of Sept. 3. **Fig. 6** shows the number of tremors observed at the Mt. Iwate observation station of JMA. A great number of volcanism-related tremors preceded the earthquake of Sept. 3, and thus might have been another cause of making the loamy soils loose.

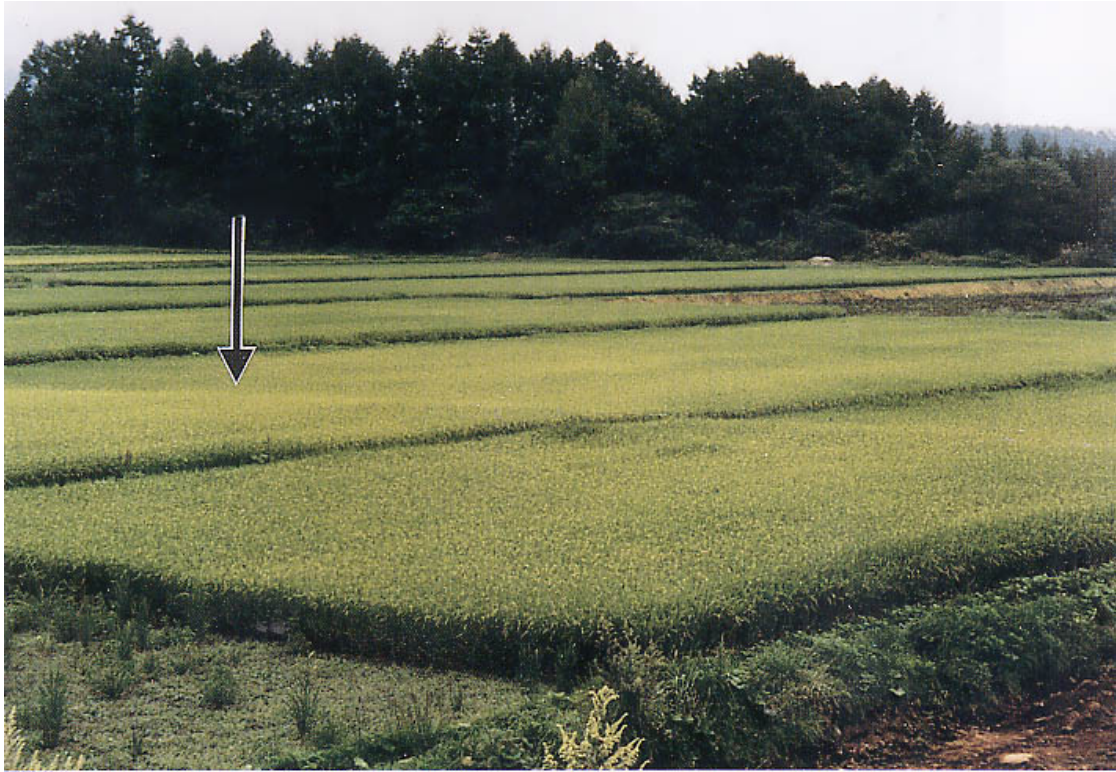
The activated fault planes were found roughly lined up at random intervals near a scarp formed along the Kakkonda glen. One of the faults which appeared in a paddy field was a straight raised mark extending a couple of hundred meters' distance, clearly showing a compressional dip-slip movement of this fault (**Photo 1**). The averaged upward movement of the soil caused by the reverse faulting reached or exceeded ten centimeters in this paddy field. This movement of the fault caused concrete walls covering up a drain to be cracked and dislocated (**Photo 2**). A fault plane branching off the lined major fault planes crossed the Kakkonda river and buckled the pavement of the prefectural route 100 (**Photo 3**).

Photo 1 Fault that appeared in paddy field

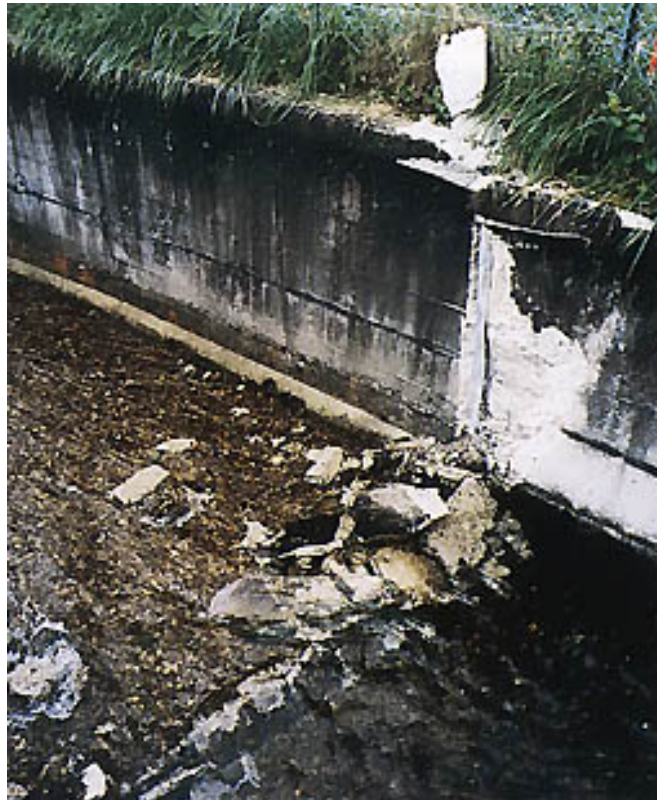
Photo 2 Damaged concrete wall of drain

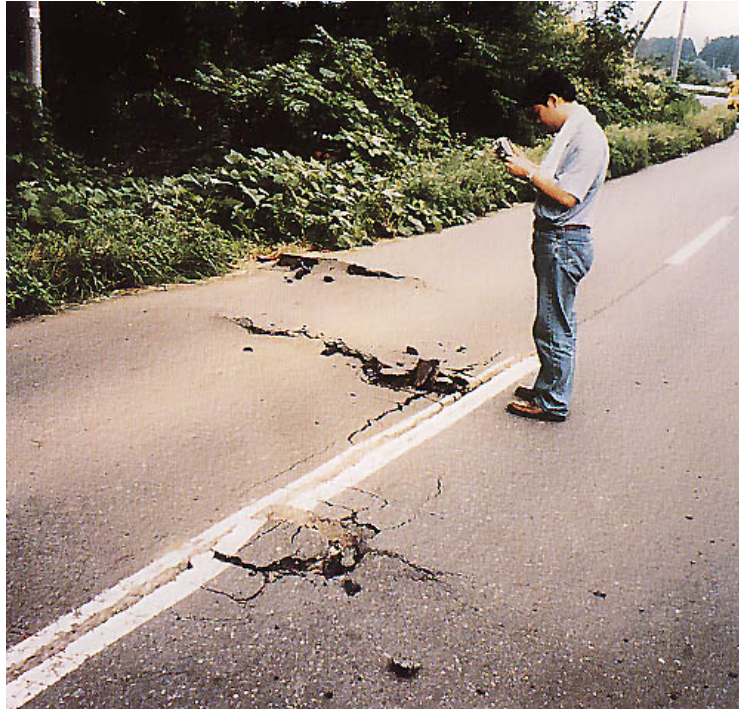
Photo 3 Buckled pavement

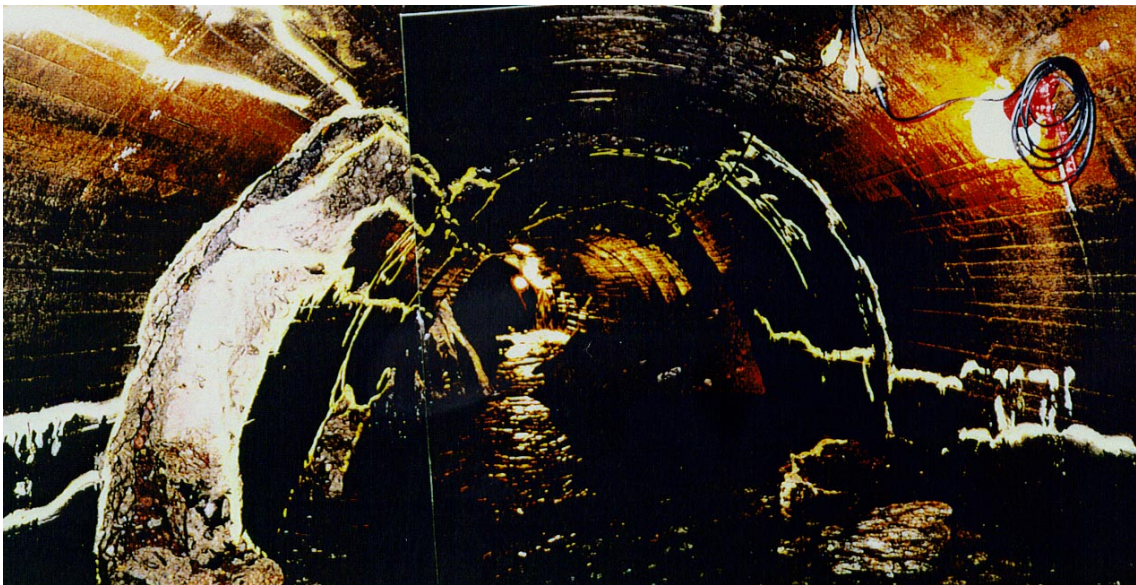
These faults observed on the ground surface form a part of Shizukuishi-Seien fault belt whose presence has been suggested by many geologists<sup>1)</sup>. Continual movement of this fault belt has formed the scarp along the Kakkonda river, and by virtue of this configuration, some hydroelectric power stations were constructed along the Kakkonda river. A concrete outlet tunnel of the second Kakkonda hydroelectric power station runs across one of the fault planes that appeared as the straight rising mark in the paddy field mentioned already. It was, thus, inevitable that the circular tunnel wall was cracked up into several large pieces and smaller fragments (**Photo 4**). Some pieces of the cracked wall were pushed in the tunnel reducing the tunnel's cross-section<sup>2)</sup>. One cracked piece of about 2 m high and 2 m wide completely fell down onto the invert allowing the soil with big boulders (30 ~ 50 cm) to be squeezed into the tunnel. An open aqueduct leading to this hydroelectric power station was also damaged (**Photo 5**). Diagonal cracks found on its concrete walls are suggestive that the aqueduct might have experienced compressional force in its axial direction. No clear evidence of the motions of the surrounding soil was found there. It is, however, quite probable that there were some fault planes that reached the ground surface causing this damage, and yet could not be clearly seen.

Photo 4 Damage to outlet tunnel (provided by Tohoku Electric Power Company)

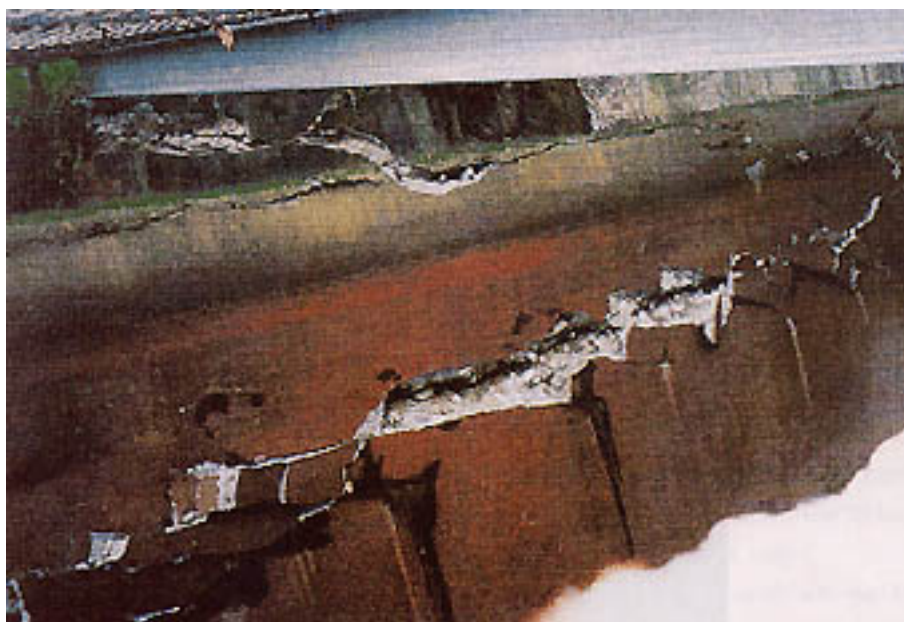
Photo 5 Damage to open aqueduct

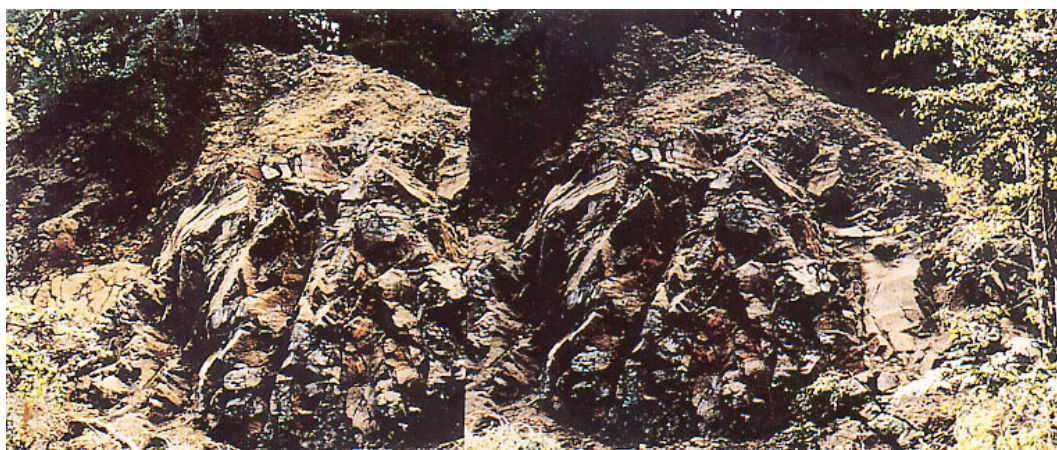
failure surface, one would see the mass of tightly-joined basalt rocks half embedded in surface soil. **Photo 7**, showing a basalt rock layer sandwiched in between loamy soils, suggests that molten rock forced its way into the soft volcanic soil deposit. The soft soils might have been responsible for amplifying the seismic motion to such extent that the soils with basalt rocks were shaken off the slopes.

Photo 6 Basalt rock that appeared on a failure surface

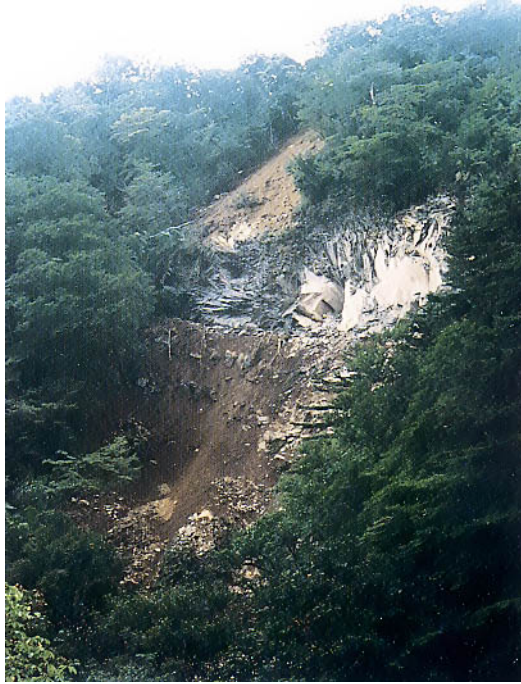
Photo 7 Basalt rock layer sandwiched in between loamy soils
