3. BUILDINGS AND DWELLINGS

The January 13, 2001 Off the Coast of El Salvador Earthquake

3.4 DAMAGE TO THE VISITED TOWNS

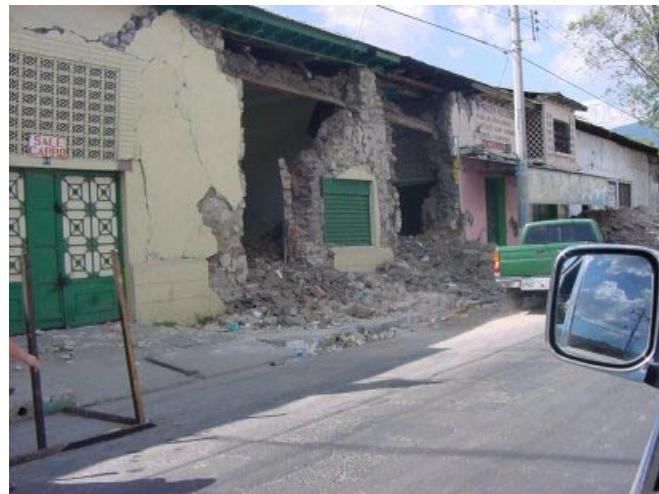
Figure 3.2. Typical adobe house that was damaged by the earthquake

Adobe buildings have poor seismic performance. They are massive and heavy, which attracts high levels of seismic forces, and the material is brittle and has almost no tensile strength by itself. Poor construction practices often decrease the bond between adobe and mortar. Although there are techniques to provide internal reinforcement to the adobe structures in order to improve their seismic performance, those techniques are not in practice in El Salvador.

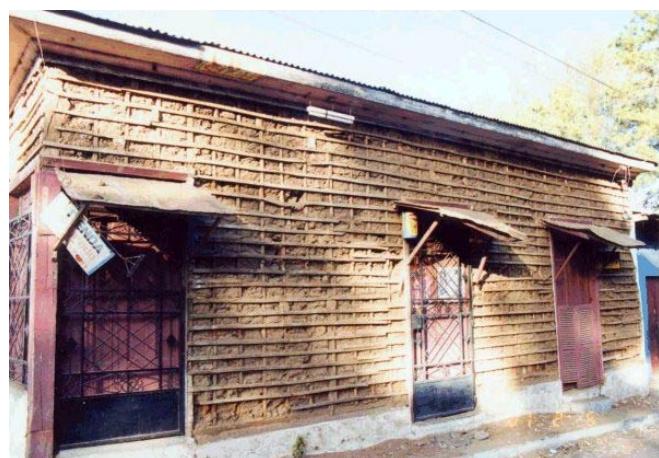
Figure 3.3. Bahareque structure which suffered mud cover spalling.

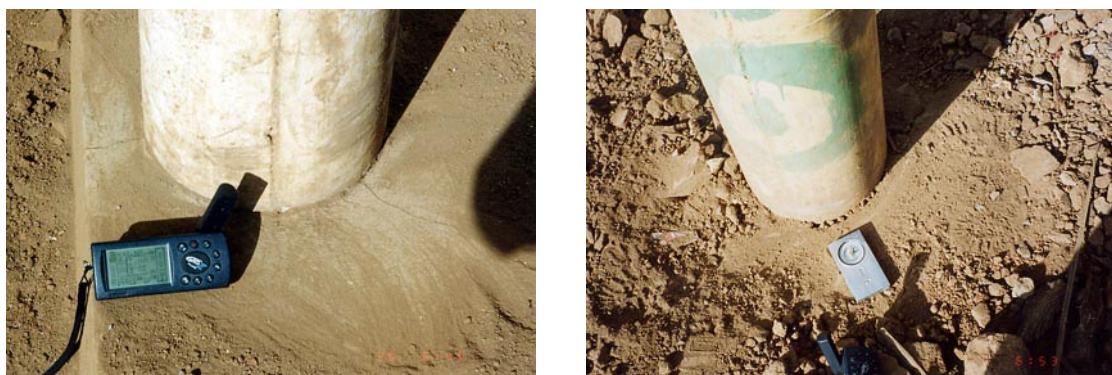
Utility poles (5m tall) are embedded upright in concrete-paved sidewalk in this town (**Figure 3.10**). Cracks developing outwardly on the pavement from these poles suggest possible directions in which ground motions were intense (**Figure 3.11**). Some poles (**No. 6 and 7**) are very close to the step-shaped edge of the sidewalk. The thin cover concrete thus might have affected the crack pattern. Though the number of the examined utility poles is not sufficient for thorough statistical manipulations, some poles seem to have been forcibly shaken in about N-S direction.

Figure 3.11. Cracks appearing around utility poles

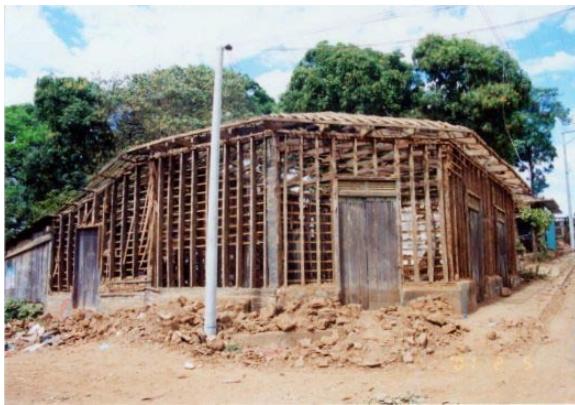
Figure 3.12. Bahareque structure that suffered mud spalling.

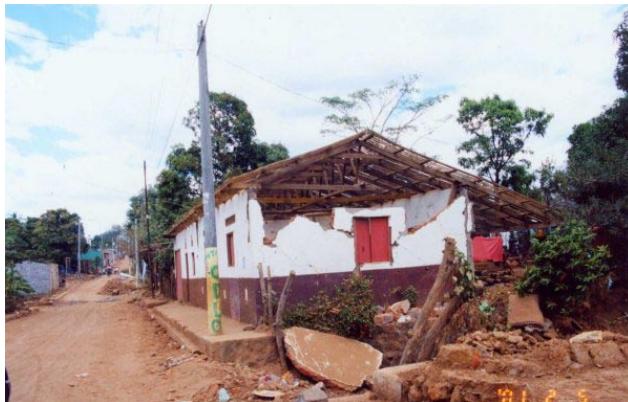
Figure 3.14. Unreinforced masonry house partially collapsed. The walls perpendicular to the street (~NE-SW direction) failed out-of-plane. The roof restrained the displacements of the top of the wall parallel to the street.

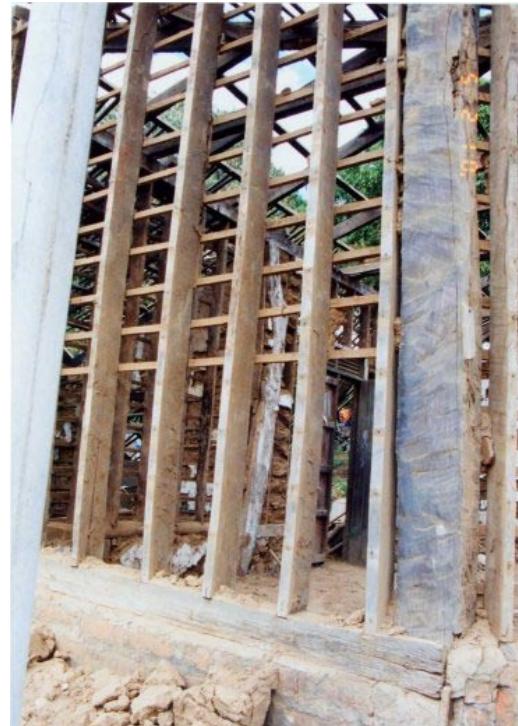
Figure 3.13. Detail of the connection between studs and foundation of the house in **Figure 3.12**. The foundation extends above the ground level protecting the wooden members.

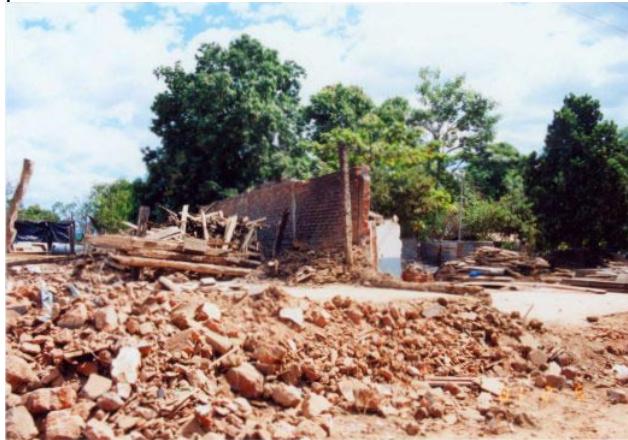
Figure 3.15. Completely collapsed adobe house.

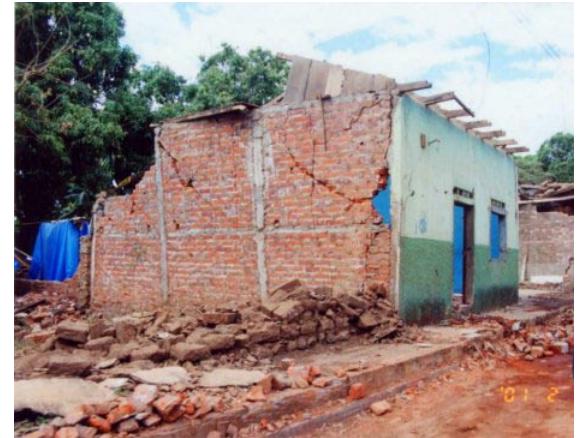
Figure 3.16. Collapsed reinforced masonry wall. The separation of the walls from the transverse walls can be observed in the two buildings shown in the photograph. The street direction is approximately NE-SW.

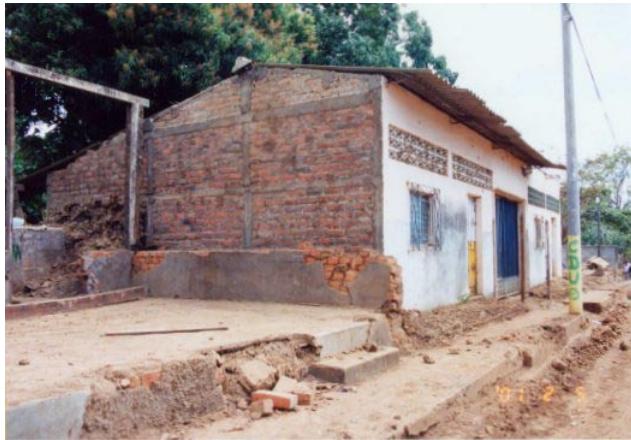
Figure 3.17. Adobe house completely flattened next to a reinforced masonry structure that did not suffer any damage.

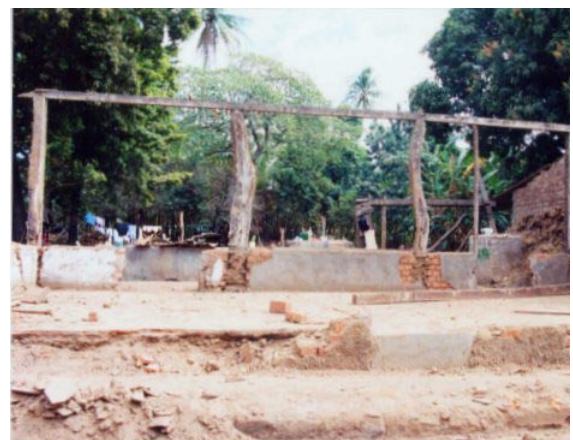
Figure 3.18. Detail of the adobe house in **Figure 3.17**. Just the confining wood of one wall remained.

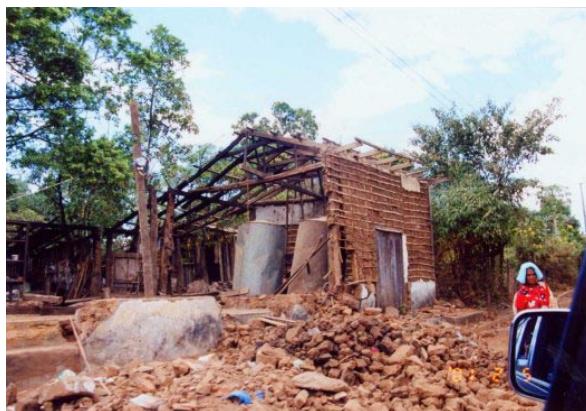
Figure 3.19. Collapsed bahareque house.

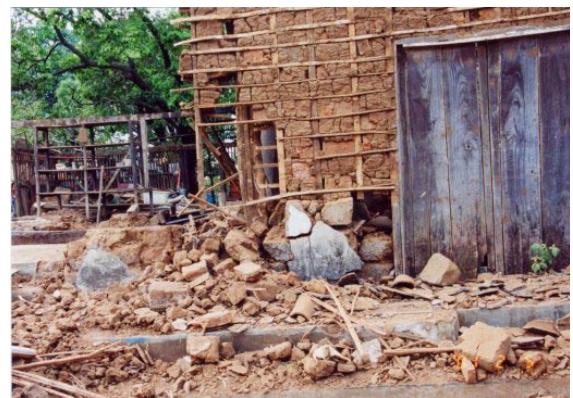
Figure 3.20. Detail of the poor foundation of house in **Figure 3.19**.

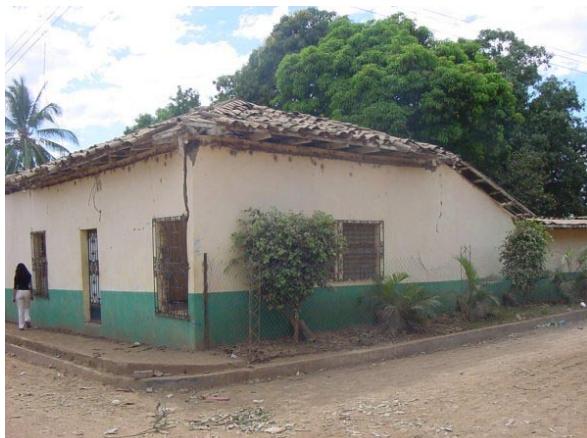
Figure 3.21. Unreinforced masonry structure. A vertical crack is observed at the connection between walls.

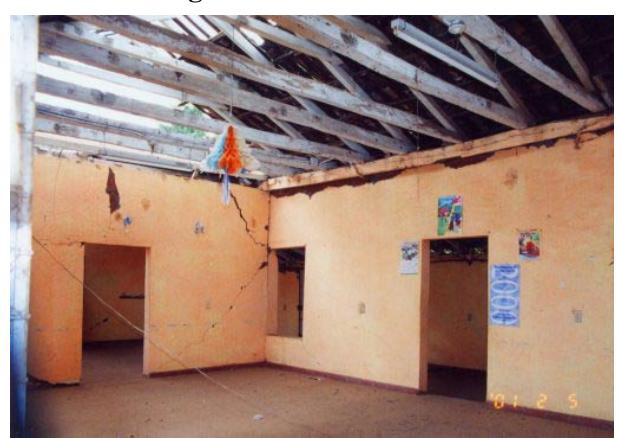
Figure 3.22. Interior of the building shown in **Figure 3.21**. The wall exhibits diagonal cracking.

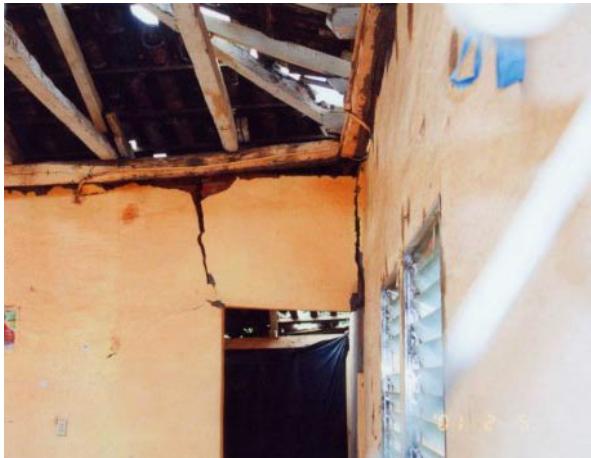
Figure 3.23. Interior of the building shown in **Figure 3.21**. Vertical cracking of spandrels over the door head can be observed.

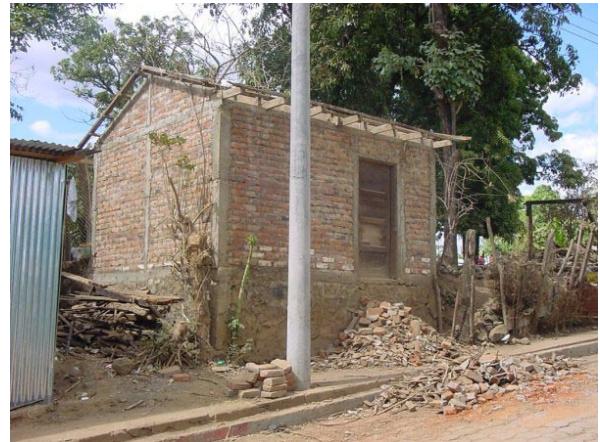
Figure 3.24. Reinforced masonry structure that did not suffer damage. However, the roof tiles fell down.

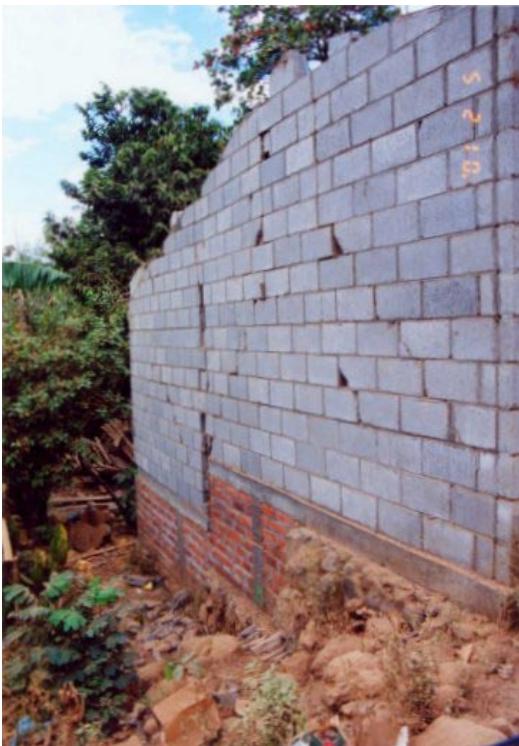
Figure 3.25. Masonry wall with clay bricks and concrete blocks. A diagonal crack crosses the concrete portion

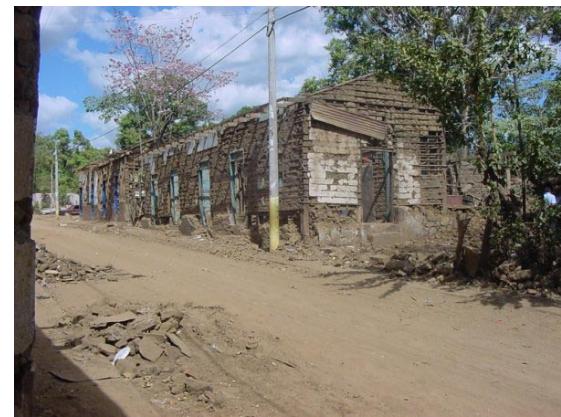
Figure 3.26. Bahareque structure damaged by the earthquake.

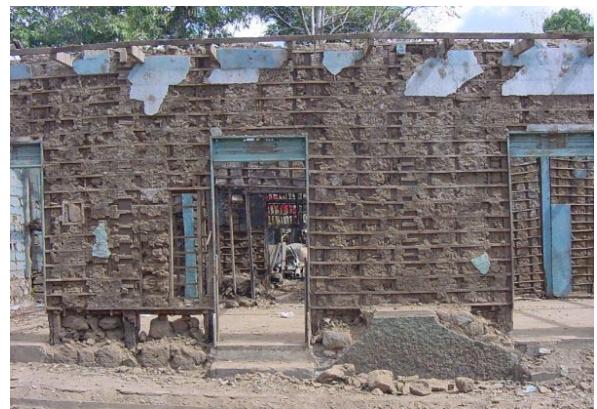
Figure 3.27. Details of the walls of the house in **Figure 3.26**. Notice the poor foundation detail.
