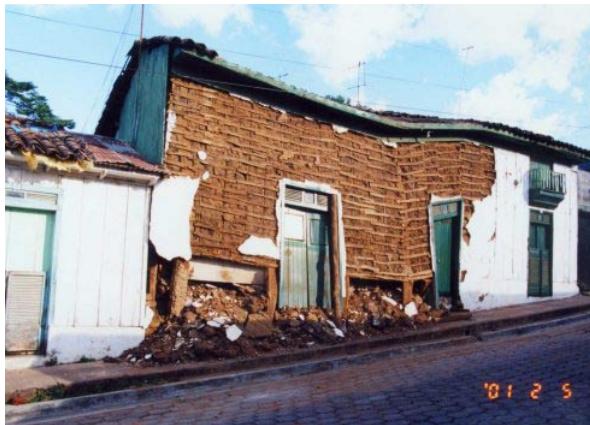
**Figure 3.28.** Damaged bahareque house with very poor foundation.

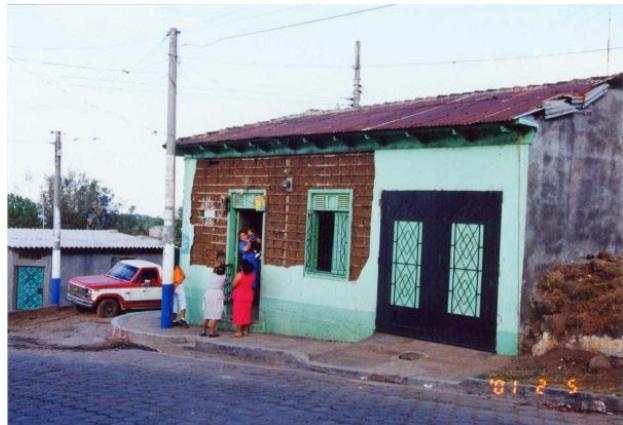
**Figure 3.29.** Bahareque house that suffered mud cover spalling.

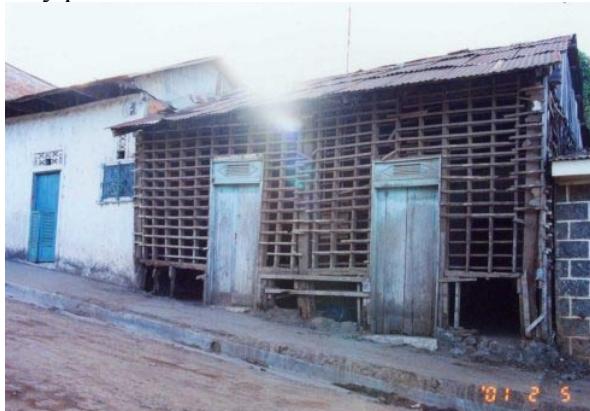
**Figure 3.30.** Bahareque house that lost all its mud walls.

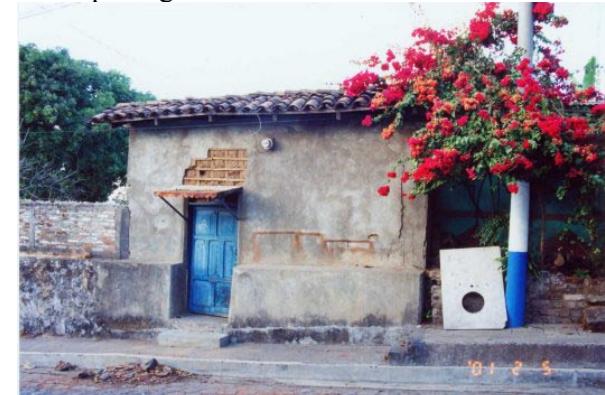
**Figure 3.31.** Bahareque house exhibiting mud cover spalling and vertical cracking at the connection between two perpendicular walls.

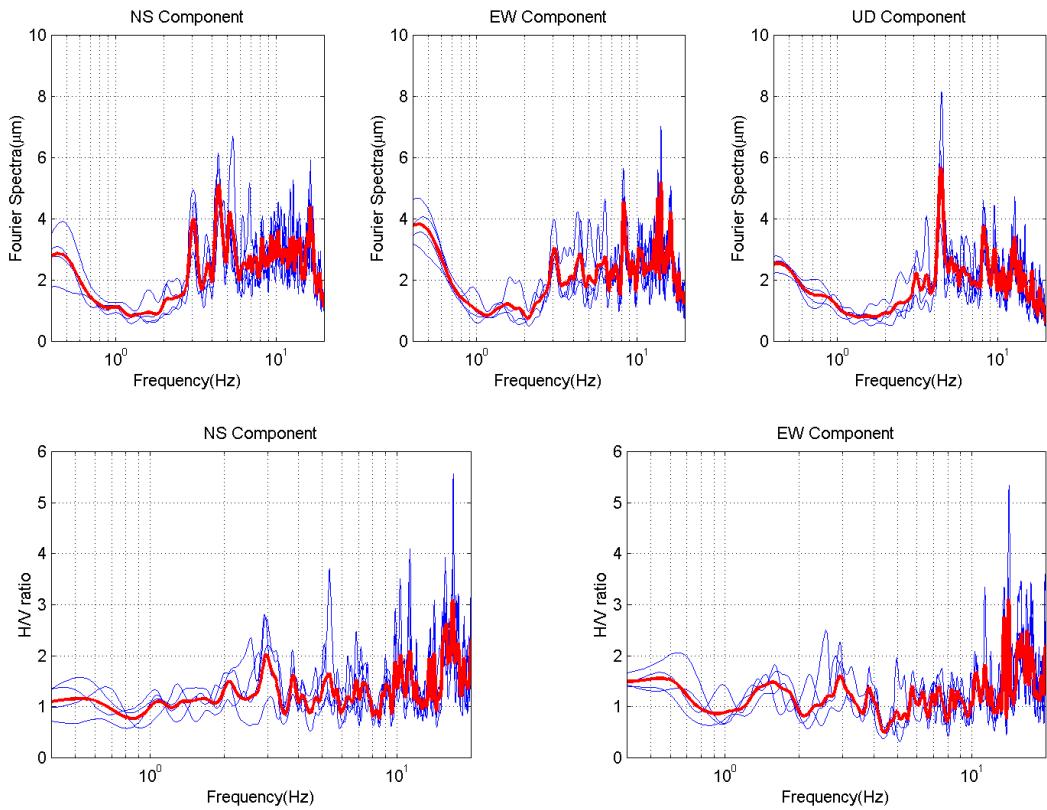
Microtremors were measured at the Explotation Station ( $88^{\circ}30.69W$ ,  $13^{\circ}30.75N$ ) and at Berlin ( $88^{\circ}31.70W$ ,  $13^{\circ}29.40N$ ) where the PGA of the January 13<sup>th</sup> event was around 200gals as mentioned in **Chapter 1**. **Figure 3.32 and 3.33** show the Fourier Spectra for each of the recorded components. The Fourier Spectra was calculated by averaging the spectra of four windows (blue lines). The averaged spectra are shown in a thick red line. The ratio of the horizontal component spectra to the vertical component spectra (H/V ratio) was calculated in order to get the predominant period of the site [Nakamura, Y., 1989]. The H/V ratio is fairly flat which might indicate the rocky nature of the site. On the other hand, at Explotation Station, a peak can be identified at 15-18Hz, which corresponds to a very stiff soil.

**Figure 3.32.** Microtremor measurements at Explotacion Station

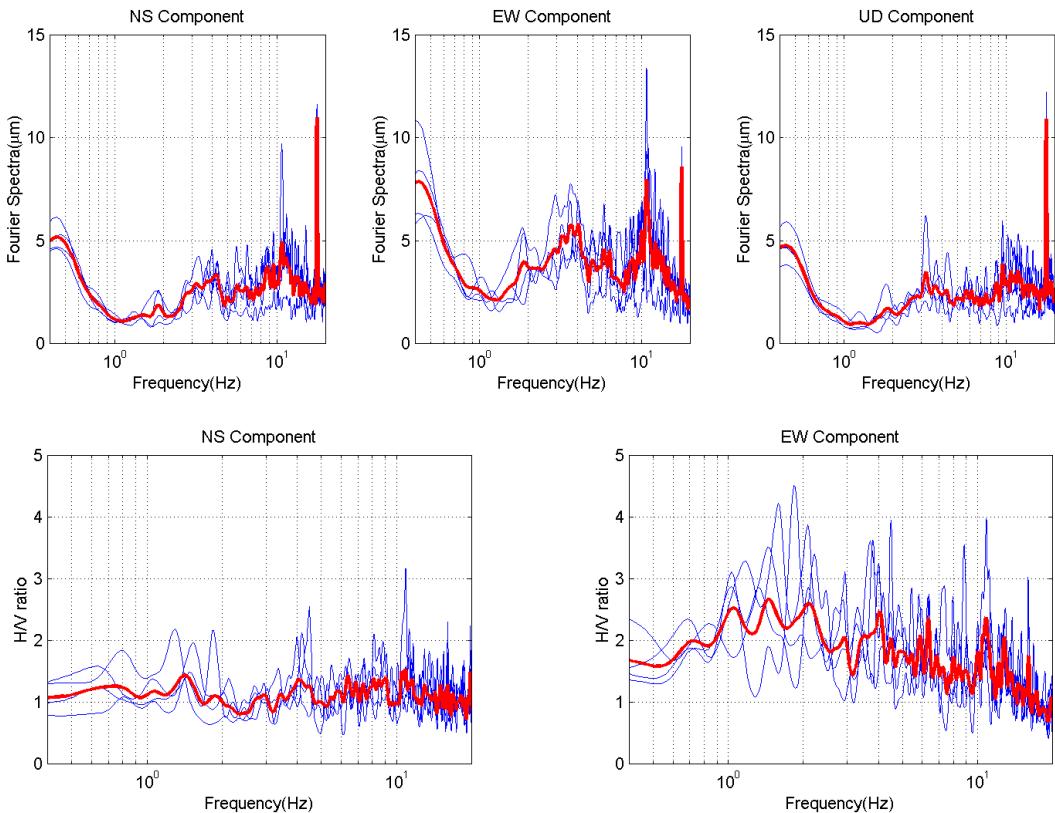
**Figure 3.33.** Microtremor measurements at Berlin

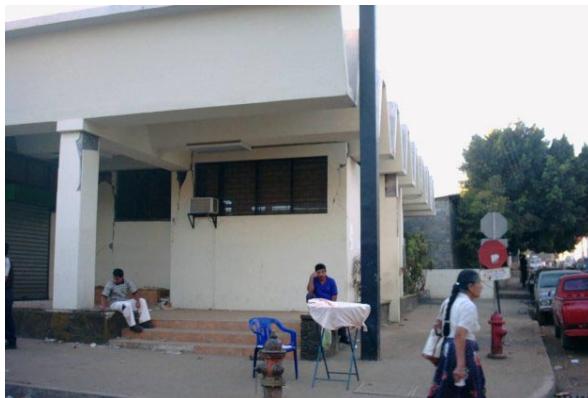
**Figure 3.34.** RC TELECOM building (Courtesy Mr. LaFolie).

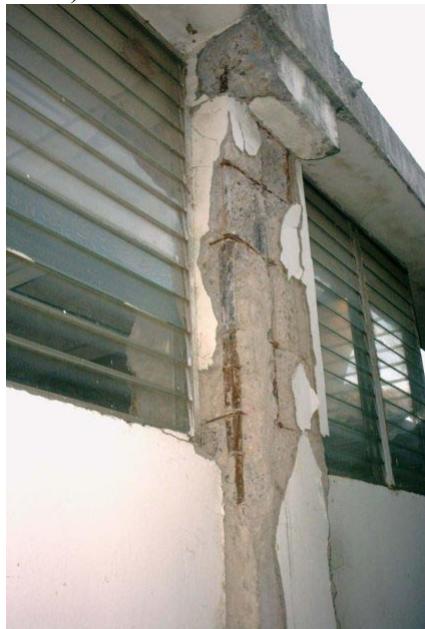
**Figure 3.35.** Typical damage in the TELECOM building. Thin concrete cover spalled (Courtesy Mr. LaFolie).

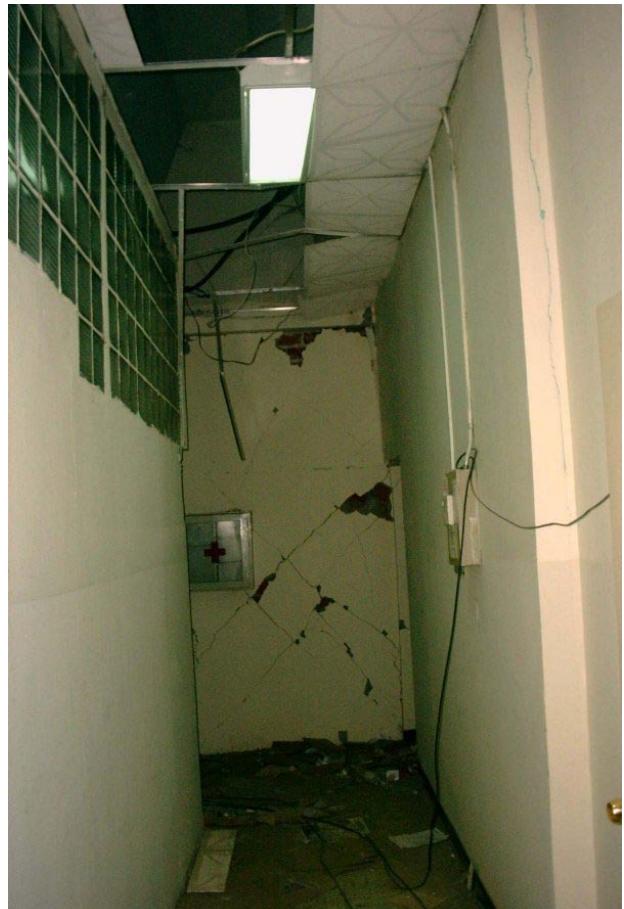
**Figure 3.36.** Typical damage in the TELECOM building (Courtesy Mr. LaFolie).

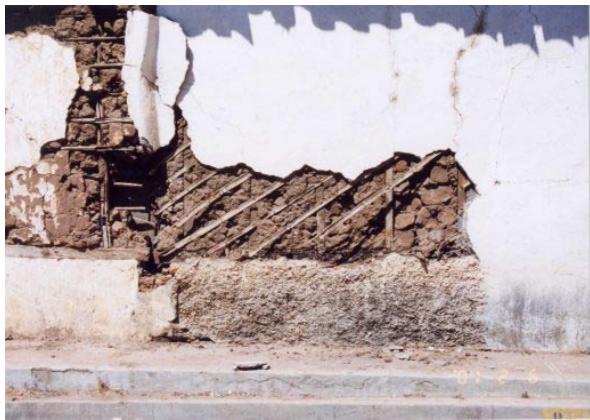
**Figure 3.37.** Spalling of the mud cover in a bahareque dwelling. The wall presents horizontal, vertical, and diagonal canes.

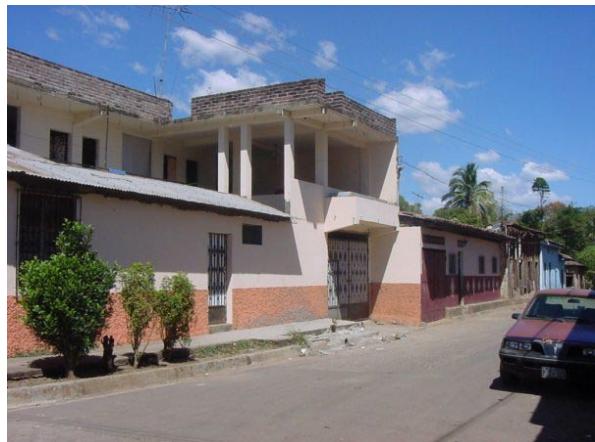
**Figure 3.38.** Reinforced masonry structure performed well.

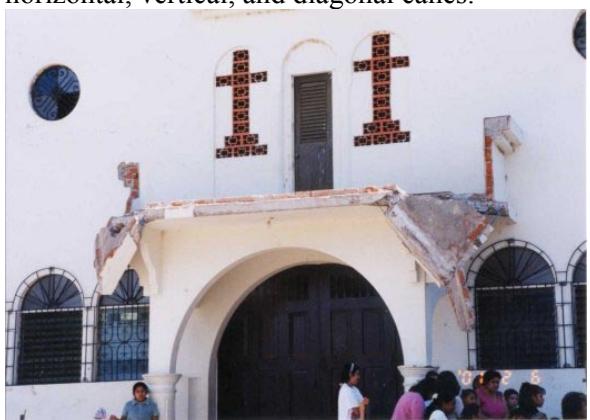
**Figure 3.39.** Failure of an unreinforced masonry parapet. The slab also shows insufficient reinforcement.

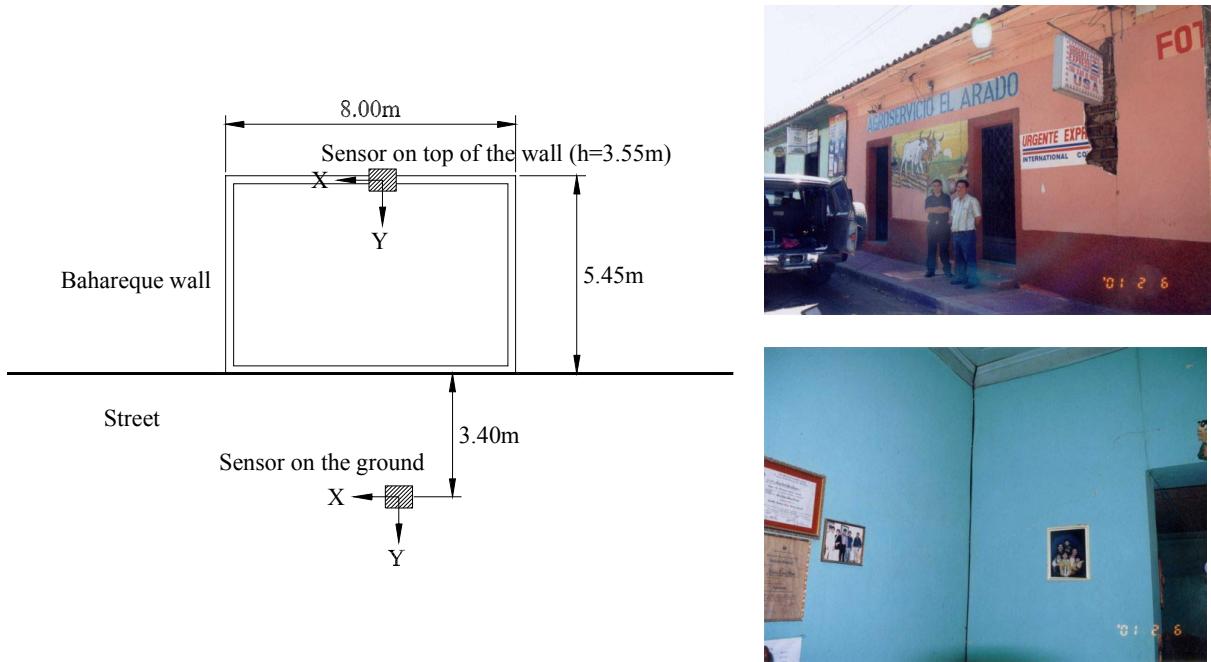
Microtremor measurements were carried out simultaneously on top of a bahareque house wall and at the ground level. The location of the house ( $89^{\circ}33.52\text{W}$ ,  $13^{\circ}41.41\text{N}$ ) and some views of it are shown in **Figure 3.40**. The house consisted of four walls (thickness=24cm; height=3.55m) and the roof composed of a wooden truss and ceramic tiles. The distance between the horizontal and vertical spreaders of the wall was 17 and 35cm, respectively. **Figure 3.40** also shows the location and orientation of the sensors used to measure microtremors (X: longitudinal direction; Y: transverse direction). In general, the house performed well during the earthquake. Only mud cover spalling and cover cracking was observed.

**Figure 3.40.** Surveyed bahareque house

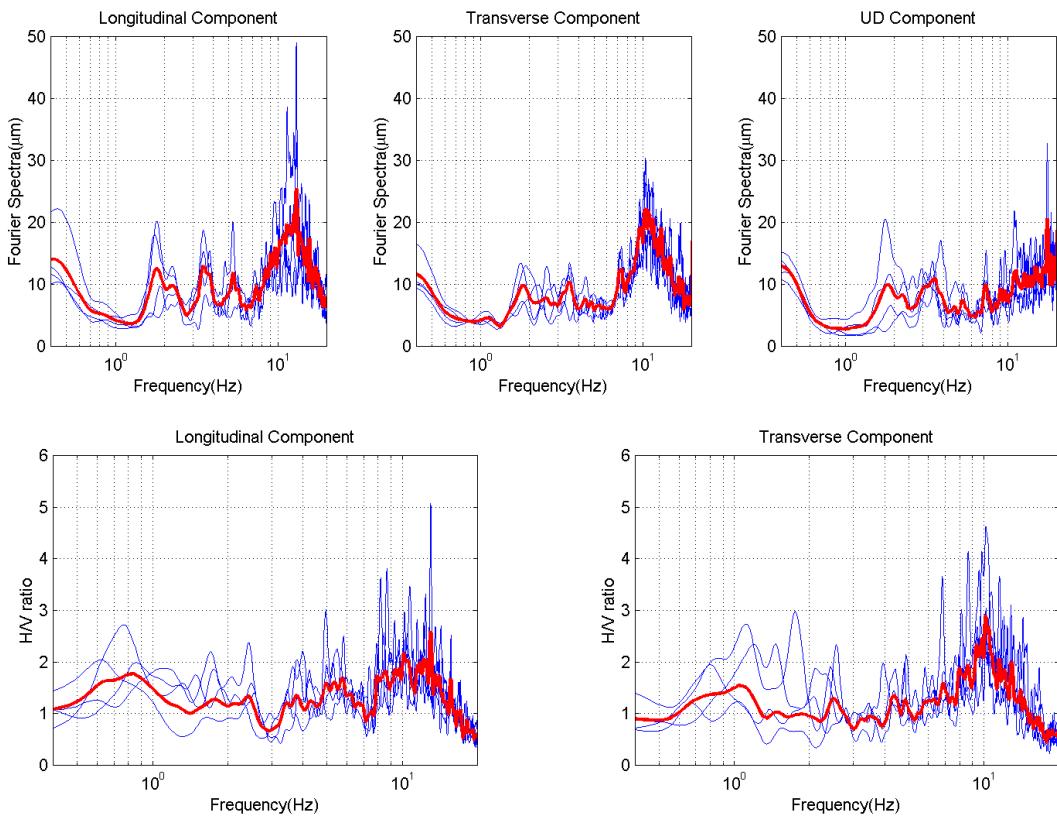
The Fourier Spectra of these three components recorded as well as the H/V ratio are shown in **Figure 3.41**. The H/V ratio graph does not show any clear peak, which might indicate a rocky type of site.

**Figure 3.41.** Microtremor Fourier Spectra at the ground level in San Julian

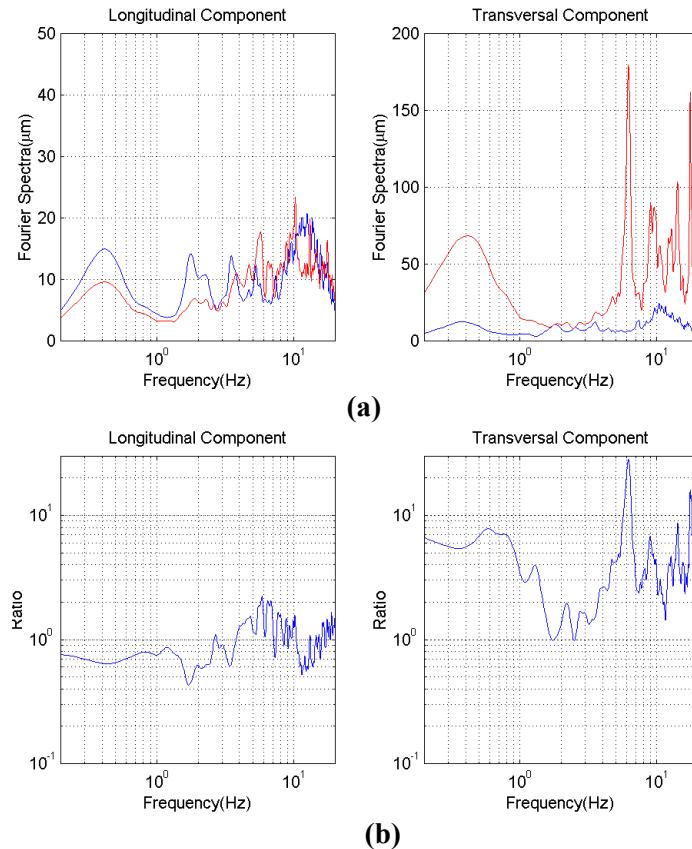
**Figure 3.42.** (a) Fourier spectra of the microtremors recorded on top of the bahareque wall (red) and at the ground level (blue); (b) Ratio of the microtremor Fourier spectra

For the analysis of the dynamic characteristics of the bahareque house, the Fourier Spectra of the microtremors recorded on top of the wall were divided by the corresponding microtremors at the ground surface. The results are shown in **Figure 3.42**.

In the longitudinal direction, a slight amplification of the components in the frequency range 4-10Hz can be observed. On the other hand, all frequency components are amplified in the transverse direction, especially at 6Hz. This might indicate that the predominant period is between 0.1 and 0.25sec in the longitudinal direction and 0.16sec in the transverse direction. The amplification of the motion in the transverse direction is higher than in the longitudinal, especially at 6Hz.

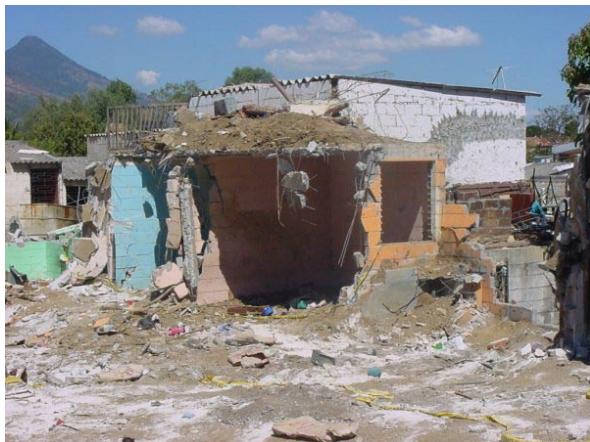
**Figure 3.43.** Concrete block dwelling affected by the landslide at Las Colinas. There is still soil on top of the roof.

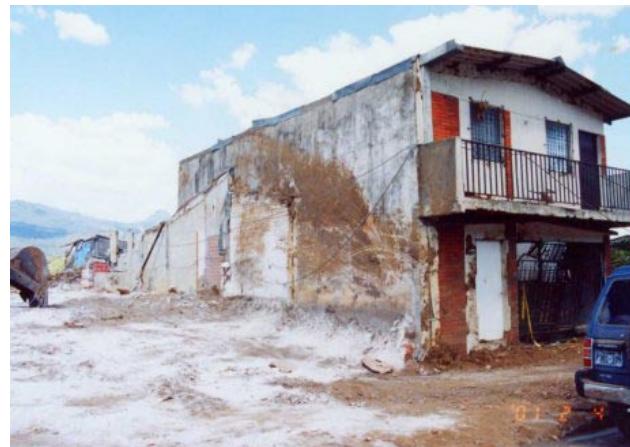
**Figure 3.44.** Dwelling on the border of the landslide. Neither the earthquake ground shake nor the landslide affected this dwelling.

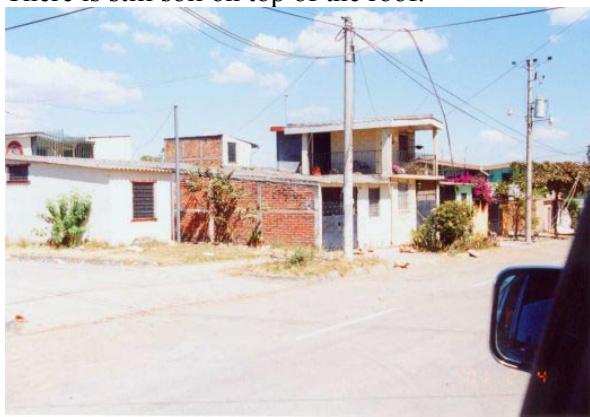
**Figure 3.45.** Reinforced masonry dwellings few meters away from the landslide did not suffer any damage.

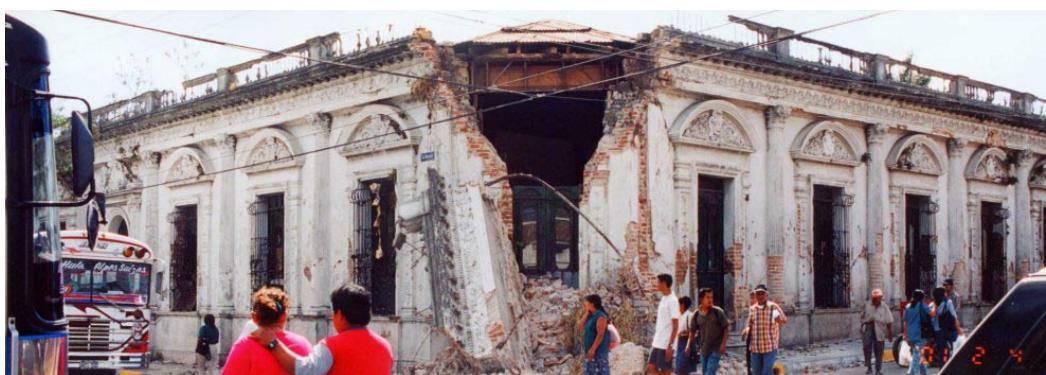
**Figure 3.46.** Unreinforced masonry structure suffered structural damage at the historical center of Nueva San Salvador.

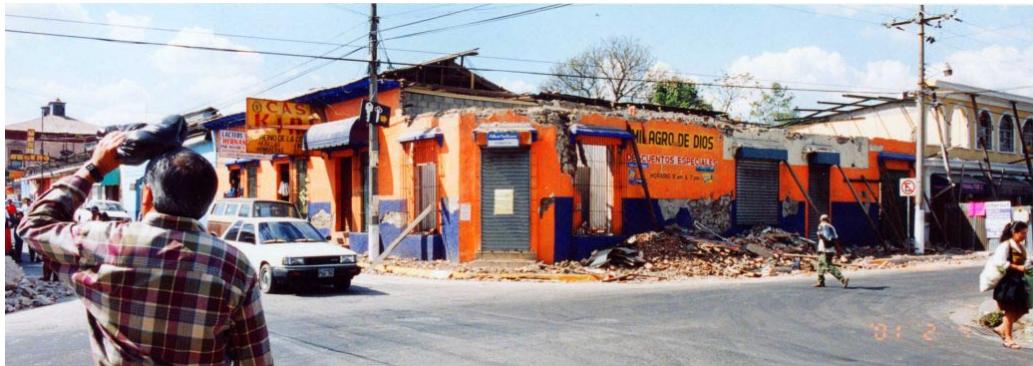
**Figure 3.47.** Adobe construction suffered damage at Nueva San Salvador.

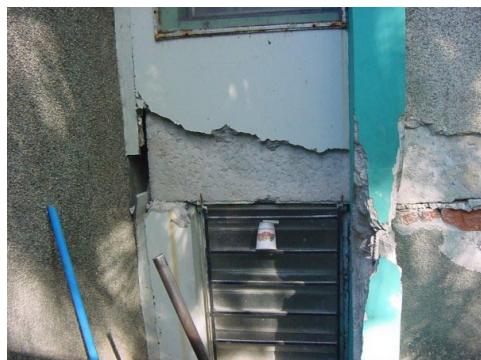
**Figure 3.48.** Finishing spalling. The seismic joint between two adjacent buildings was 5cm. No evidence of pounding was observed.

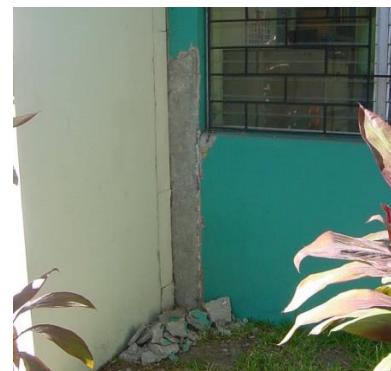
**Figure 3.49.** A thin layer of styrofoam was placed between the window splay and the column of the main structure.
