## 4.3 WATER SUPPLY SYSTEM

## 4.4 TRANSPORTATION

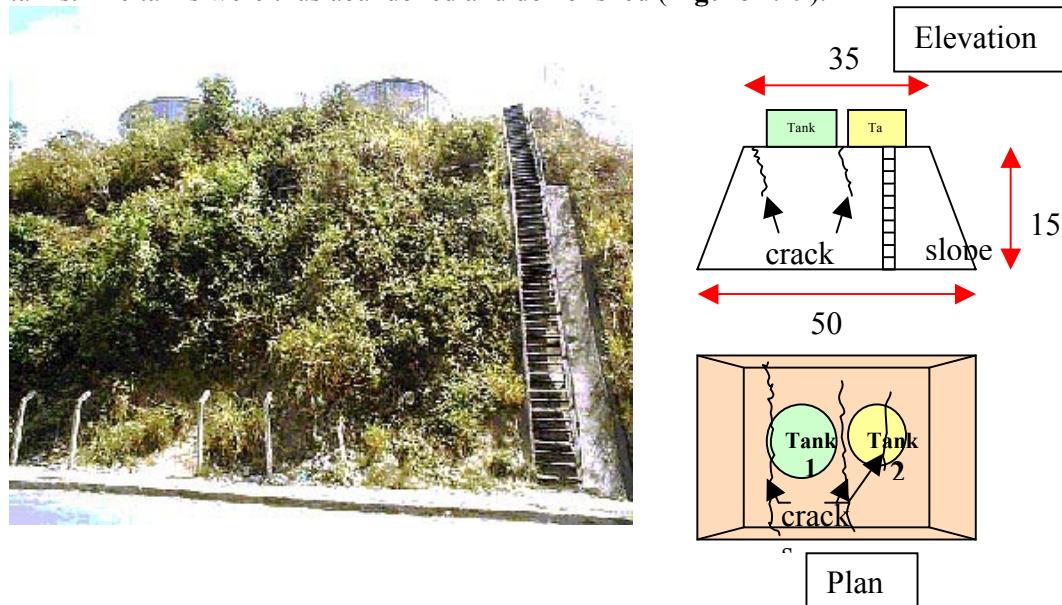
Water tanks are often constructed on hilltops and thin mountain ridges so that they can supply waters to widely spread areas. A typical wall of a water tank in El Salvador is a cylindrical shell of reinforced masonry or reinforced concrete. Two tanks of “*Las Colinas del Norte*” are located on a thin hilltop of Apopa Town (**Figure 4.18**). There appeared extensive 1m-deep cracks on the top terrace as illustrated in **Figure 4.18**. Paved walkways around the tanks were fissured. The cracks were certainly a serious threat for about 200 houses around the hill of a possible landslide that can carry off foot soils of the tanks. The tanks were thus abandoned and demolished (**Figure 4.19**).

**Figure 4.18.** Tanks on a thin hilltop, “*Las Colinas del Norte*”, Apopa

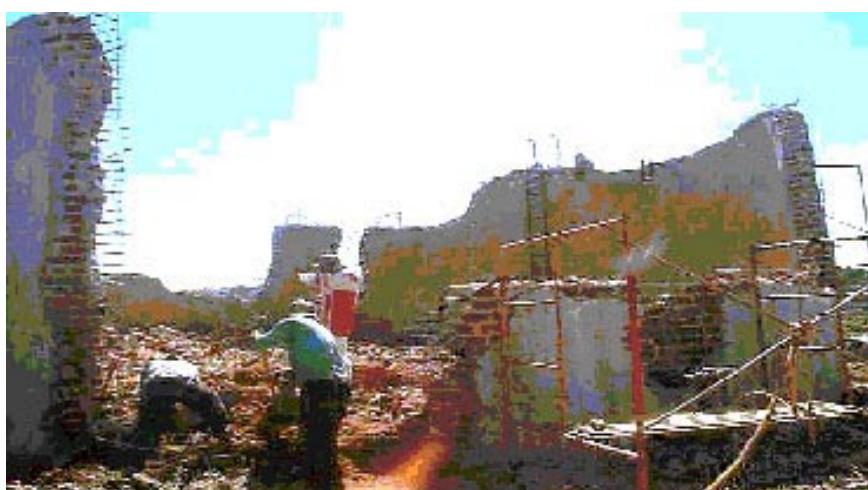
**Figure 4.19.** Reinforced Masonry wal of “*Las Colinas del Norte*” tank

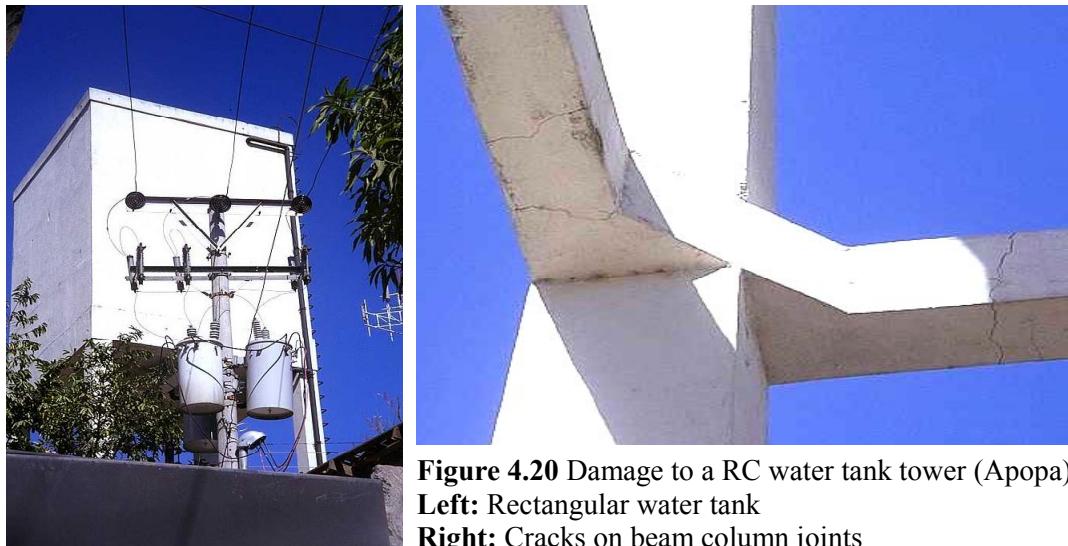
RC towers for some elevated water tanks were cracked. Beam-column joints of these towers carrying heavy tanks are the most susceptible to intense shakes (See **Figures 4.20 left and right**). Intense ground motions, however, were not the sole cause of the damage to the towers. At San Luis Talpa, Comalapa, RC columns were arranged in octagon and joined together slightly above their bottom ends with an octagonal RC frame. Cracks were mostly found on the mid-span of each side of the horizontal RC frame. The cause of this cracking may be attributed to unequal settlement of the column foundations (**Figure 4.21**), which settlement could induce some unexpected torque within the beams.

**Figure 4.20** Damage to a RC water tank tower (Apopa)  
Left: Rectangular water tank  
Right: Cracks on beam column joints

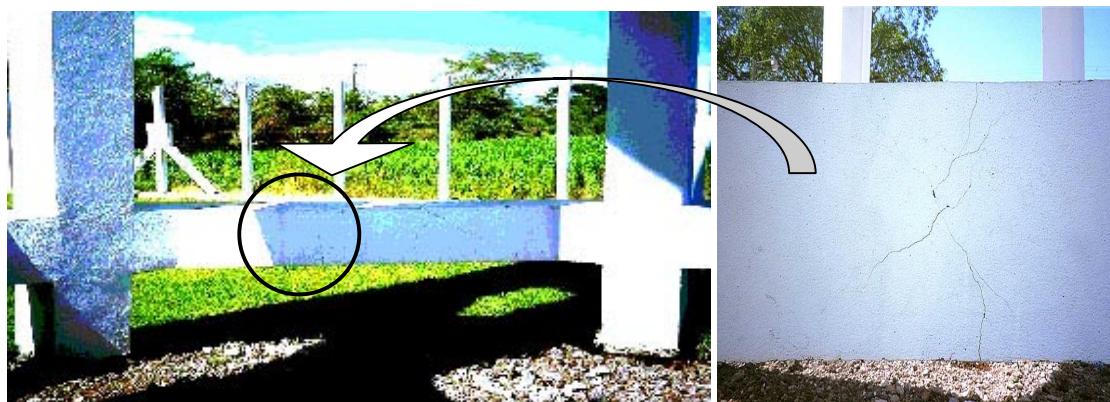
**Figure 4.21.** Damage to a RC water tank  
tower (San Luis Talpa, Comalapa)

**above:** Cracks and spalling of a RC beam  
at the bottom end of the tower

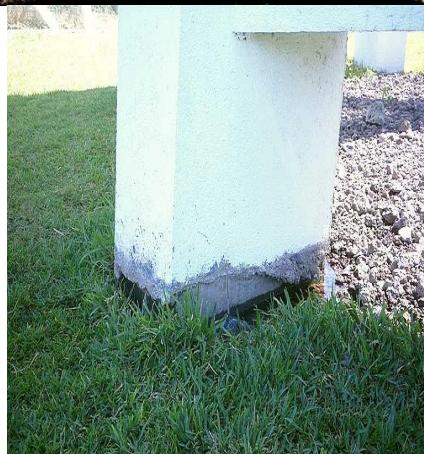
**below:** uneven subsidence of foot soil

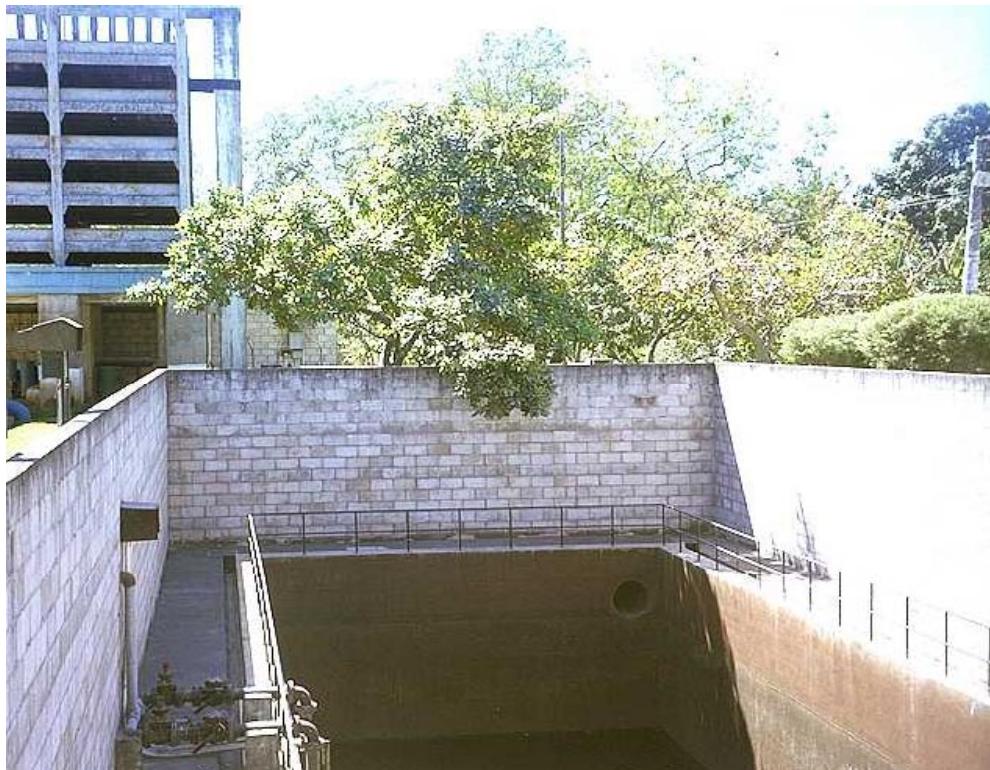
A 50m long sedimentation basin at Guluchapa Treatment Plant, Ilopango, takes 300 m<sup>3</sup> water from Cuaya River and neighboring wells (**Figure 4.22**). The continuous concrete bottom slab of this basin was cracked, and the possibility of introducing watertight joints was discussed in its restoring work. Cracks were also found on construction joints on the walls surrounding a filtering facility (**Figure 4.23**).

**Figure 4.22.** A 300 m<sup>3</sup> sedimentation basin at Guluchapa Treatment Plant, Ilopango.  
The bottom slab was cracked

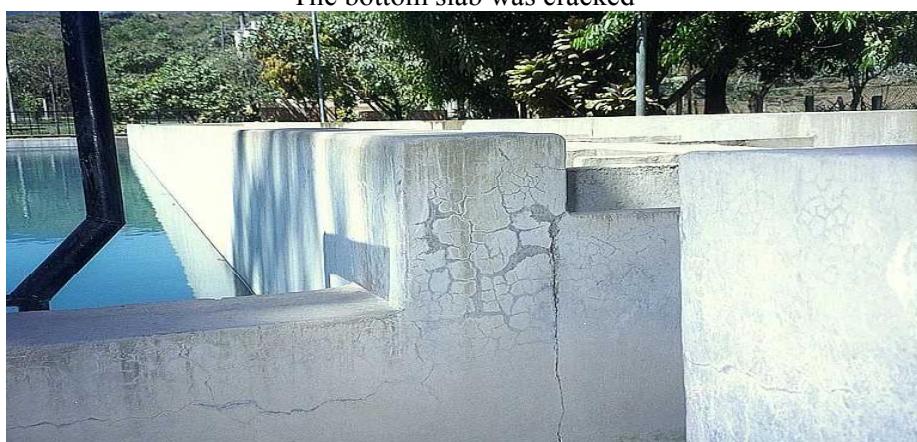
**Figure 4.23.** Cracks on construction joints on RC walls surrounding filtering facility

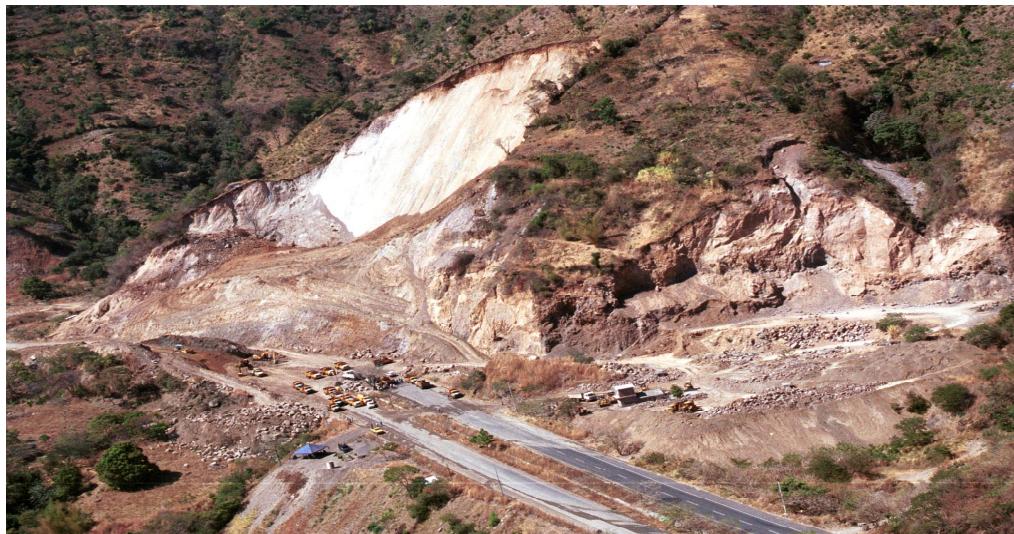
The most significant traffic disruption was due to the blocking of the Pan-American mountain highway by a large landslide (see **Section 3.5**) at the curve “Leona” to the East of San Vicente. The coastal highway “El Litoral” became an alternative traffic route for several weeks while the Pan-American highway was being cleared from the 100,000 m<sup>3</sup> slide (**Figure 4.25**). Two of the four lanes of the highway were re-opened for restricted traffic following the earthquake.

**Figure 4.25.** Landslide at “Leona” blocking the Pan-American Highway.

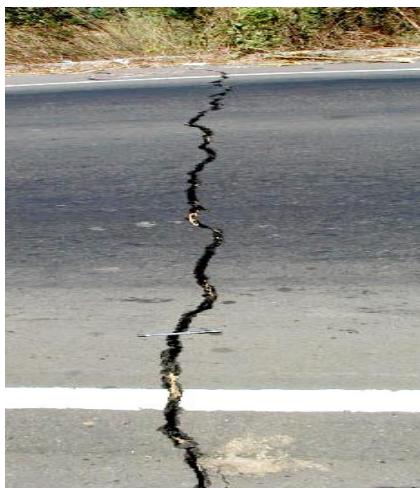
Other damage to the main routes includes cracks crossing the “El Litoral” and the route to the International Airport (see **Figures 4.26** and **4.27**).

**Figure 4.26.** Horizontal Crack at Km 78 of El Litoral highway.

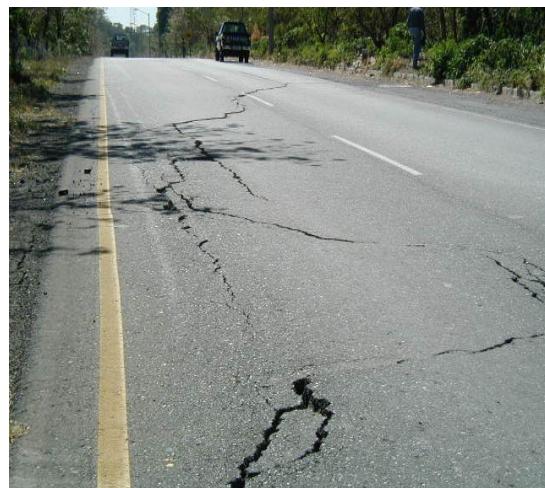
**Figure 4.27.** Cracks at Km 19 ½ of Comalapa Road.

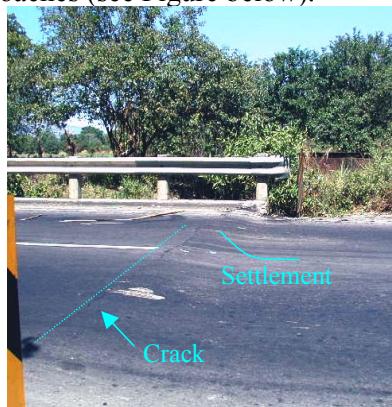
In general, bridges sustained no or very little damage. The most affected bridges were found in the central western part of El Salvador (Sonsonate, Comasagua, Zacatecoluca, Comalapa, and Usulután departments) where minor damage such as settlements and cracks were commonly observed at the bridge approaches (see Figure below).

**Figure 4.28.** Settlement of a bridge approach

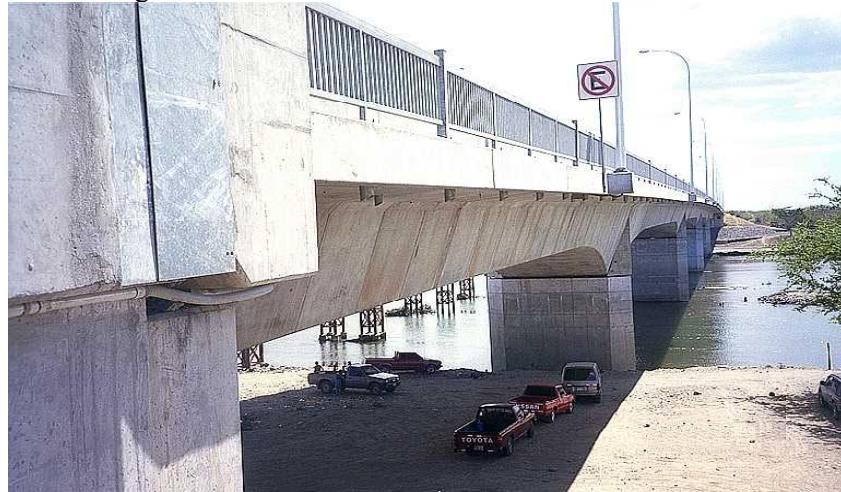
The recently constructed San Marcos Lempa bridge, spanning the River Lempa sustained only superficial concrete cracks and buckling of expansion joint covers and typically observed settlement and cracks at the west bridge abutment.

**Figure 4.29.** San Marcos Lempa Bridge.

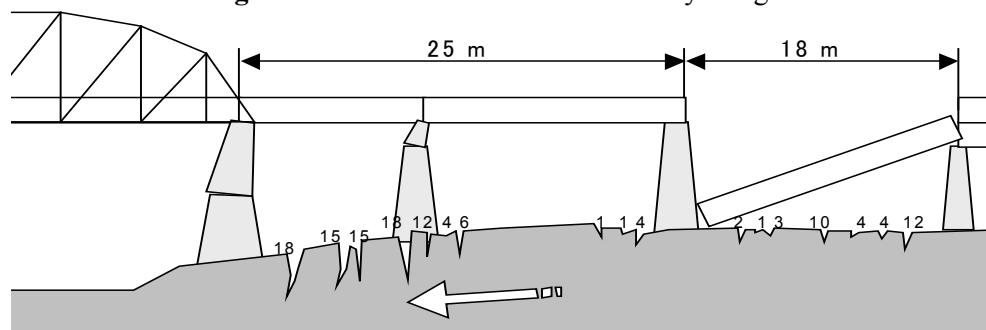
Liquefaction was observed along the riversides, but it did not cause any damage to the San Marcos Lempa Bridge. Next to the San Marco Lempa Bridge stands a 65-year-old railway bridge, "El Puente de Oro" (The golden bridge, **Figure 4.30**). Liquefaction induced lateral spreading with up to 18 cm wide cracks toppled one of its simple supported spans and cracked its concrete piers as shown in **Figure 4.31** below.

**Figure 4.31.** Sketch of toppled span and cracked piers caused by lateral spreading.

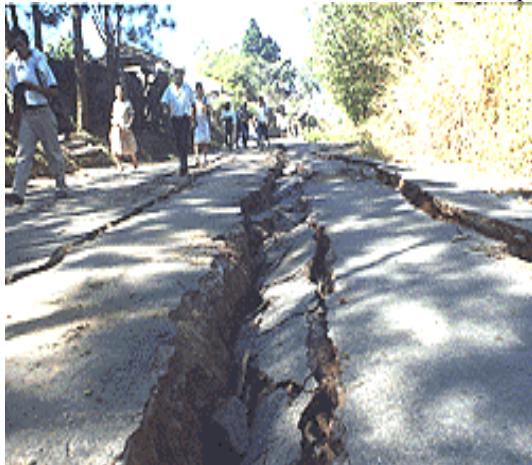
Typical widespread damage consists of slope failure and rock fall debris blocking the roads and embankment deformations causing cracks especially in unpaved roads. Debris from collapsed dwellings block roads at many locations. **Figures 4.22 and 4.33** show some typical damage. Most block roads were cleared from debris and re-opened for traffic within 24 hours of the Earthquake.

**Figure 4.32.** Longitudinal cracks in road to Comasagua, La Libertad

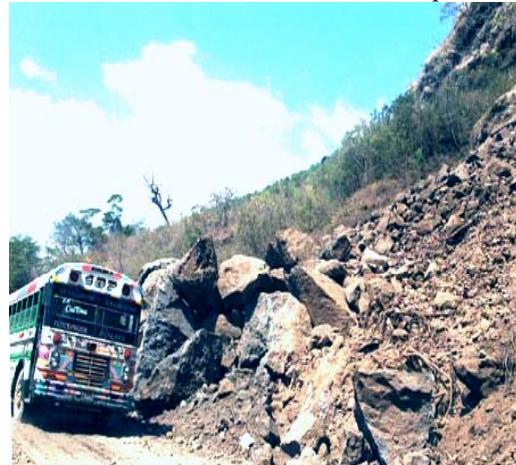
**Figure 4.33.** Rock fall blocking the road to Teotepeque, Jicalapa, La Libertad

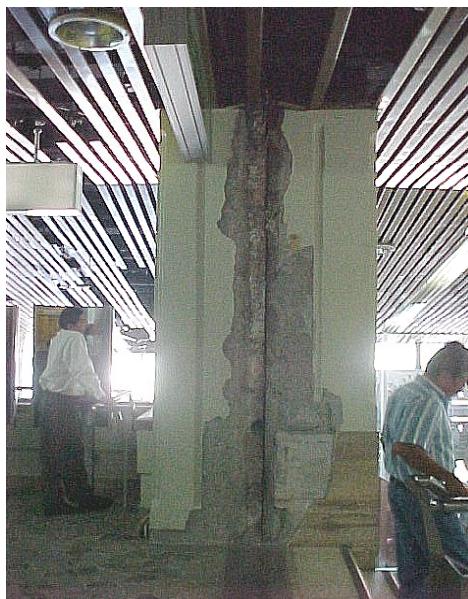
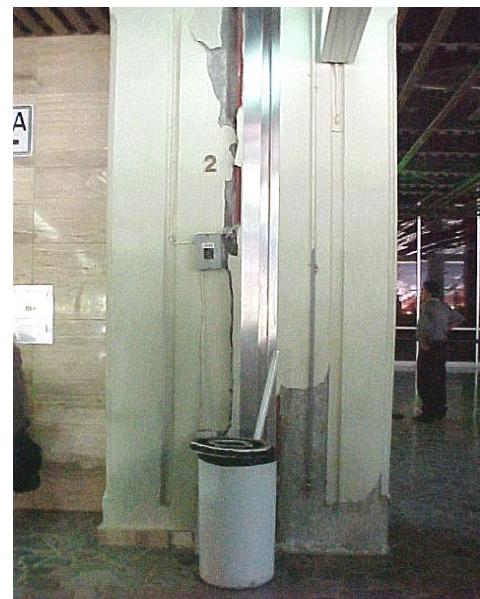
**Figure 4.34.** Spalling of concrete columns

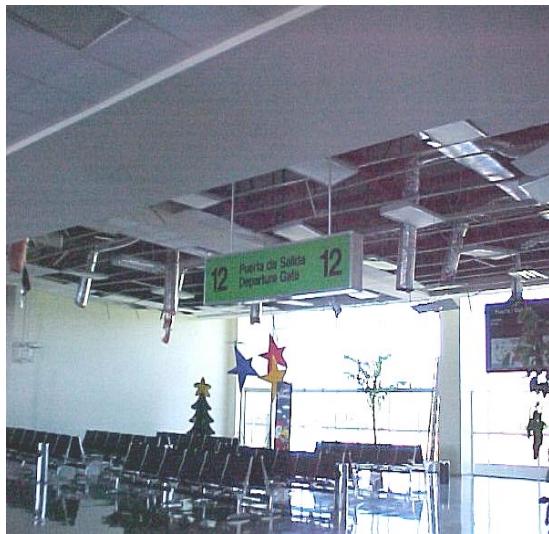
On the second and third floors, there were clear marks of pounding remaining on some expansion joints between building blocks. Several walls were moderately cracked. Ceiling panels came off (**Figure 4.35**), and about 80% of the air conditioners and signs fell down. A reinforced masonry wall near boarding gates was cracked along mortar block joints (**Figure 4.36**). On the third floor, about 75% of the windows were left unusable because their window frames were deformed.

**Figure 4.35.** Damage to ceiling panels (passengers waiting room)

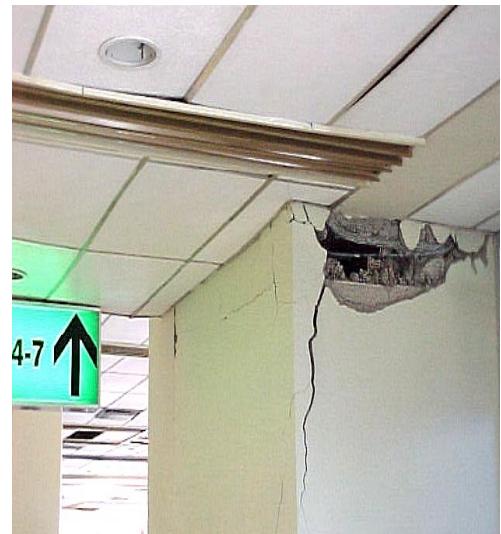
**Figure 4.36.** Reinforced masonry wall near boarding gates cracked along mortar block joints

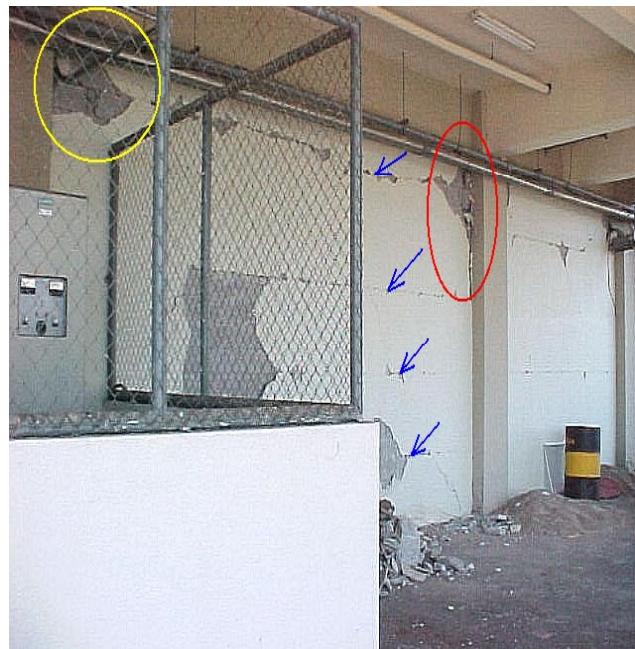
Cracks were found in other RC buildings in AIES-I and AIES-II, newly extended zones of the airport. Lateral and diagonal cracks appeared on some infill walls (**Figure 4.37**). A short RC column carrying thick beams sustained heavy damage (**Figure 4.38**). Transverse and longitudinal cracks appeared on runways and their approaches (**Figure 4.39**). These cracks, however, turned out to be less serious for aircrafts to pass.

**Figure 4.37.** Lateral and diagonal cracks appeared on some infill walls

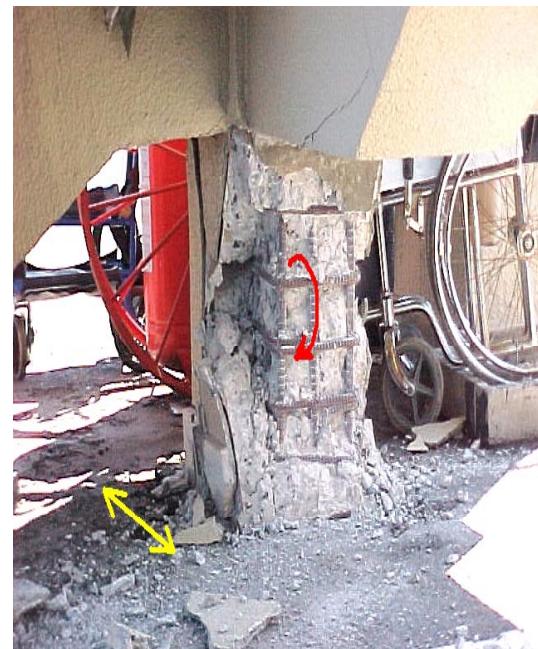
**Figure 4.38.** Crumbled short RC column

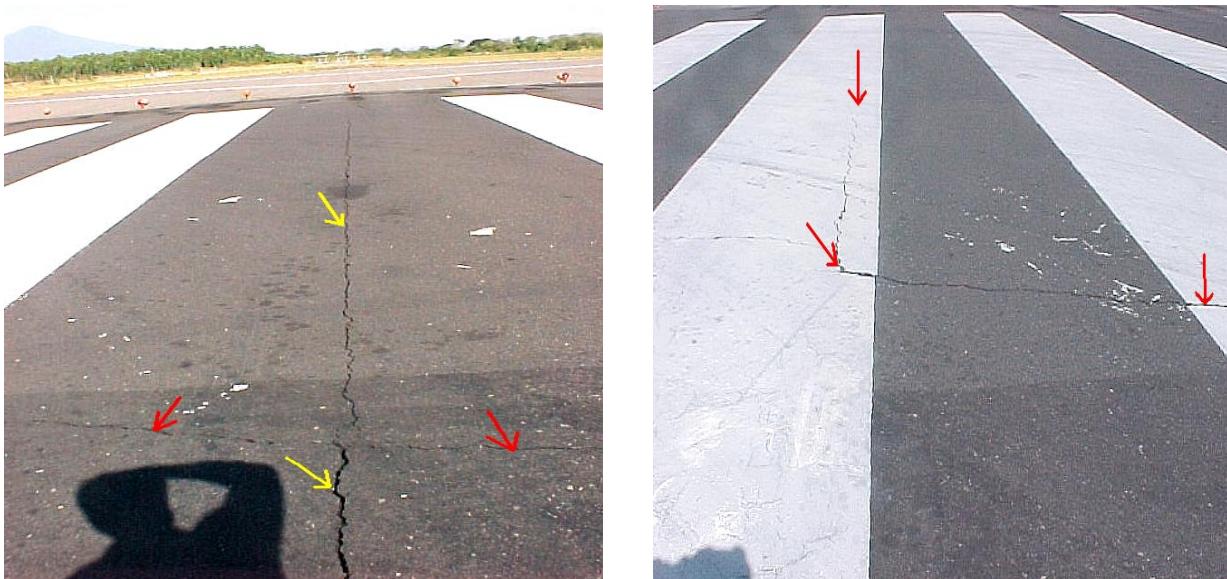
Figure 4.39. Transverse and longitudinal cracks appeared on runways and their approaches
