2.5 LAS COLINAS LANDSLIDE

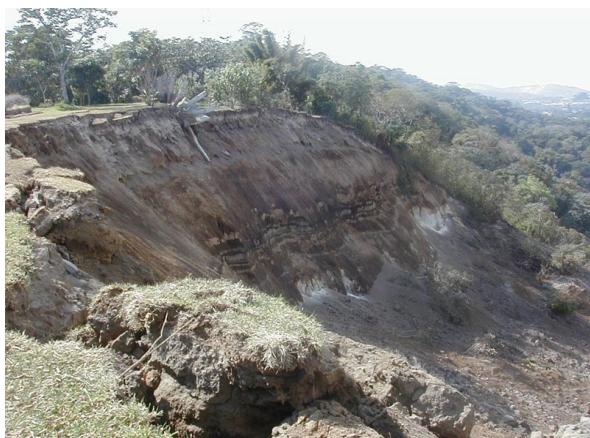
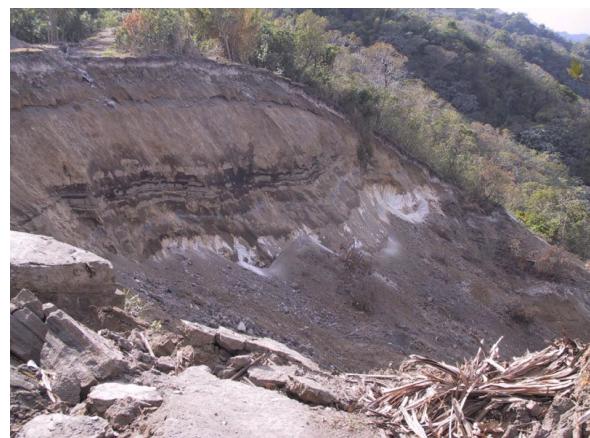
Two photos (**Figure 2.19**) of the same soil layers appearing on the west half of the uppermost scarp were taken on January 14 and February 4, respectively. Dark and blight colored stripes appearing on the scarp shows a stratified soil profile with the top lapilli tuff layer of about 2.0 m thickness overlying a pair of two differently colored (ocher and white) pumice layers of about 11.9m thickness. Some bedding planes separate the lapilli tuff into some sub-layers of varying thickness (10cm to 25cm). Dark brown color of soil indicates that the soil is moistened, and this pair of photos shows that the dark colored stripes were steadily thinning, in other words, exposed soils were drying. This fact may evidence that the intact soils along the slip surface were wet before the event. Beneath the dark and wet soils, there appear white and/or ochre colored pumice soils. They were also moistened and weakly cemented. The pumice is easily broken into small pieces or into powder just by rubbing together with fingers. Broken fragments of this pumice have sub-angular or angular shapes. Some pieces were medium-sized (1 mm × 4 mm × 7 mm for example) and some were fairly large reaching 12 mm × 25 mm × 35 mm (**Figure 2.20**). As shown in **Figure 2.21**, cracks and joints were observed even on an intact part of pumice.

Figure 2.19 West slope of main scarp

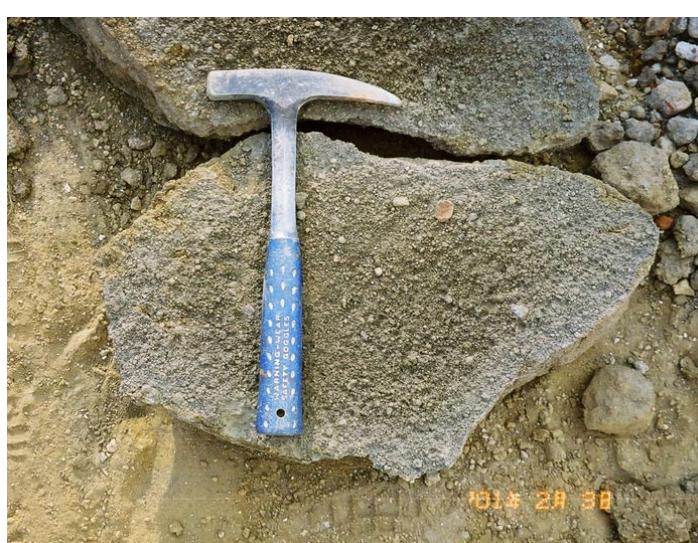
Figure 2.20 A piece of lapilli tuff

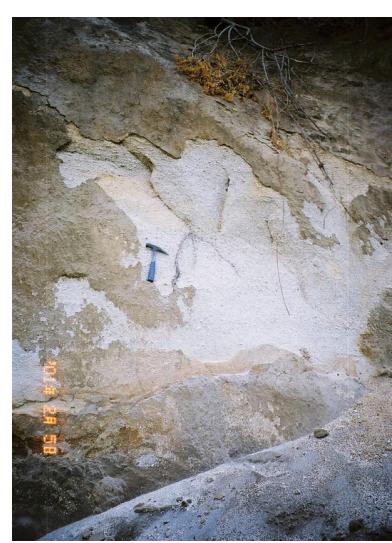
Figure 2.21 Cracks and joints on the exposed intact pumice

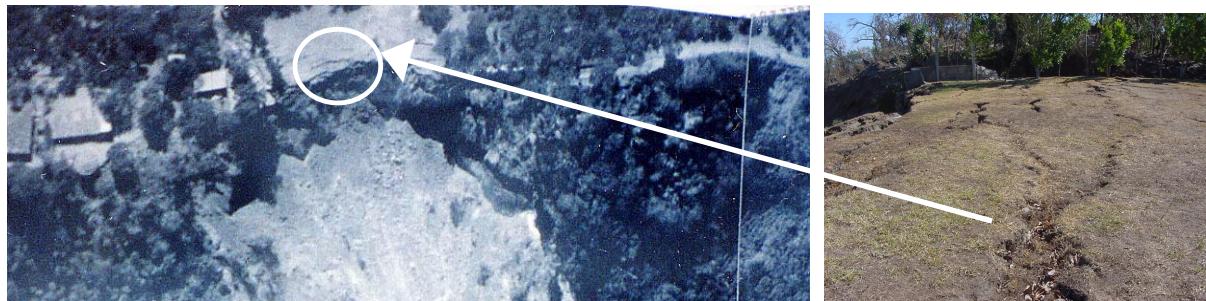
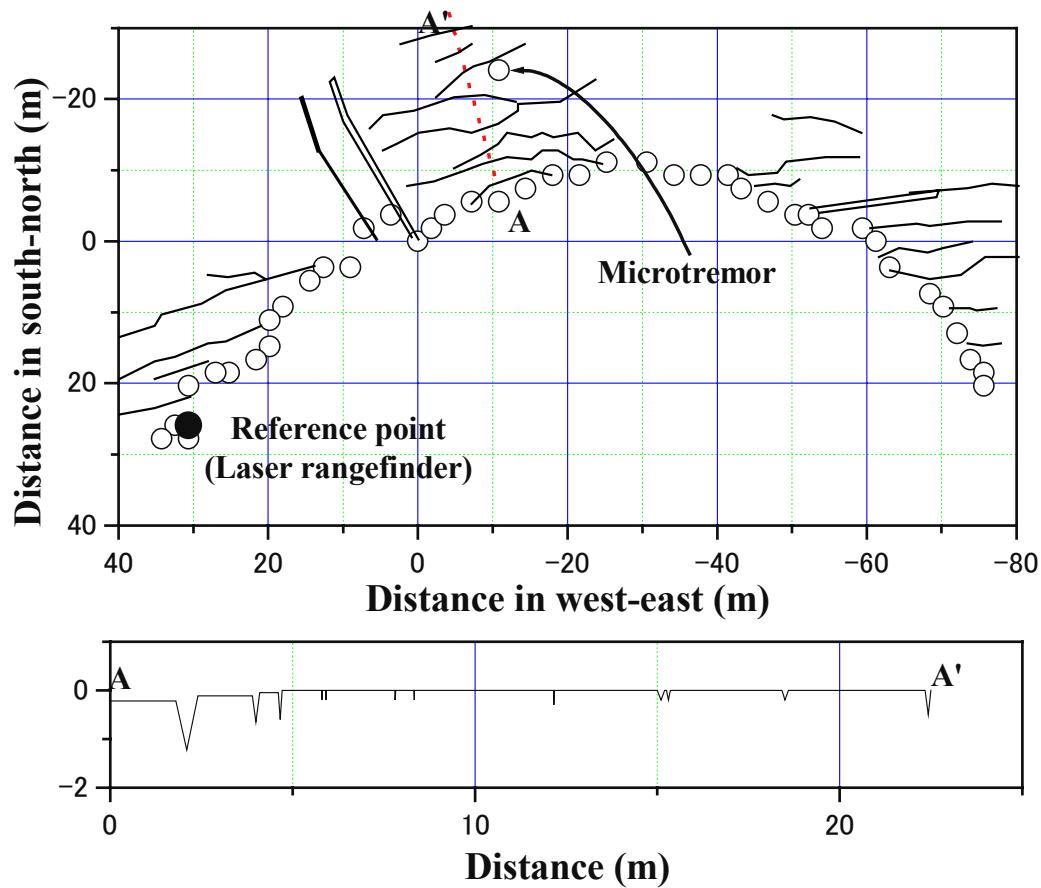
Figure 2.22. Perimeter of scar, Las Colinas Landslide

Total 43 points were marked along the perimeter of the scar using a GPS receiver (**Figure 2.22**). Behind the scar, there were extensive cracks running in almost west-east (See photos in **Figure 2.22**). Crack openings (12 visible cracks; **Table 2.2** and **Figure 2.22**) were measured along Line A-A'. Total 1.25 m's opening was reached over the 22 m's distance of Line A-A'. Namely, about 5% average strain was induced within the soil behind the scar. Extensive cracks were found along the ridge crest even in areas that did not slide (see **Figure 2.12**); the cracks can certainly cause further slides.

Cracks appearing on the top terrace behind the scar (**Zone 1**): Cracks map is shown below.

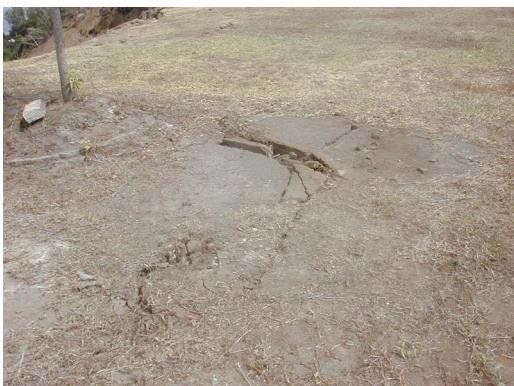
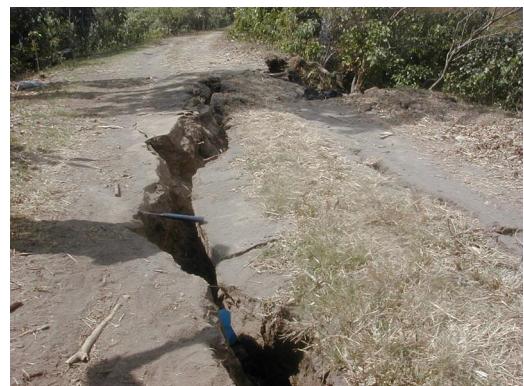
Figure 2.23. Crack at the top terrace (photographed on Jan. 14 by Mr. Jose Antonio Rivas)

A pair of photos (**Figure 2.23** by Jose Antonio Riva, Geotérmica Salvadoreña) was taken on January 14, a day after the earthquake. Both pictures show that edges of cracks were lightly dusted with fine sand. This fact may evidence that the landslide caused some soils to liquefy though the underground water level did not seem to be substantially high from the field observation. There was no written material available showing the possible underground water level.

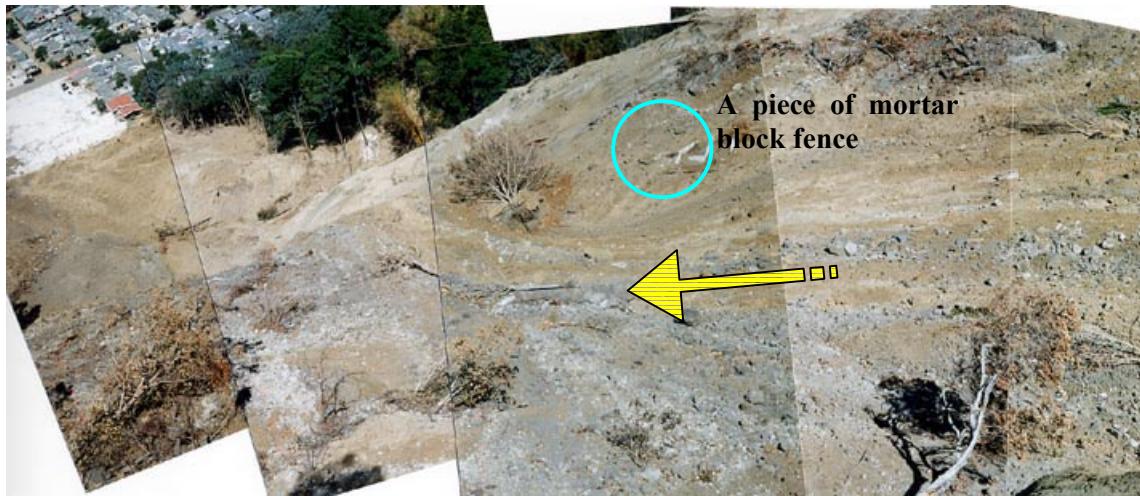
There are some downward streaks remaining on the bottom of the upper hollow (arrow in **Figure 2.24**), and broken pieces of a mortar-block fence were caught on the soil mass remaining on the outer edge of the hollow (arrow in **Figure 2.25**). These may evidence that most soil mass, which originally fitted into the hollow, seems to have been pushed forward, and flown down the lower steep slope. Along the streaks, a number of broken pieces of lapilli tuff and some uprooted trees were found. The largest piece of the lapilli tuff remaining there was 88 cm×64 cm×14 cm.

Figure 2.24. Lower part of the hollow: A piece of mortar block fence (within the circle) is caught on the small amount of the soil mass stopped at the lower edge of the hollow.

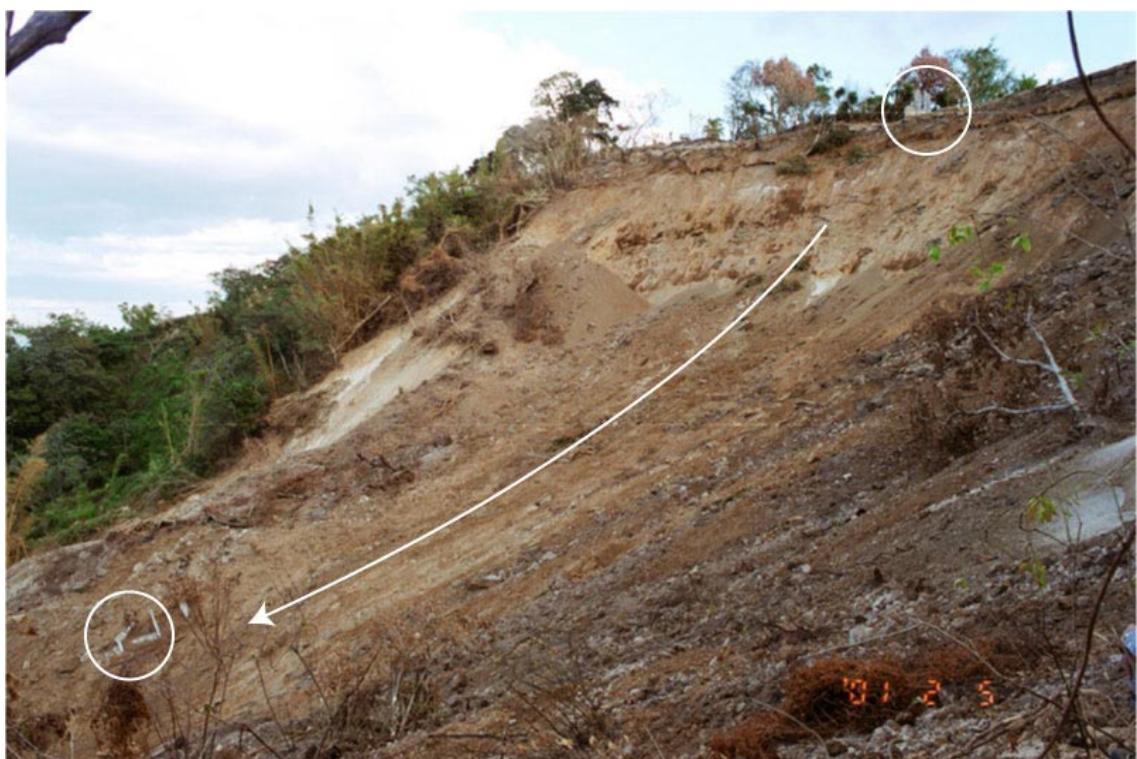
Figure 2.25. Fallen block fence

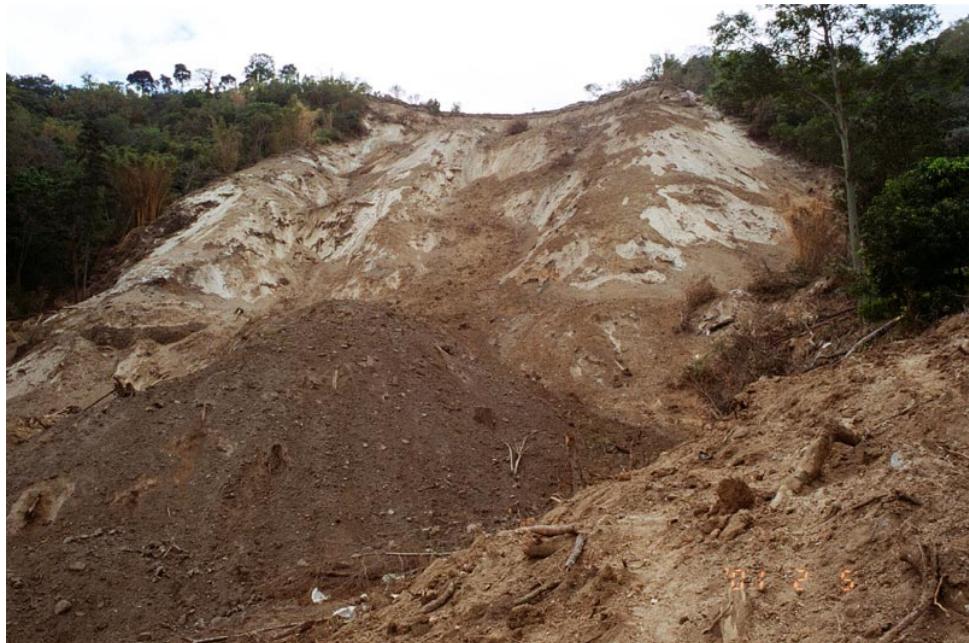
Figure 2.26 shows the lapilli tuff exposed on the lower steep slope (**Zone 2**). This surface exhibits an arrangement of volcanic products in strata of varying thickness (7 to 30 cm) and about general 10 degrees dip toward the toe of the slope.

Figure 2.26. Steep slope (**Zone 2**)

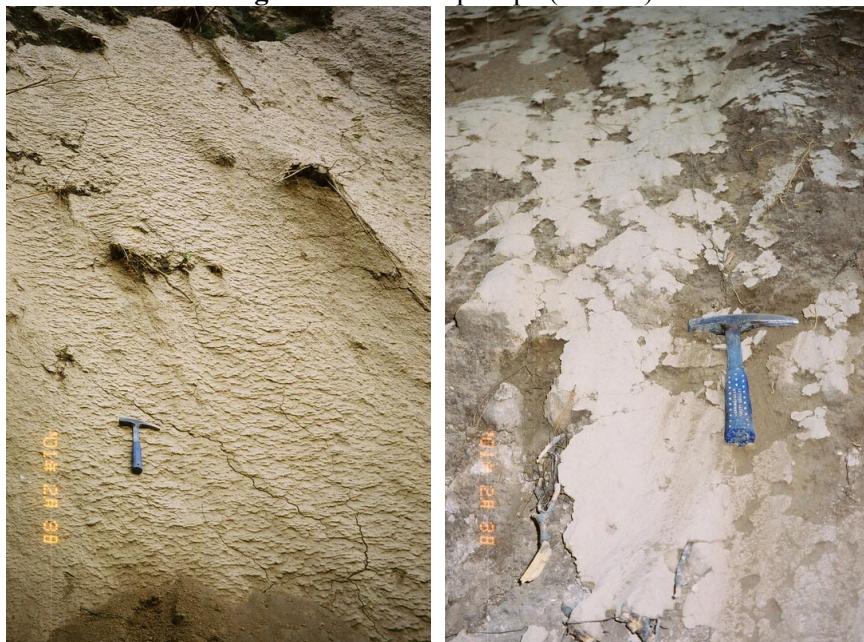
As shown in **Figure 2.27**, the steepest slope in **Zone 2** was covered thin with a film of mud including porous fragments of pumice; the film was noticeably stiff after totally dried up. The film covered trees, bamboo and other plants pushed down on the slope. This fact suggests that the original slope in **Zone 2** was not scraped off, and is consistent with the result from the 3D survey of the slope configuration. This fact also suggests that the bottom surface of the slid soil mass was wet, and may have liquefied (Sassa, 2000), possibly related to some weak tephra layers spreading over less permeable paleosols.

Figure 2.27. Thin mud film

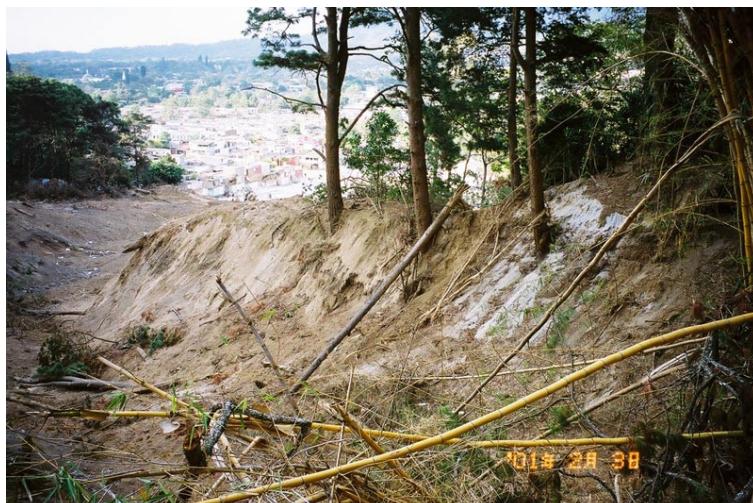
The slid soil mass seems to have surged across a small ravine coming down from east mountainside, and splashed up a small bank. Some splashes were remaining 6-8 m high on some tree trunks on this bank (**Figure 2.28**). The huge amount of slid soil mass flooded many houses and thus caused more than 500 deaths. A complete view of Zone 3 was taken from the toe of the exposed slip surface (**Figure 2.29a**). The slid soil mass and destroyed houses had been removed, and the cleared area was totally white with disinfectant.

Figure 2.28. Toe of the slope

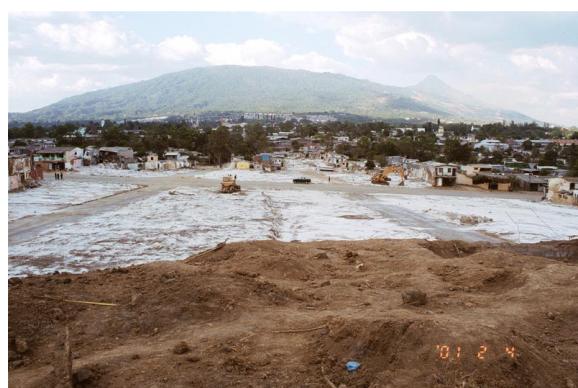
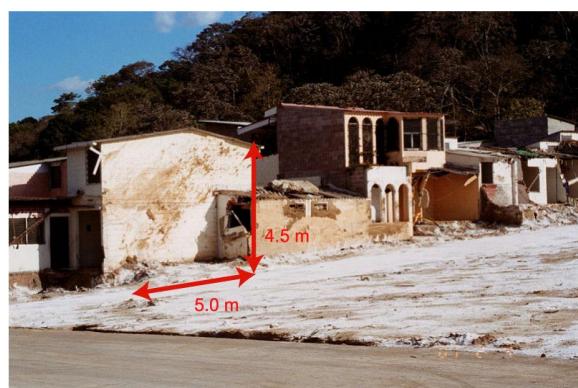
Figure 2.29. Photos from Zone 3

There were many splashes of mud remaining on house walls, trees and etc. In general, the splashes seem to be higher at around the toe of the slope than those in the middle or close to the distal end of the soil deposition zone. The highest splash of about 8 m was found on a trunk near the toe. **Figure 2.29b** shows the walls of a dwelling on the eastside perimeter of the slid soil mass, the wall spotting in parabola with mud splashes. The parabola with its peak of about 4.5m high drops downward, and reaches the ground after about a 5m horizontal run. This fact suggests that the time t needed for the splashes to reach the ground from their peak height $\Delta h (= 4.5 \text{ m})$ was about 1s ($\Delta h = g \cdot t^2 / 2$), and during this time, the splashes ran about the 5m horizontal distance (5 m/s). The main stream of the soil mass flow might have faster than this speed after running through dwellings standing close together.

(a) Complete view of Zone 3
(Feb. 4, 2001)

(b) House wall spotting with splashes
