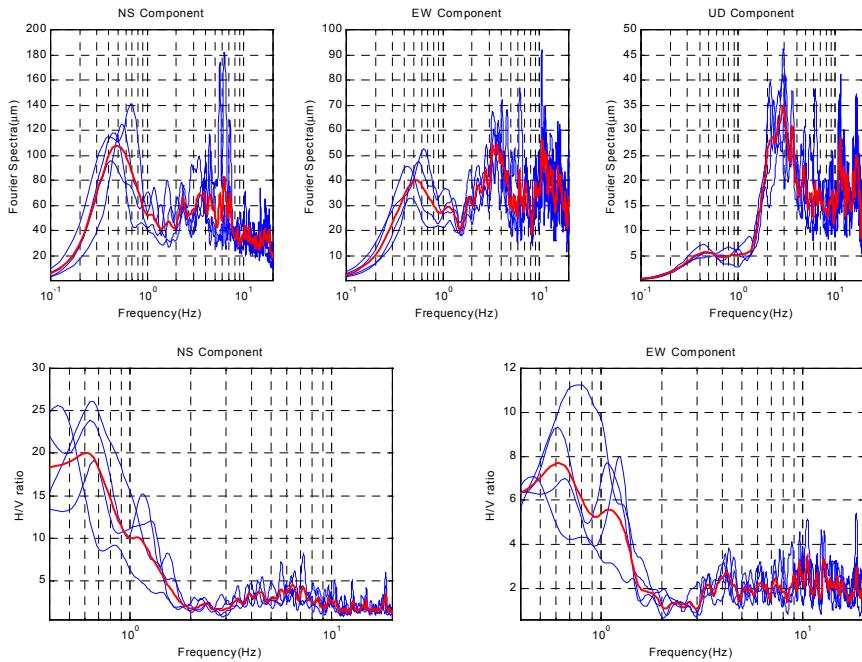
Fourier Spectra of three components of the tremor as well as the H/V ratios are shown in **Figures 2.47** and **2.48**. Thin (blue) lines correspond to four separate windows of 40.96sec opening and the thick (red) lines show the averages. At the top of the ridge, two peaks at 0.6 and 1.1Hz (on the H/V diagram) are distinguished for the EW and NS components, while 0.75Hz component in NS direction is predominant at the toe, and no clear peak is observed for the EW component there.

Figure 2.47. Fourier spectra of microtremors at the top of El Balsamo ridge

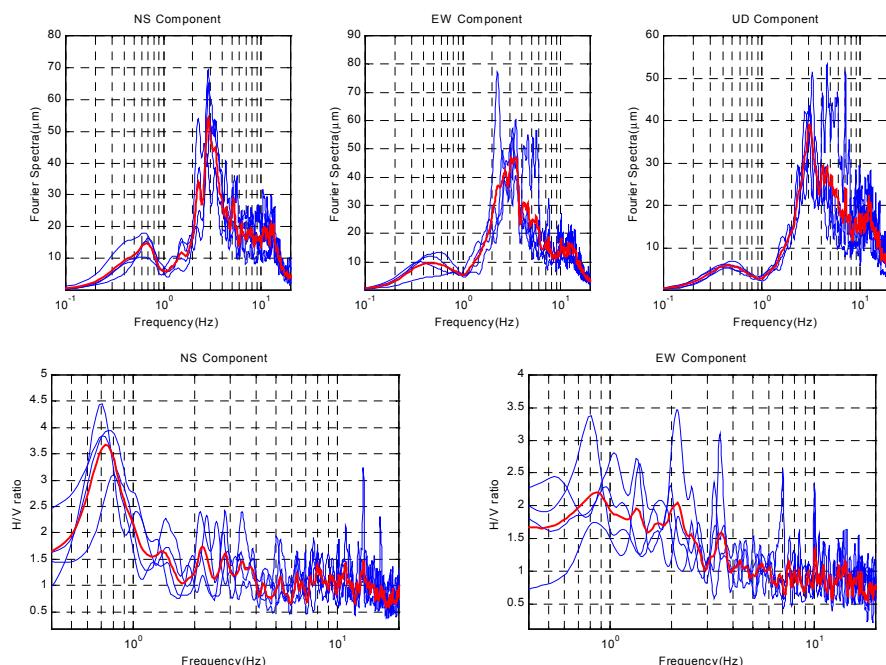
Figure 2.48. Fourier spectra of microtremors at the toe of El Balsamo ridge

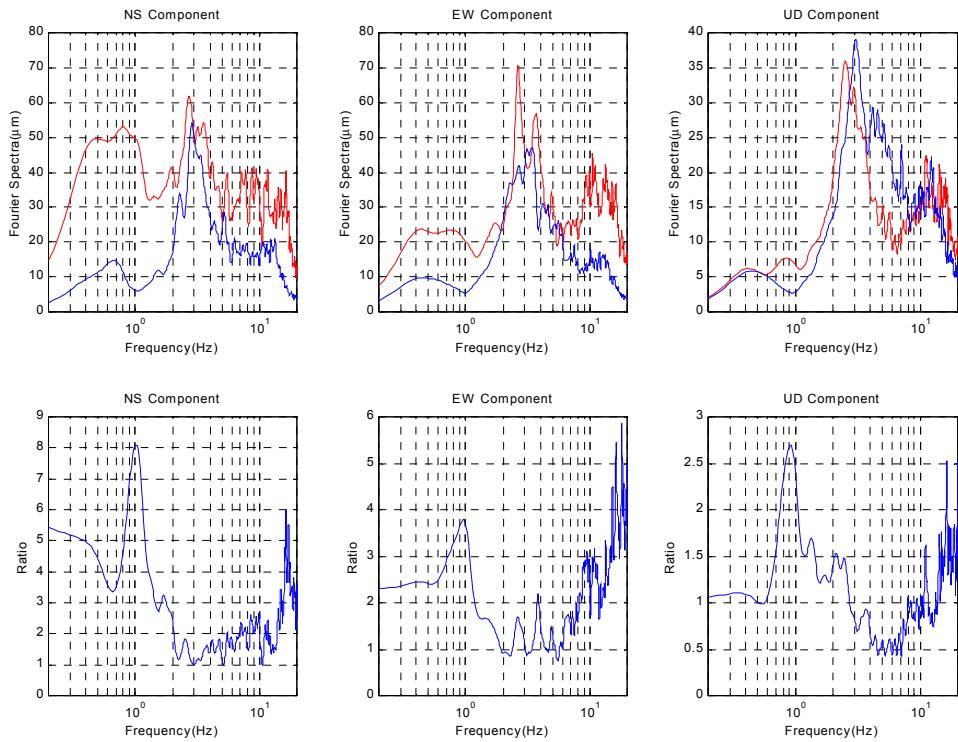
Figure 2.49 Ratios of Fourier Spectra (top of the ridge / toe of the ridge)

In order to evaluate the topographical effect at Santa Tecla, the microtremors at the top and toe of the El Balsamo ridge were compared. The Fourier Spectra of the three components at the top of the ridge were divided by the corresponding components at the toe. The results are shown in **Figure 2.49**. The three upper graphs depict the average of the Fourier Spectra at the top (red) and the toe (blue) of the ridge, respectively. The three lower graphs show the ratios of the Fourier Spectra (top of the ridge / toe of the ridge).

1. Fourier Spectra of the horizontal components at the top of the ridge are larger than the corresponding components at the toe of the ridge.
2. Fourier Spectra of the UD components at the top and the toe of the ridge are generally similar to each other. A slight shift of the latter towards higher frequencies can be observed.
3. NS components below 1.5Hz are about twice as large as the EW components at the top of the ridge. This is not the case for the rest of the frequency range.
4. The spectral ratio of the NS, EW and even UD components show a clear peak at around 1Hz.
5. For NS, EW and UD components, another peaks at around 18Hz can be identified.

Findings 1 and 2 suggest that lateral components of the ground motion have been amplified at the top of the mountain ridge due to the topographical effect, and from **Finding 3**, the effect was more pronounced in the transverse direction of the ridge. The fundamental resonance frequency of the ridge is considered to be about 1Hz judging from **Finding 4**.

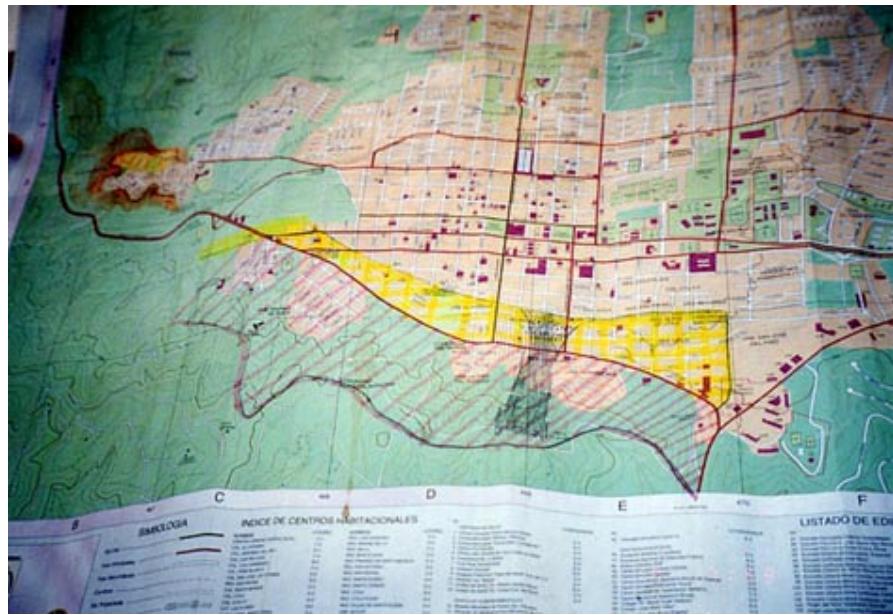
Extensive cracks remaining along El Balsamo ridge are certainly the serious threat of further slides. The city of Santa Tecla was controlling the potential hazard zones, the red zone with the highest risk and the yellow zone of slightly less danger (**Figure 2.50**). A week after the earthquake, the number of residents evacuated from the zones exposed to the menace of possible landslides reached 14,000, and as of Feb. 3, about 4,000 refugees were still being forced to live in tents (**Figure 2.51**). Since the rainy season starts in April or May, necessary countermeasures should be taken because even flat-lying areas away from sudden changes in slope angle may be still within the possible reach of the soil mass. Recommendations will be given in Section **2.6**.

Figure 2.50. Zones of potential risk

Extensive cracks remaining along El Balsamo ridge are certainly the serious threat of further slides. The city of Santa Tecla was controlling the potential hazard zones, the red zone with the highest risk and the yellow zone of slightly less danger. A week after the earthquake, the number of residents evacuated from the zones exposed to the menace of possible landslides reached 14,000, and as of Feb. 3, about 4,000 refugees were still being forced to live in tents. Since the rainy season starts in April or May, necessary countermeasures should be taken because even flat-lying areas away from sudden changes in slope angle may be still within the possible reach of the soil mass.

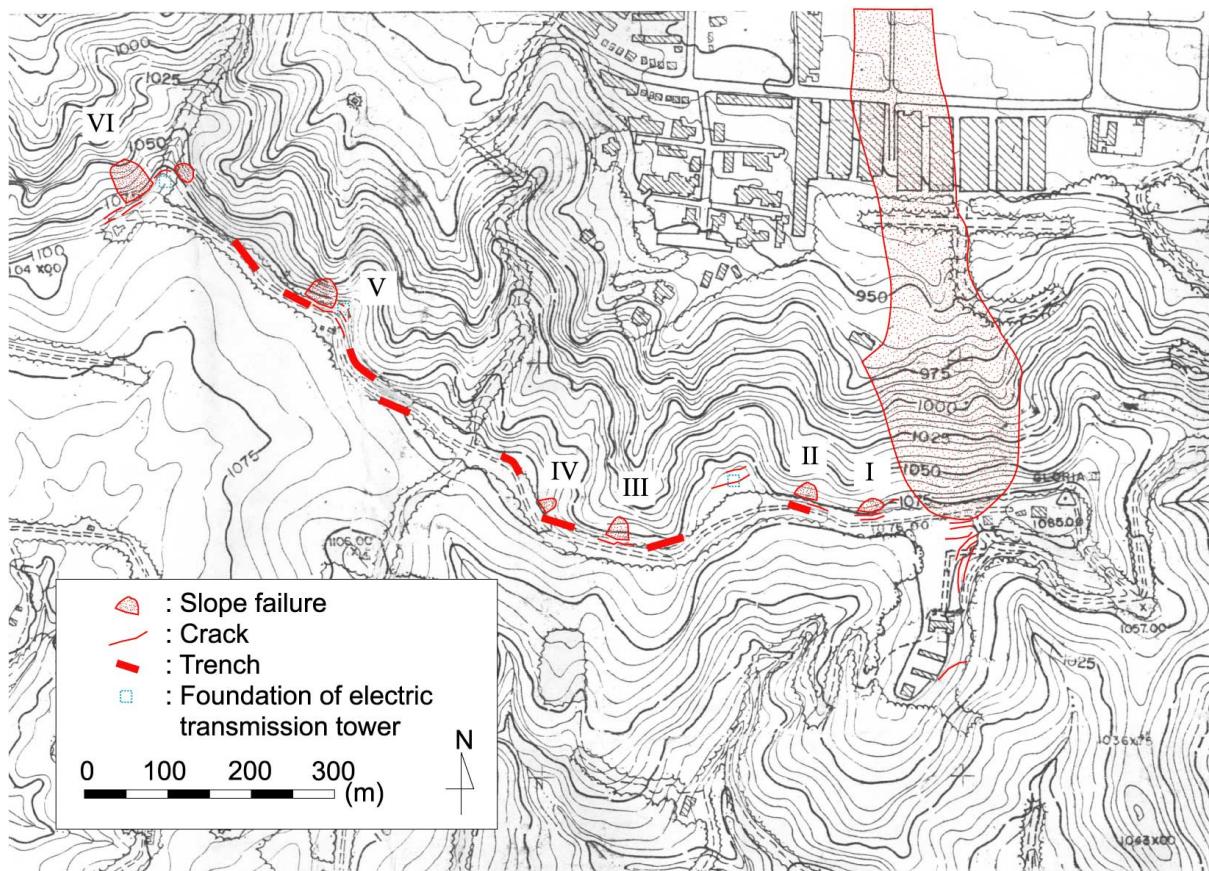
El Balsamo ridge rising south behind Neuva San Salvador is shown in **Figure 2.53** (Ministerio de Obras Públicas, 1970). Red spots and lines at the top or along the nose of the ridge show landslides and cracks. The largest red zone is the Las Colinas landslide. Since the north slope of the ridge is much steeper than its south side, slope failures were found on its north side. Salvadorian army took a quick action of excavating trenches (thick red lines in **Figure 2.53**), and they were all grouted with soil cement to stop water soaking into the soils. The sizes of these slope failures are roughly described in **Table 2.6** in terms of their heights and widths measured by using a laser rang finder.

Figure 2.53. Slope failures along El Balsamo ridge
(Topographical map: Ministerio de Obras Públicas, 1970)

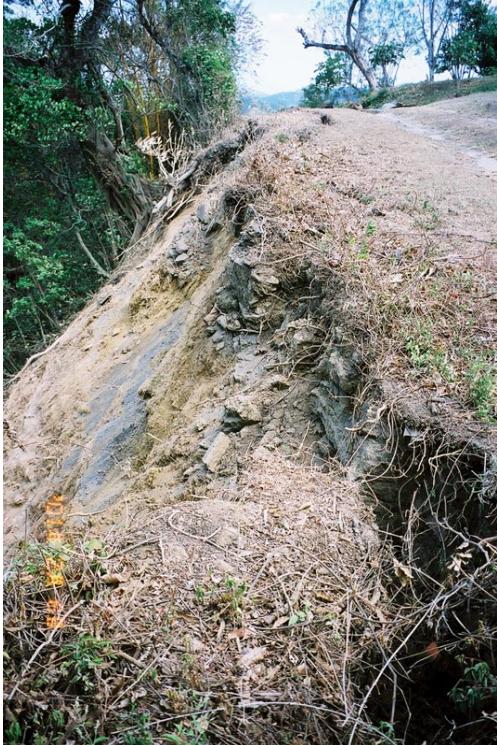
Figures 2.54-2.56 show a slope failure at **Site III**, 22.3 m wide, and 32 m long, on a steep slope of about a 45degrees inclination. A longitudinal crack was open wide and deep along the nose of the ridge (**Figure 2.55**) The slope shows a stratified soil arrangement with a top lapilli tuff layer (dark bluish gray) of about 90 cm thickness overlying a pumice soil deposit (grayish ocher: see **Figure 2.56**). A couple of thin lapilli tuff films were bedded in the pumice. The pumice grains that came off the intact surface are rather coarse (1.2 mm×2.3 mm×3.5 mm, 1.3 mm×2.3 mm×3.5 mm, e.g.). The stratified soil arrangement with the inclusion of weak pumice might be the cause of this slide.

Figure 2.54. Slope failure at Site III

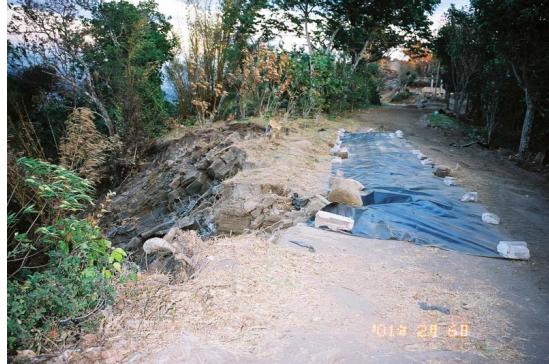
Figure 2.55. Longitudinal crack at Site III

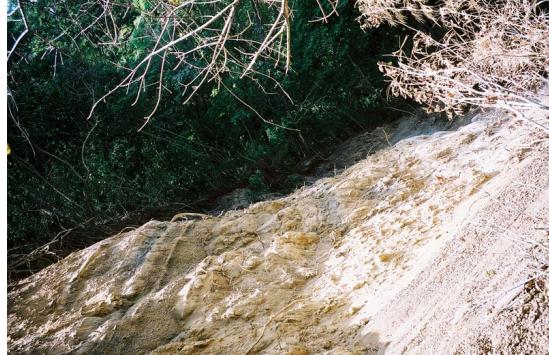
Figure 2.56. Stratified soil arrangement at Site III

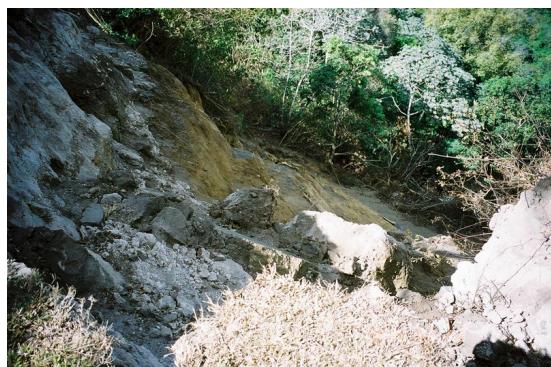
Figures 2.57-2.58 show an about 30 m wide and 51 m long slope failure at **Site VI**. The soil exposed on the top terrace is a pyroclastic flow sediment of 2.5 m thickness overlying a pumice sediment. The stratified structure is about the same as those abovementioned. Some cracks appearing close to the nose of the ridge were 1.3 m wide and 1.0 m deep e.g. (**Figure 2.58**).

Figure 2.57. Slope failure at Site VI

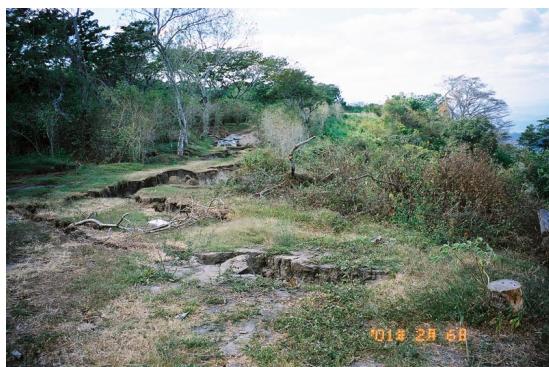
Figure 2.58. Crack at Site VI

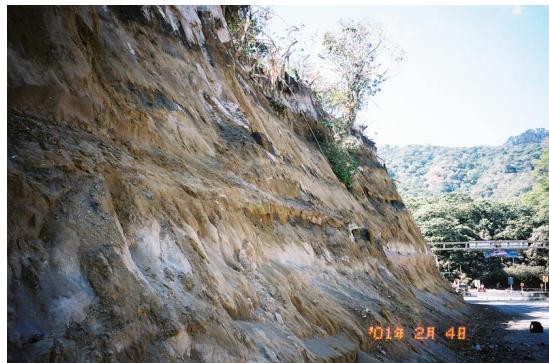
A number of slope failures occurred on slopes excavated for the Pan-American Highway in Los Chorros area. The exposed failure surfaces are classified in the following three geological categories: 1) stratified arrangement of lapilli tuff and pumice (Figure 2.59), 2) pyroclastic flow sediment (Figure 2.60), and 3) fresh volcanic rock (Figure 2.61).

Figure 2.59. Failure surface exhibiting an arrangement of volcanic products in strata. Two lapilli tuff layers (dark gray) lie between the loose pumice soil sediment (ocher).

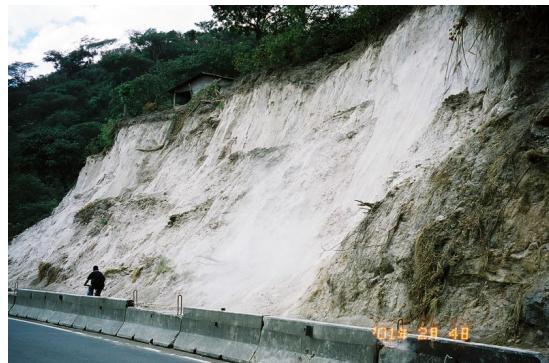
Figure 2.60. Exposed failure surface of pyroclastic flow sediment.

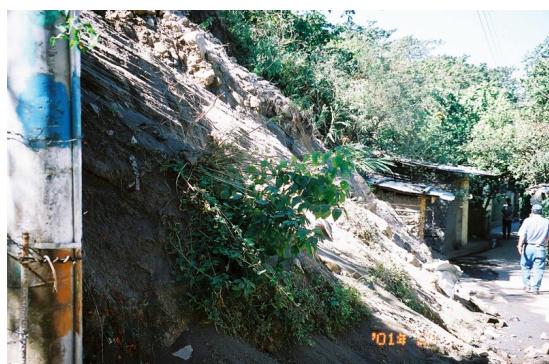
Some slope failures took place at Nueva Cuscátlan. **Figure 2.62** shows the largest one among them, 19.5m wide and 6 m high, on an about 50 degrees slope of weathered lapilli tuff (dark gray). Two adobe houses were broken under the slid soil mass. Some cracks were found wide open along the nose of the mountain ridge cutting roots of coffee trees, while a pressure ridge of about 22 cm high was found around the toe of the slope (Figure 2.63).

Figure 2.62. Slope failure on weathered tuff

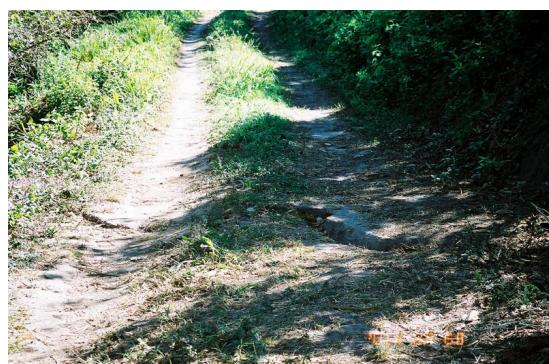
Figure 2.63. Pressure ridge

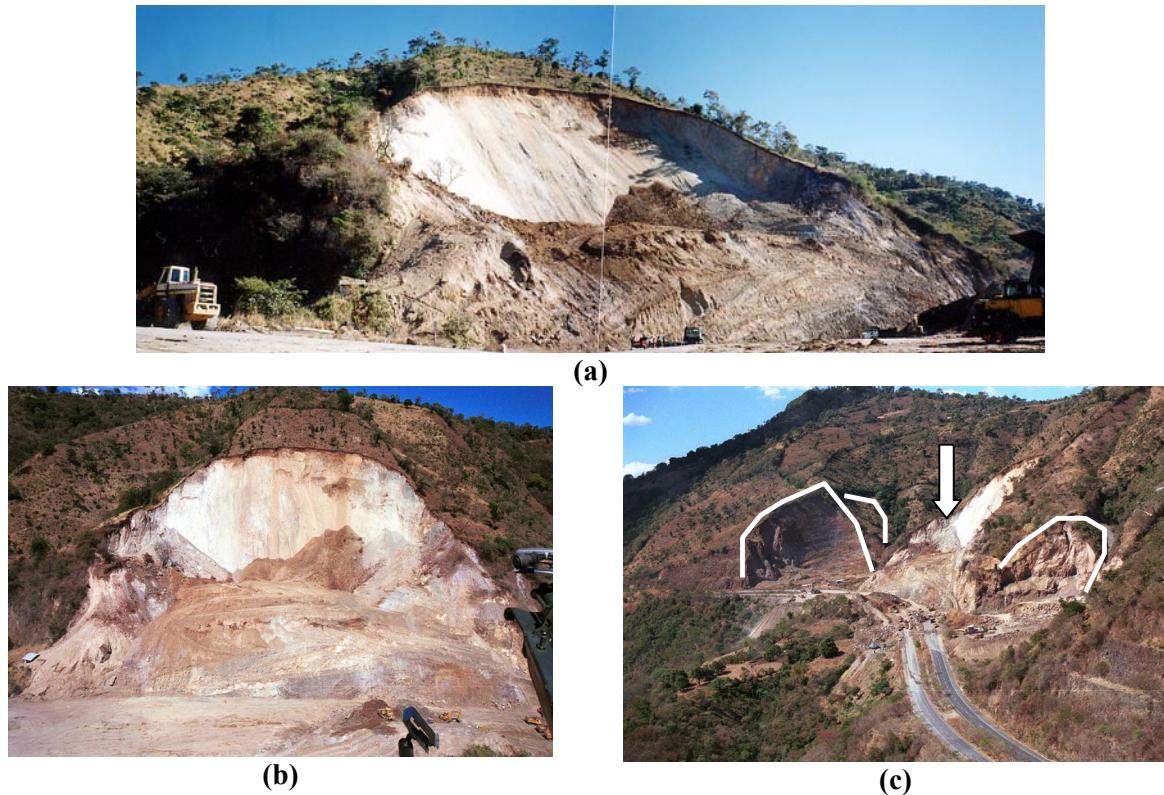
At the 53rd km of the Panamerican Highway, in San Vicente, a slid soil mass blocked the road (**Figure 2.64 (a),(b) and (c)**). Three-dimensional shape of the slip surface (hollow) was measured by using a laser-rangefinder (**Figure 2.65**), and the volume of the slid soil mass was roughly estimated to be about 300,000 m³. A dipping joint surface seems to have served as a slide plane. It is noted in **Figure 2.64(c)** that there are some suspect old scarp-like marks (white curves) recognized on both sides of the slide. Some cracks were found further above the upper end of the scar.

Figure 2.64. San Vicente landslile

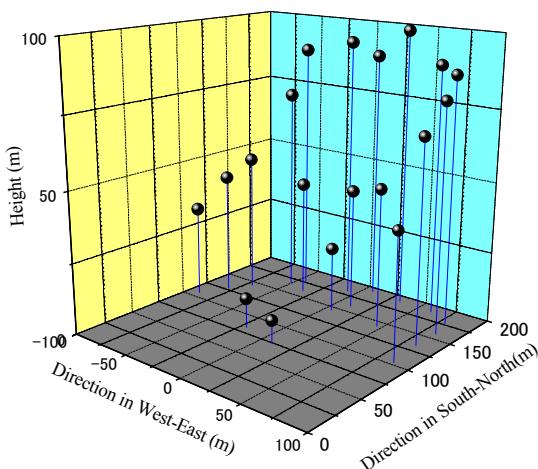
Figure 2.65. Configuration of San Viente Landslide

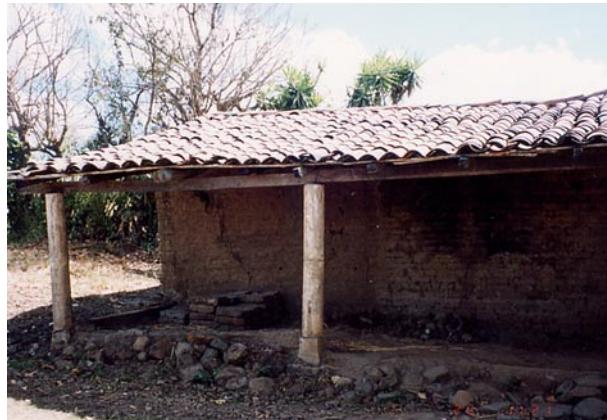
Figure 2.66 shows bahareque house near San Vicente landslide. This bahareque house, standing on the terrace high above the headscarp of the slide, performed quite well, though it suffered some diagonal shear cracking.

Figure 2.66. Bahareque house near San Vicente landslide
