2.3 OBSERVED SITE EFFECT AND MICROTREMOR MEASUREMENT

2.4 GEOLOGIES OF THE DAMAGED CITIES

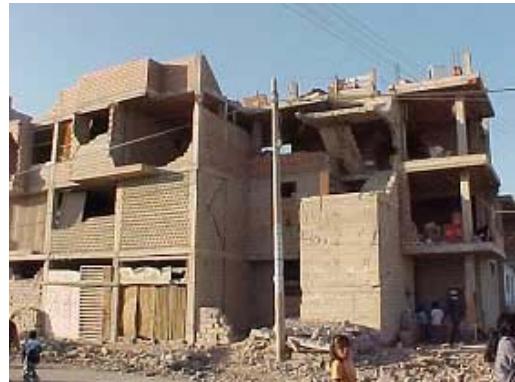
Figure 2.9

The northeast area, which has been being developed since 1980's along the northwestern hillside, was the most seriously damaged. Most dwellings there were RC framed with infill walls of mortar blocks and/or bricks (**Figure 2.9**).

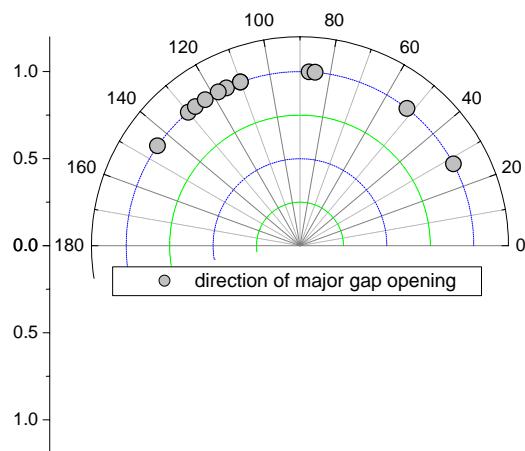
Utility poles (5m tall) are embedded upright in concrete-paved sidewalk. Cracks developing outwardly on the pavement from these poles were mapped. Some poles are very close to the step-shaped edge of the sidewalk. The thin cover concrete thus might have affected the crack pattern. Though the number of the examined utility poles is not sufficient for thorough statistical manipulations, some poles seem to have been forcibly shaken in about Northwest –Southeast direction, transverse direction of the valley (**Figure 2.10**).

Figure 2.10 Directions of major gap openings at bottom ends of utility poles (Tacna)

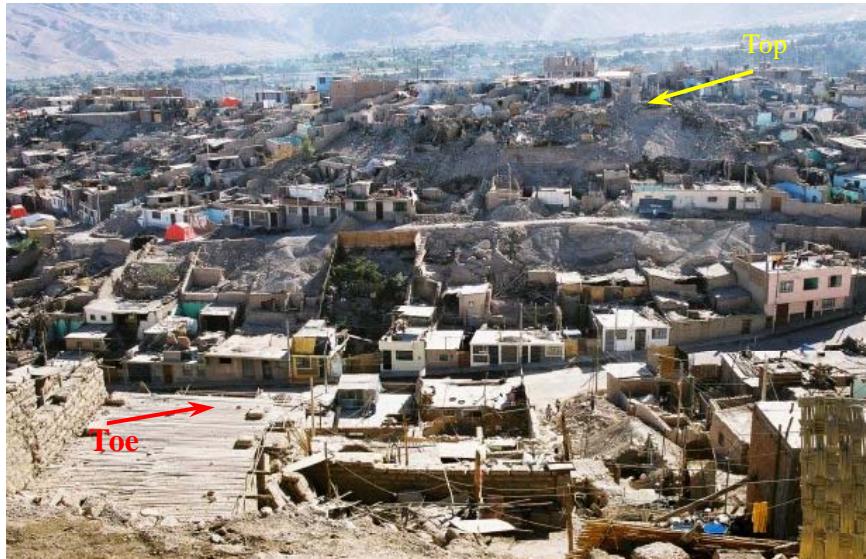
Moquegua was the hardest hit city by this earthquake. A number of adobe buildings collapsed in the downtown area and many others sustained heavy damage. A thin mountain ridge, the northeast extension of a sand rock terrace rising behind the central area of Moquegua city, dips gently towards northeast. This ridge is densely covered with adobe dwellings, and the damage to dwellings was the severest there (**Figure 2.11**).

Figure 2.11 View of the terrace next to San Francisco hill

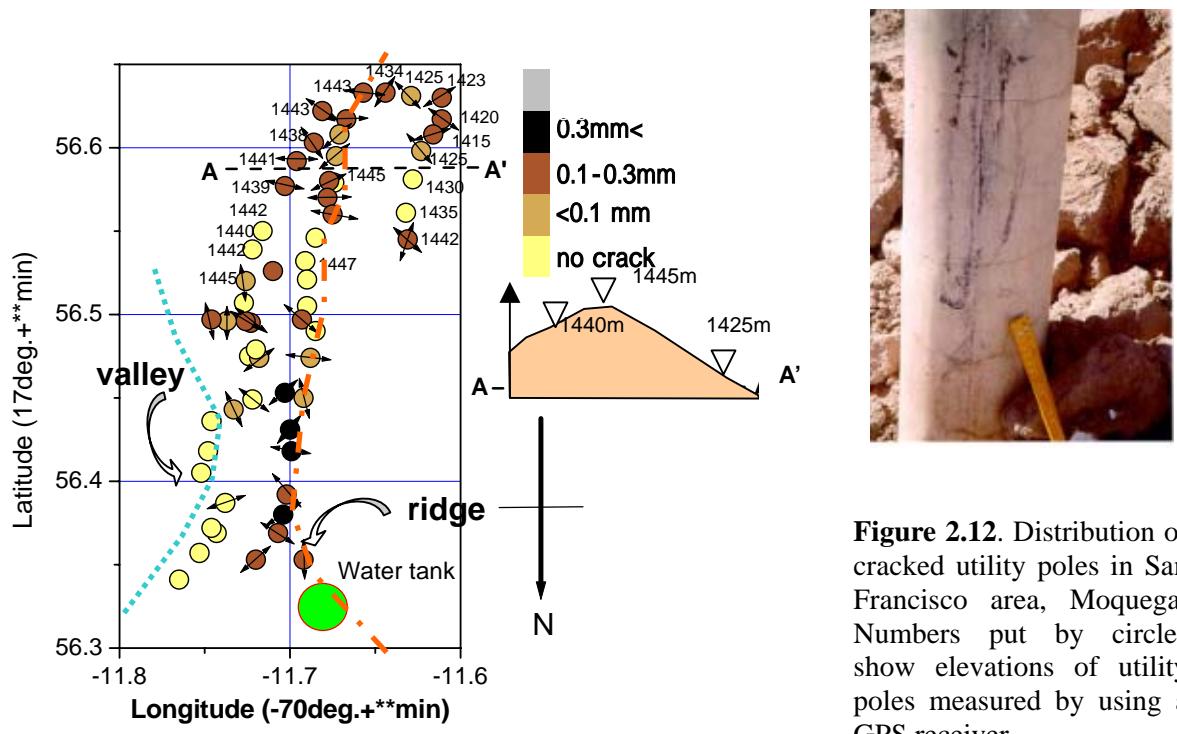
Distribution of cracked utility poles is considered to be a good index for discussing possible spatial distribution of intense ground motions. Observed crack intensities on total 59 utility poles were roughly classified into the following 4 groups:

Group 1: no visible crack.

Group 2: with hair cracks (>0.1 mm)

Group 3: with cracks (0.1-0.3 mm)

Group 4: with cracks (<0.3 mm) that can be seen at a distance of about 2m

Figure 2.12 shows the observed distribution of crack intensities. Arrows indicate the inferred directions of strong ground motions. In this figure, the first, second and third lines from left to right lined up with the inspected utility poles are streets along a narrow valley, along the ridge and on the other hillside, respectively. It is noted that no utility pole along the valley was cracked while those around the highest peak of the ridge near a water tank (green solid circle) were severely cracked. This contrast suggests that some topographical effect must have been responsible for amplifying ground motions. The arrows along the ridge show that the effect was more pronounced in the transverse direction of the ridge.

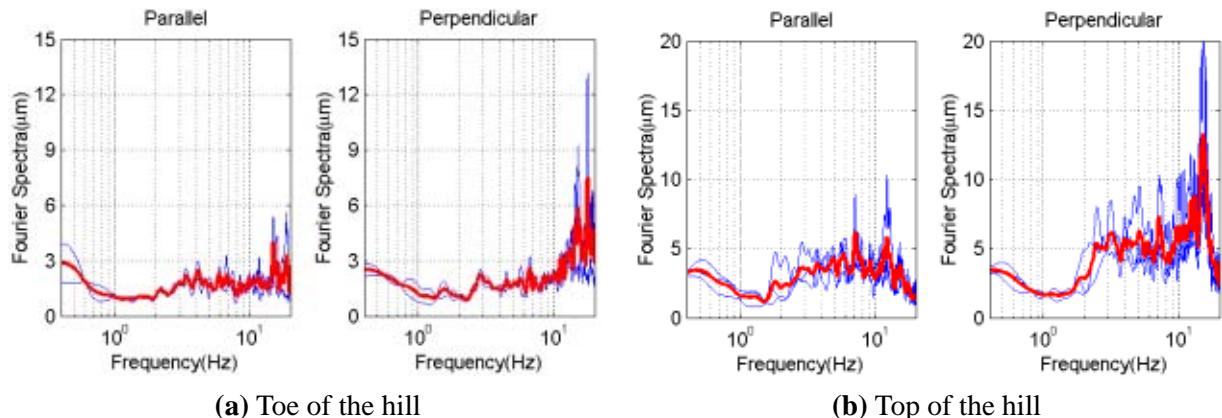
From **Figure 2.14**, it is clear that larger vibrations were recorded on top of the hill, particularly in the direction perpendicular to the ridge. In order to approximately assess the fundamental period of the hill, the microtremor spectra on the top of the hill was divided by the spectra at the toe. The results are shown in **Figure 2.15**.

Figure 2.14 Fourier Spectra of the microtremor measurements at San Francisco, Moquegua

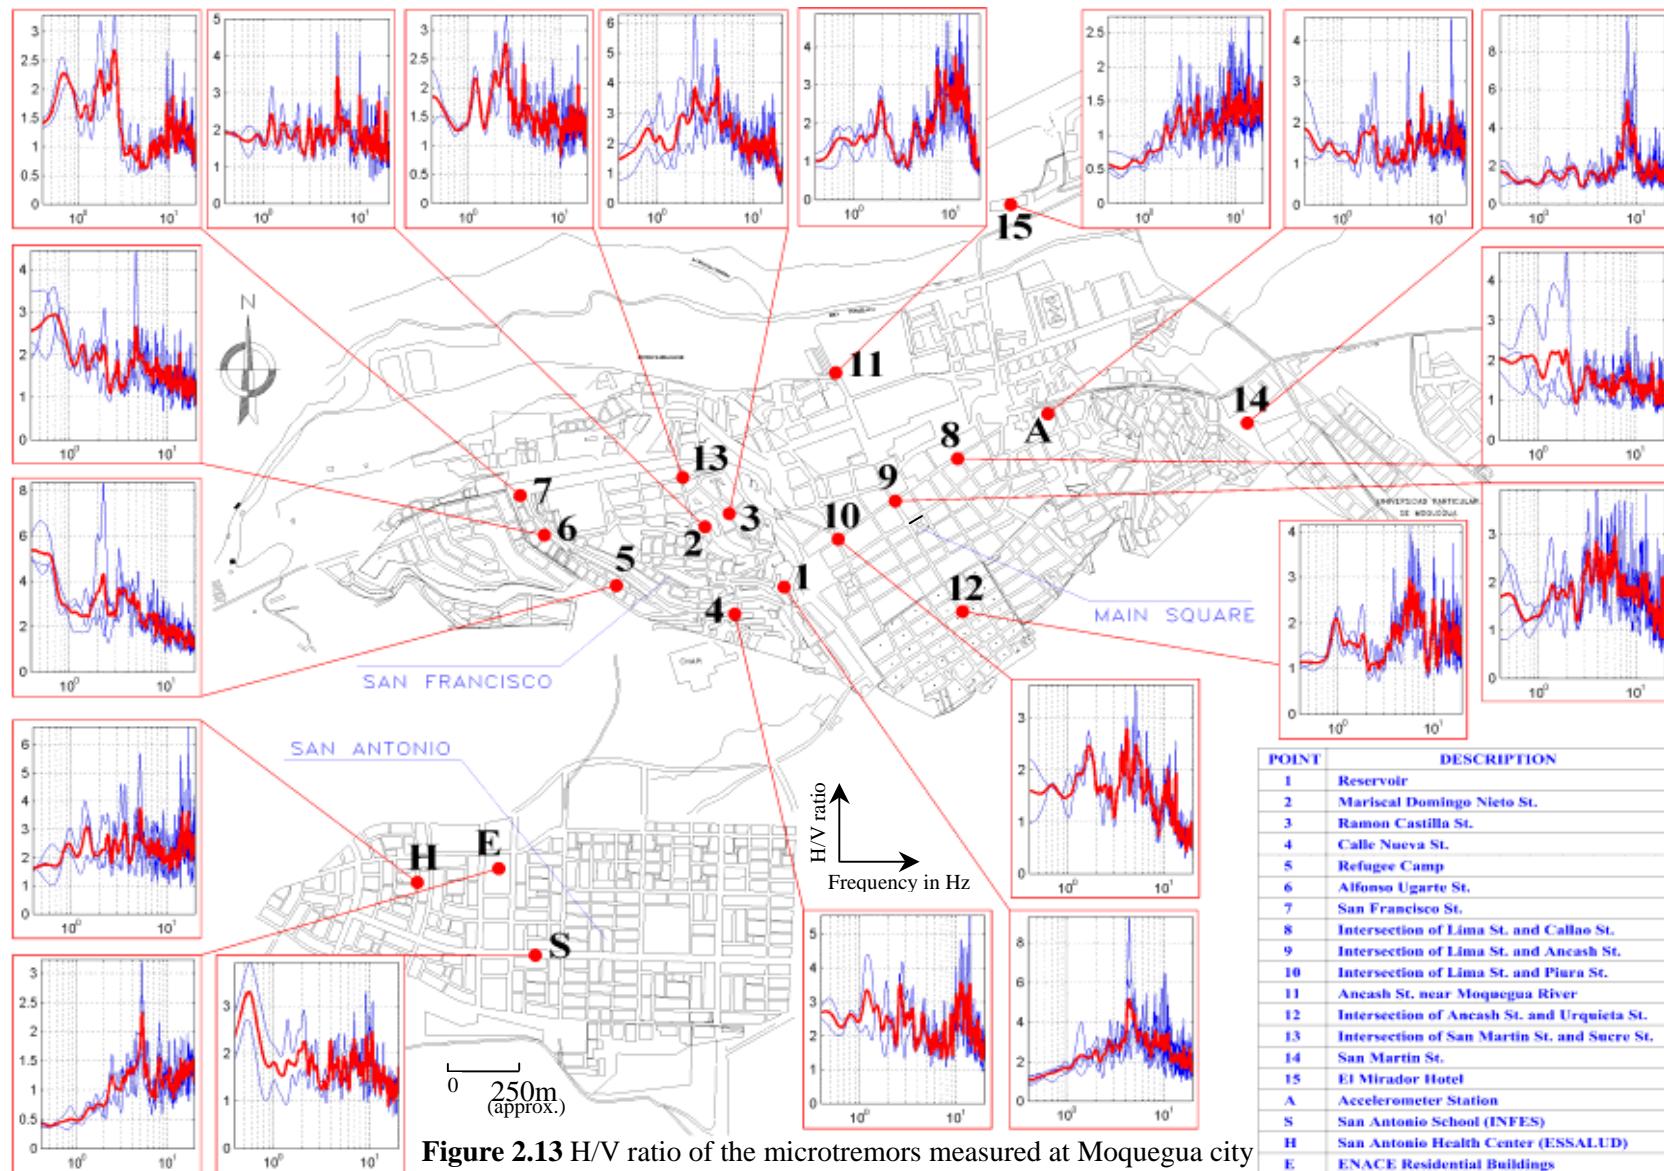
Figure 2.13 presents the locations where free field microtremors were measured at Moquegua. In order to assess the site predominant frequency, the H/V ratio was used [Nakamura, 2000]. The square root of the sum of the squares of the H/V ratio for NS and EW component is shown at each position. Blue thin curves correspond to a 40.96sec-measurement whereas the thick red curve represents the average of all the measurements. A particularly low frequency site is “S” where the predominant frequency is approximately 0.6Hz. On the other hand, site “14” has a high predominant frequency equal to 8Hz.

Figure 2.13 H/V ratio of the microtremors measured at Moquegua city

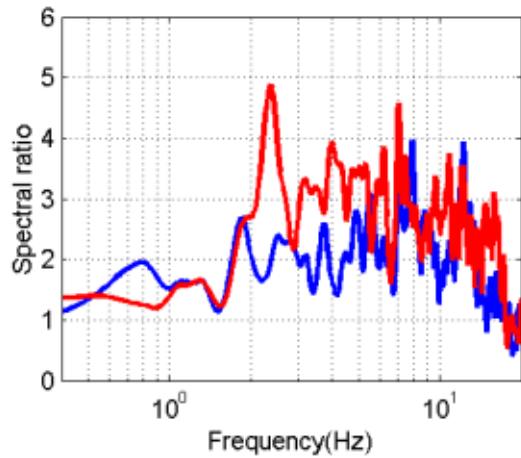
Figure 2.14 Ratio of the spectra on top and at the toe of the hill. (blue: parallel to the ridge, red: perpendicular to the ridge)

Figure 2.14 shows that larger amplification is observed in the direction perpendicular to the ridge. Furthermore, the predominant frequency in this direction, approximately 2.5Hz, is lower than the predominant frequency in the direction parallel to the ridge, 7Hz. This is consistent with the hill being more flexible perpendicularly to the ridge.

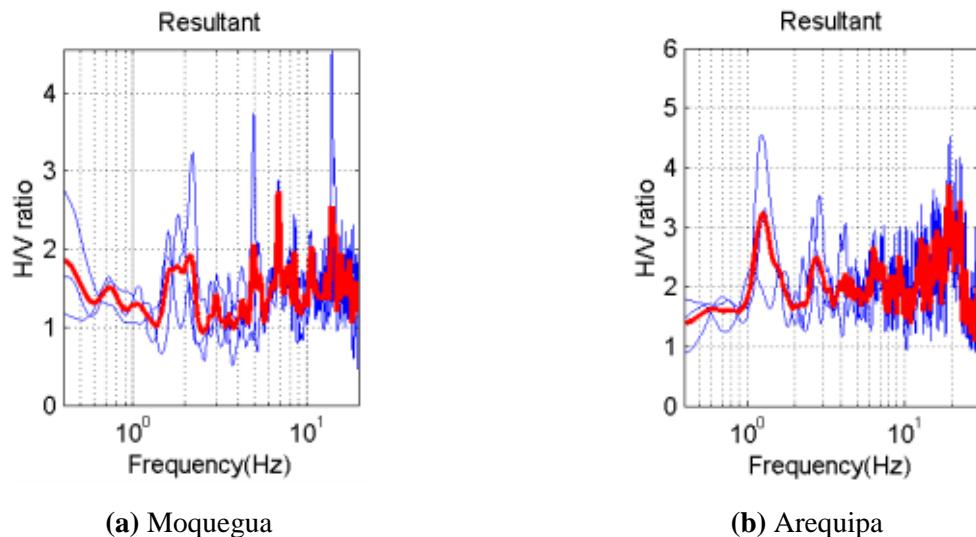
Measurements were also carried out at Moquegua and Arequipa accelerometer stations. **Figure 2.15** presents the results of the spectral analysis, which clearly show predominant frequencies of 7 and 1.1 Hz at Moquegua and Arequipa, respectively. Although there is a peak around 20Hz at the Arequipa station, this component might have been caused by some external source. When comparing this spectrum with other free field measurements in the vicinity of the station, such peak is not observed. In general, amplification at Arequipa station is larger than at Moquegua station. Note that the latter corresponds to the site where the only record of the main shock of the Atico Earthquake was recorded.

Figure 2.15 Resultant H/V ratio at accelerometer stations

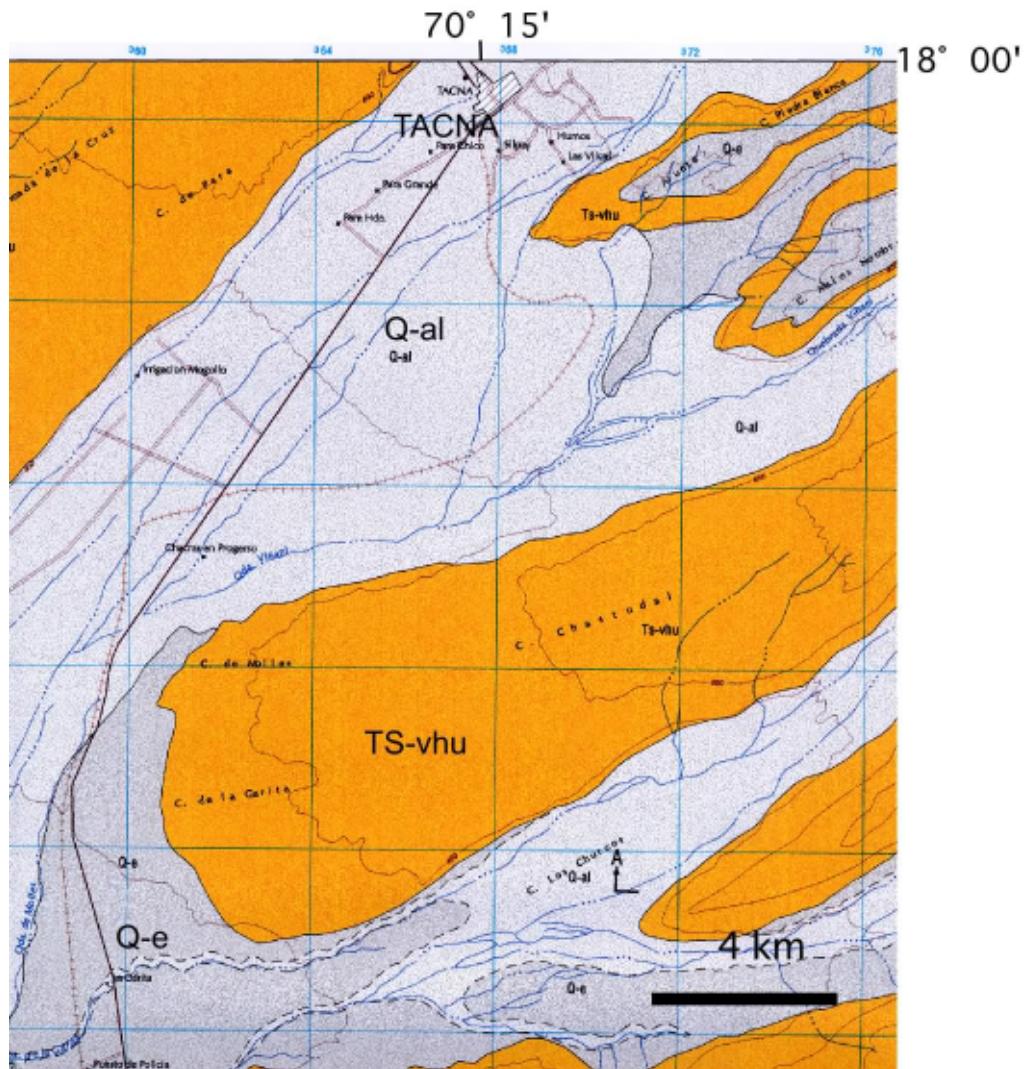
Around the city of Tacna, probable Pliocene volcani-clastic sediments (the Hyalillas Formation) are widely distributed. From the regional stratigraphy, the Hyalillas Formation unconformably overlies with the Plio-Miocene Moquegua Formation, which consists of sedimentary rocks. Probable thickness of the Hyalillas Formation is about 200 m. Along the low lands, including the city of Tagua, thin Quaternary alluvial and deposits are distributed.

Figure 2.15 Geological Map of Tacna after Jaen and Ortiz (1998).

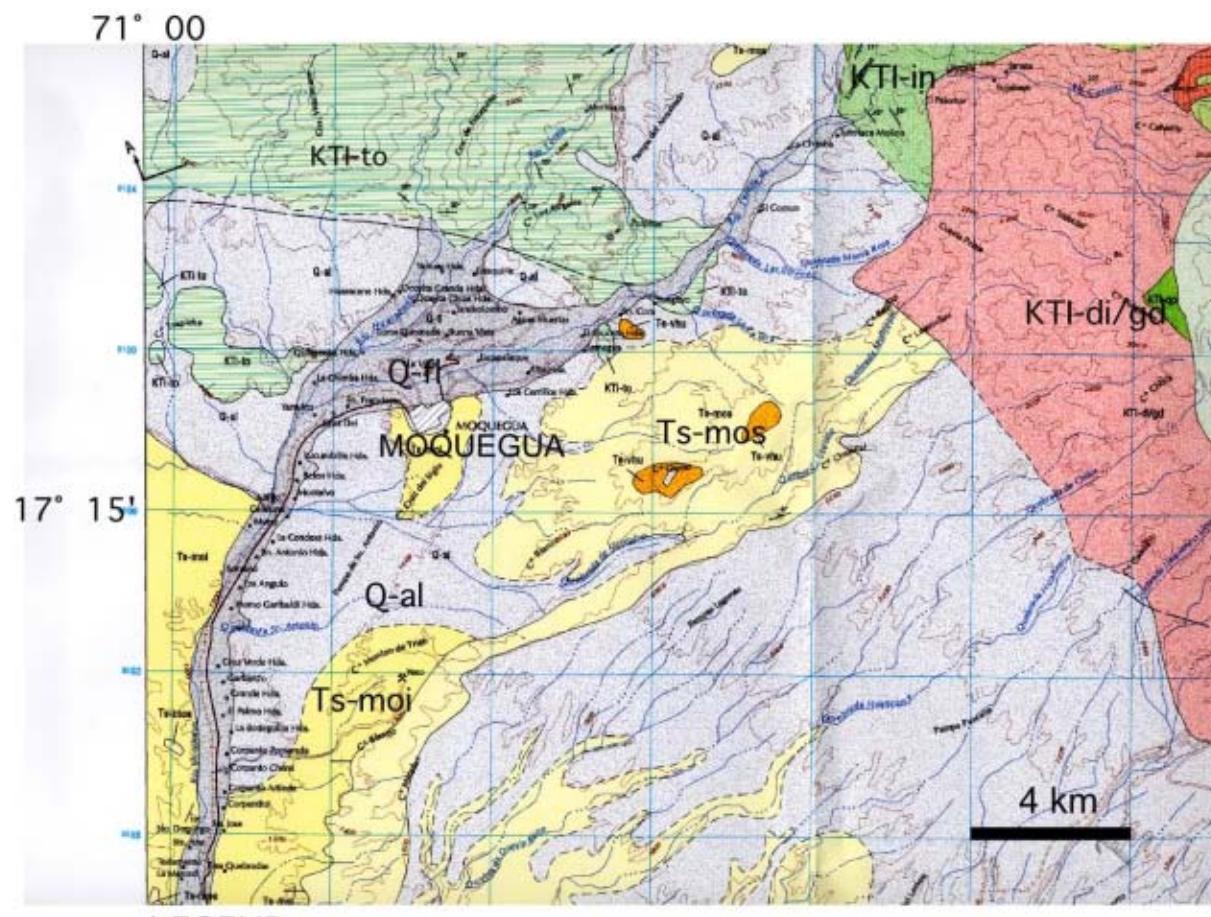
In the northern part of Mogeugua, folded Cretaceous sedimentary rocks (Torquepara and Inagoya Formation) and Cretaceous intrusive rocks are widely cropping out. The Plio-Miocene Moquegua Formation, consist of sedimentary rocks, distributes in the southern part of Moquegua. The Quaternary alluvial and fluvial deposits, unconformably overlying the Moquegua Formation, are distributed in the city of Moquegua. The geologic succession of the city of Moquegua consist of Cretaceous hard rocks with thin younger sediments cover. From geologic point of view, the city of Moquegua has good ground condition against shaking.

Figure 2.16 Geological Map of Moquegua after Bellido and Landa (1998).

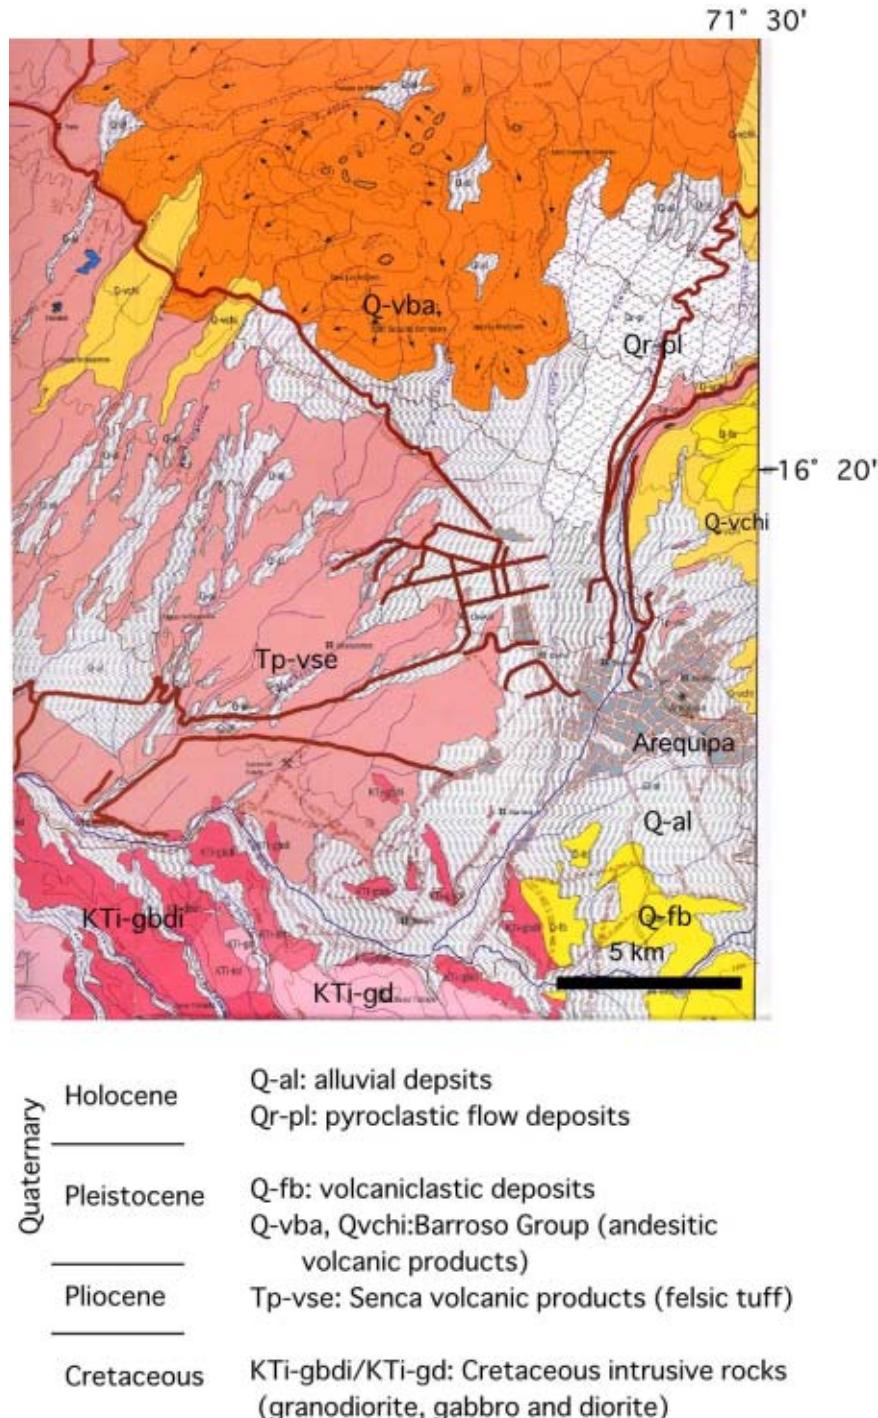
In the south of the city of Arequipa, Cretaceous igneous rocks are widely cropping out forming a seismic basement rocks. Around the city of Arequipa and its northern area, mainly Quaternary volcanic and volcaniclastic sediments are widely distributed. In the northern part of the city of Arequipa, Pliocene felsic tuff (Senca volcanics) is cropping out. Due to the covering of the Pliocene to Quaternary deposits, the actual depth of the Cretaceous rock in the city of Arequipa is not well understood.

Figure 2.17 Geological map of Arequipa after Vargas (1970).
