Strain Induced in Cracked Utility Poles and Damage to Dwellings in the Dec 26, 2003, Bam Earthquake

Kazuo Konagai^{1)*}, Masayuki Yoshimi²⁾, Kimiro Meguro¹⁾, Miho Yoshimura¹⁾, Paola Mayorca¹⁾, Masasuke Takashima¹⁾, Alireza Farahani¹⁾, Hossein Tahghighi¹⁾ and Mohammad Keshavarz³⁾

Abstract

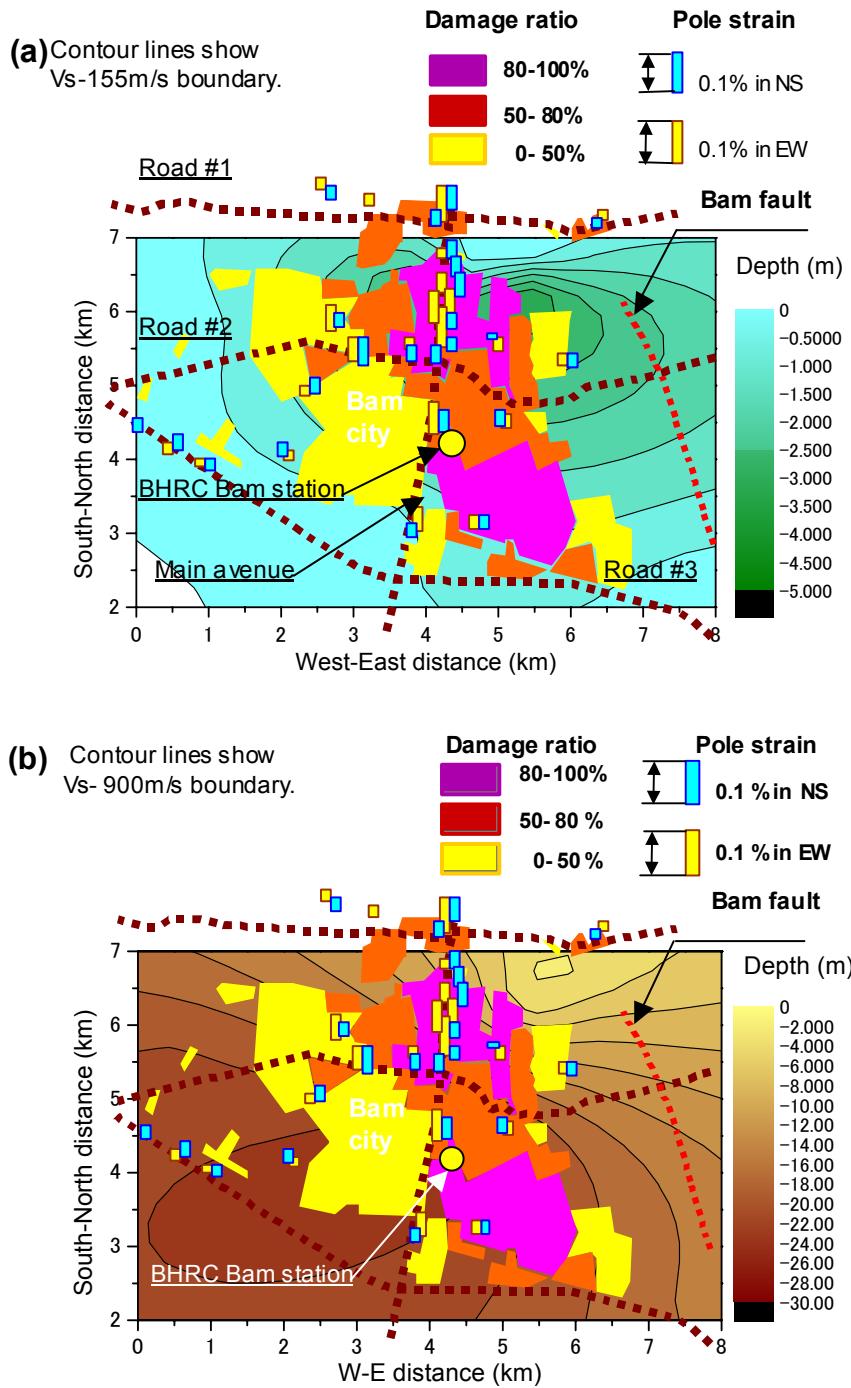
Fig. 8b Strains remaining in poles: (Damage ratio provided by NCC of Iran, 2004)

holes were taken to minimize the effect of transmission lines, the cracks caused by poles' motion in Y direction. For each pole, crack openings were added up over about 2m distance near the lower pole end, and then the total openings were divided by the distance to obtain average strain remaining on the pole. Total 270 poles were taken both in the city and its suburbs. The poles were then divided into several tens clusters in such a way that each cluster includes at least one crossing in it. Since the poles in one cluster line up at least two roads crossing each other, both north-south (NS) and east-west (EW) average strains were obtained cluster-wise. Fig. 8(a) and 8(b) show the distribution of remaining average strains in the city. Contour lines in Figs. 8(a) and (b) show inferred layer boundaries of shear wave velocities $V_s = 155m/s$ and $V_s = 900m/s$, respectively (see Fig. 3), and colored zones show percentages of damage to dwellings mapped by the National Cartographic Center

of Iran (2004). In general, strains are large along the main avenue that runs through the city from north to south. Damage was also severe along this avenue (Fig. 9a) and it faded out quickly as we go some street blocks away from the avenue (Fig. 9b). Some severe damage to dwellings was also found along Road #2, which used to be an old river trace, and goes through the city from East to West (Fig. 9c). The strain distribution thus seems to be consistent with the overall damage distribution pattern. However, a calibration is necessary to interpret the strain distribution pattern in terms of intensity in spite of the fact that only one strong ground motion record was available in the city (see the location on the map Fig. 8). The further discussion will turn up in a future publication.

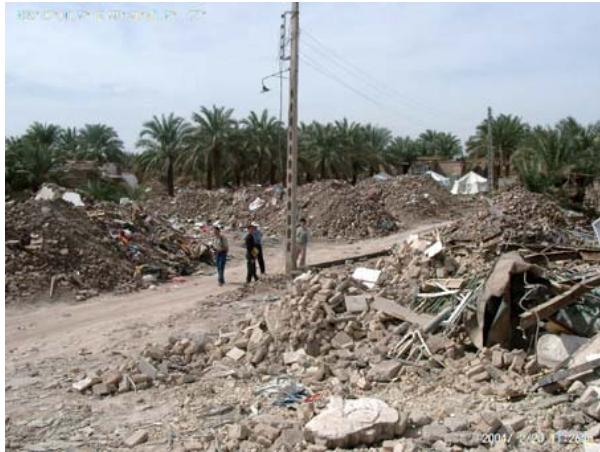
(a) Near the main avenue
N29°07'00.5" E58°21'41.5" 77°

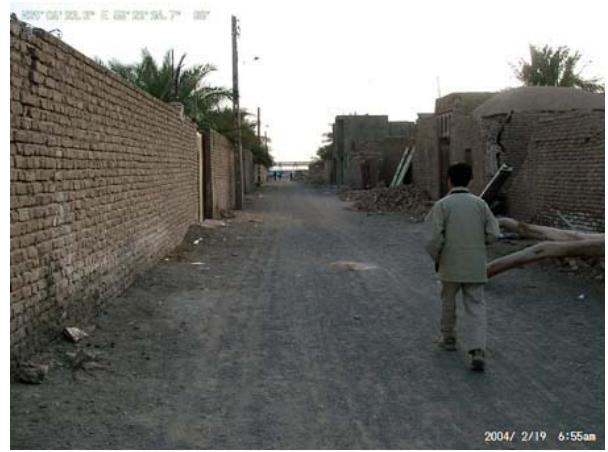
(b) East of the city
N29°06'23.3" E58°22'36.7" 88°

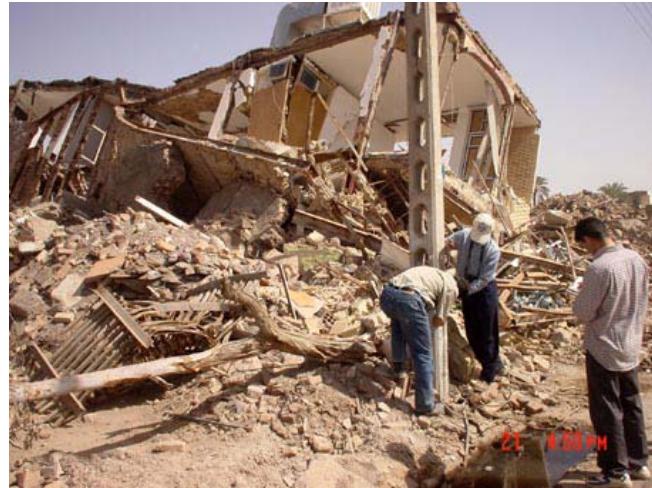
(c) Along the Street #2
N29°06'24.6" E58°21'13.1" 74°
