# **Provisional Report of the May 27, 2006, Mid Java Earthquake, Indonesia**

June 15, 2006

**Advanced Body of the  
“JSCE/AIJ mission for reconstruction  
recommendations for areas devastated by the  
May. 27, 2006, Java earthquake, Indonesia”**

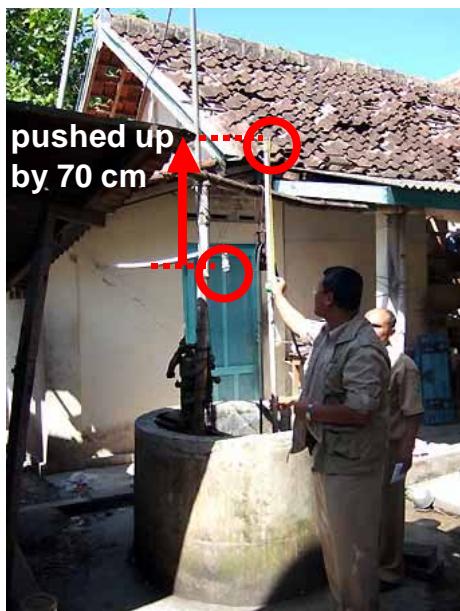
(a) S7deg. 57.416 min,  
E110deg. 18.291 min  
plastic pipe was pushed 0.7m up.

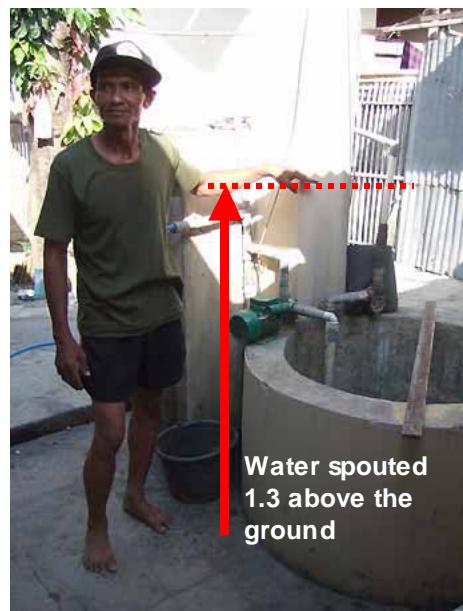
(b) S7deg. 53.706 min,  
E110deg. 22.995 min  
dark colored water spouted about  
1.3 m up above the ground level.

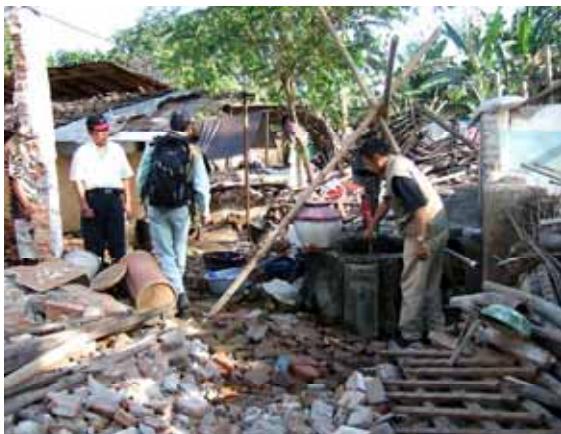
(c) S7deg. 53.458 min,  
E110deg. 23.186 min  
no change in water level of -5.0 m.

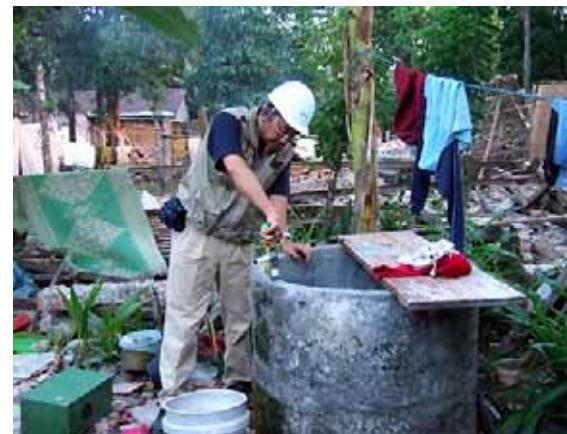
(d) S7deg. 51.044 min,  
E110deg. 20.031 min  
water level decreased by about 0.25 m.

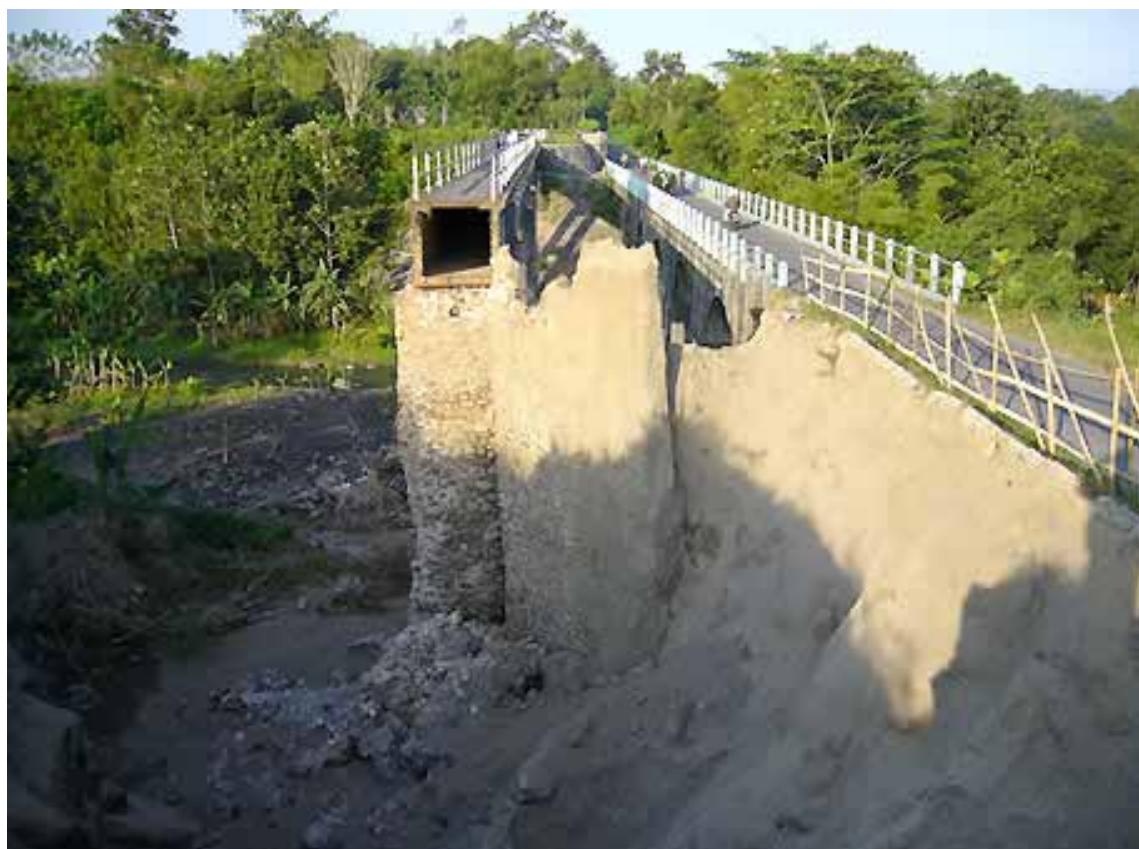
A bridge of Mataram canal, supplying drinking water and irrigating 19,000 ha of land extending the lower basin of Progo and Opak river, was damaged as shown in Fig. 3. Two masonry abutments and four RC piers support a steel box aqueduct of 80m long. RC open channels on both riversides resting on embankments narrow to this aqueduct. The sandy soil mass of the right embankment behind the masonry abutment of about 10m high slid down towards the river. The scar was formed 26 m west behind the abutment immediately beneath a construction joint of the open channel, suggesting that water might have been seeping through the joint into the embankment soil.

Fig. 3. Mataram canal bridge: Soil mass of right embankment behind masonry abutment has gone.

Quick restoration of the bridge is a must because of the canal's important functions. Moreover, a road running along the canal resting on the remaining soil mass of the same embankment is under a threat of subsidence. However, a complete reproduction of the embankment will be just a stop-gap measure, and won't mitigate its geotechnical hazard potential. Even an inch settlement of the embankment will cause cracking of concrete joints, and water will leak again through the joints. A possible and efficient measure may be to replace the embankment with some piers.

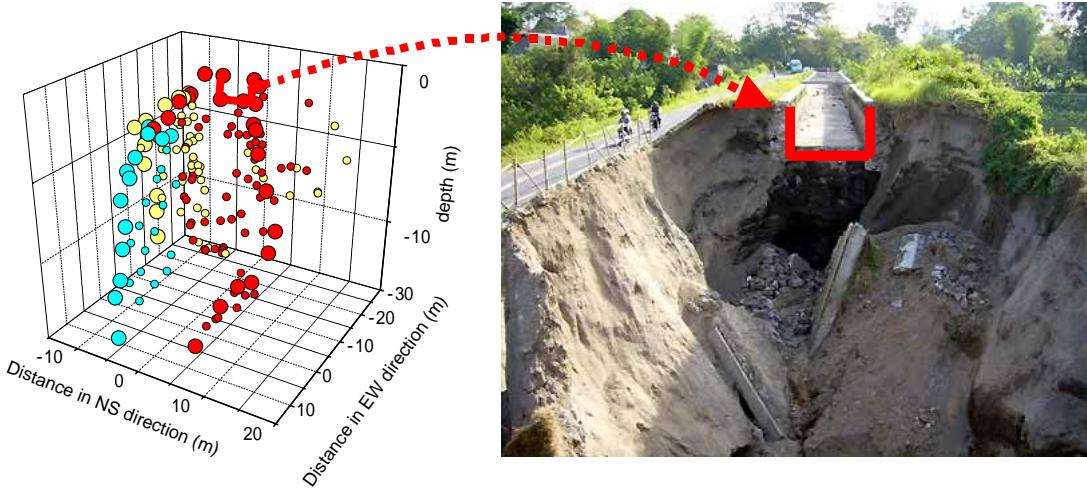
Fig. 4 Measured cave: The cave of the embankment was laser-scanned for its 3D image. Total soil volume about 2,000 m<sup>3</sup> has gone. Scar did appear immediately beneath the construction joint.

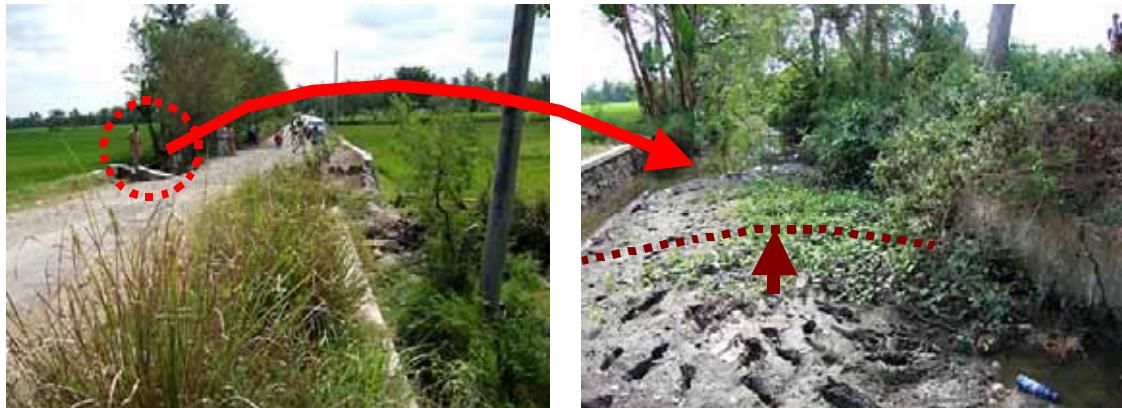
Fig. 5. Bridge (S7deg 47.102 min, E 110 deg 34.680 min)

A skewed simply supported RC bridge (4 beams) of 3.5 m wide fell down due to embankment soil subsidence. The sunken soil mass seems to have pushed bottom of a stream flowing near by the embankment.

(a) Location of skewed bridge: Edge lines of road are seemingly dislocated right-lateral. However no clear dislocation was found in rice paddies.

(b) Bottom of stream along the road has been pushed up

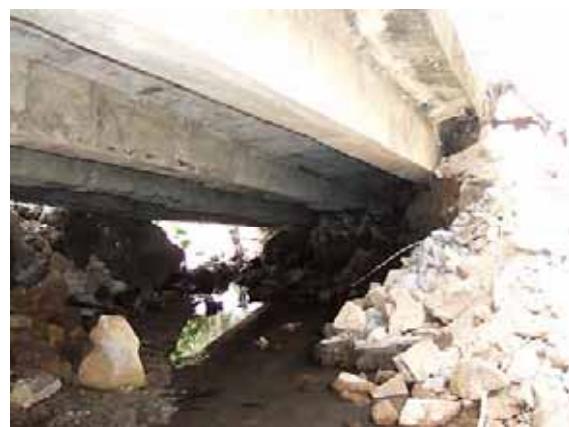
(c) Four simple beams support the deck.

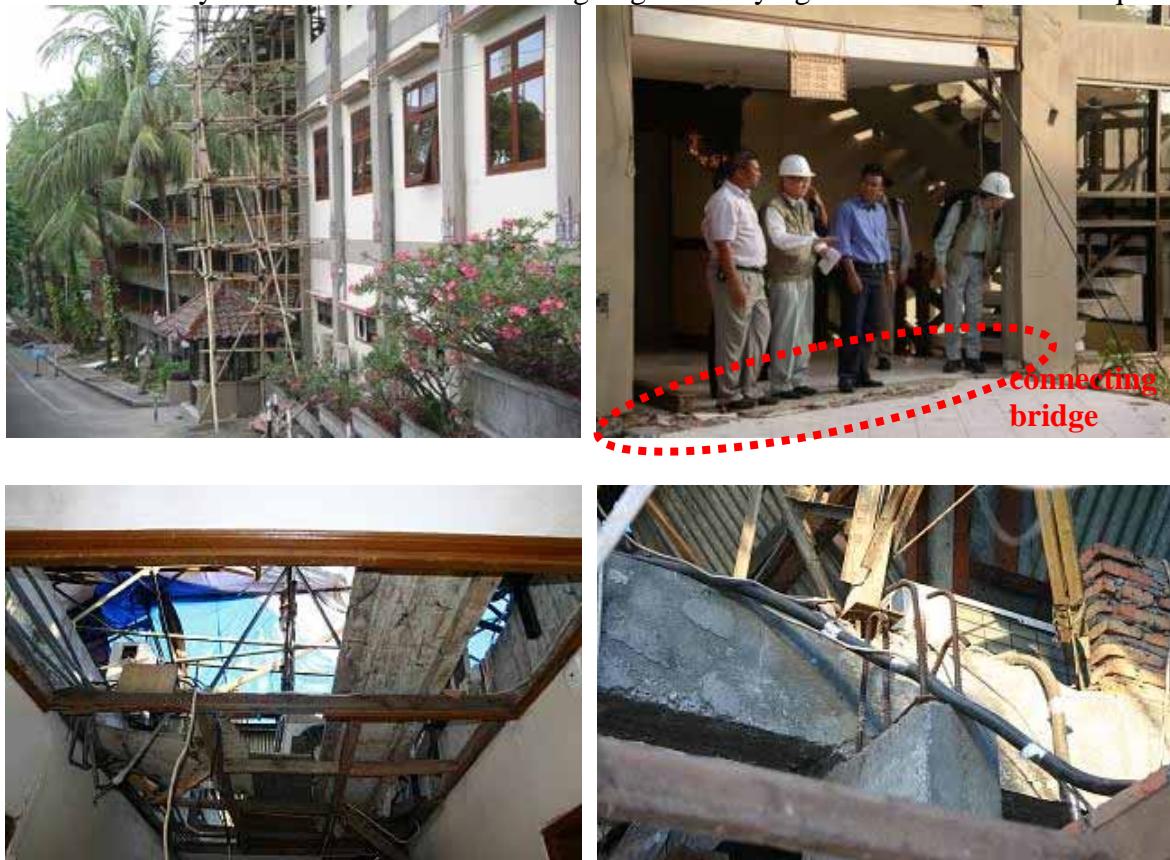
Jayakarta Hotel

URM walls (brick walls) in RC frames had damage and a connecting bridge between two adjacent buildings (lobby building and lodging building) was damaged at the expansion joint as well as its roof and handrail wall due to pounding. Roofing tiles on a truss system with steel-angle fell down through the ceiling board of guest rooms on the top floor, and falling debris were likely to have been life-threatening to guests staying at the time of the earthquake.

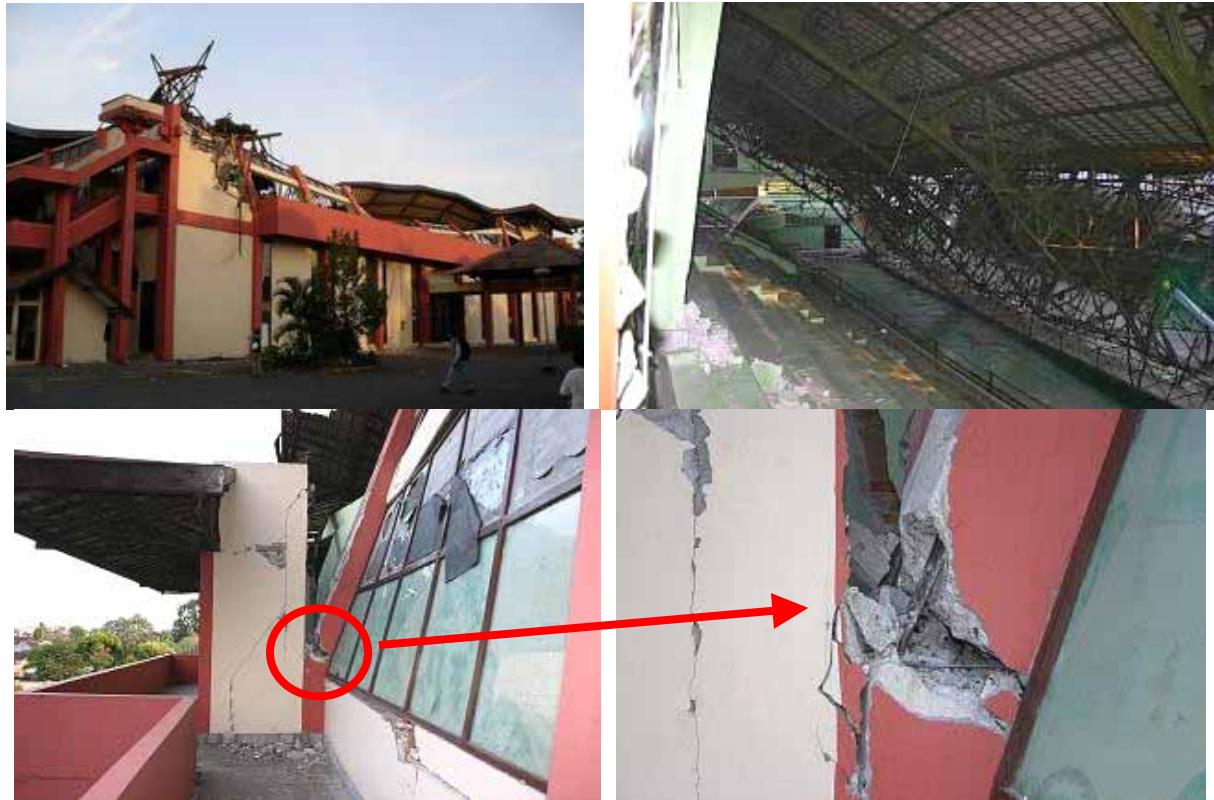
Amonggogo Sports Center

Extensive damage was found in cantilever RC columns on the top floor as well as in the roof system. The column damage may be attributed to the large inertia force due to shaking and the inward force due to the roof's collapse since the reinforcement was slightly provided in the columns.

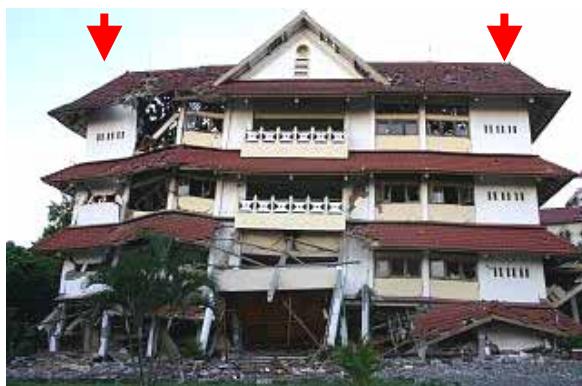
The campus had several multi-story buildings. Serious structural and nonstructural damage was found in most buildings. One 4 story RC building, which was located just across the open square at the entrance gate, lost its first story due to collapse at beam-column joints. It had 2 URM wall frames while the neighboring 5 story building had 4 URM wall frames and did not collapse. The damage was also attributed to the insufficient beam-column joint section as compared to the amount of reinforcing bars, which resulted in the poor anchorage at the joints and their failure.

4 story building with 2 URM walls frames

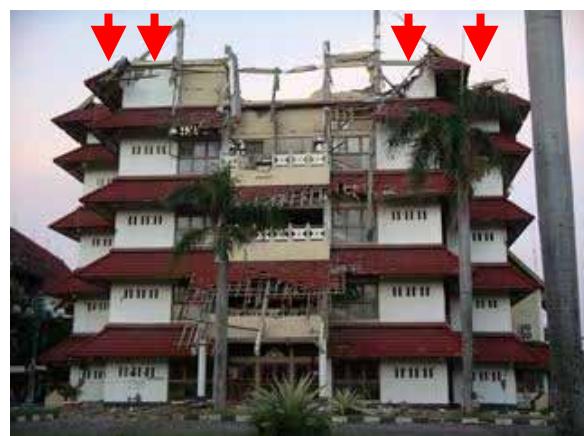
5 story building with 4 URM wall frames

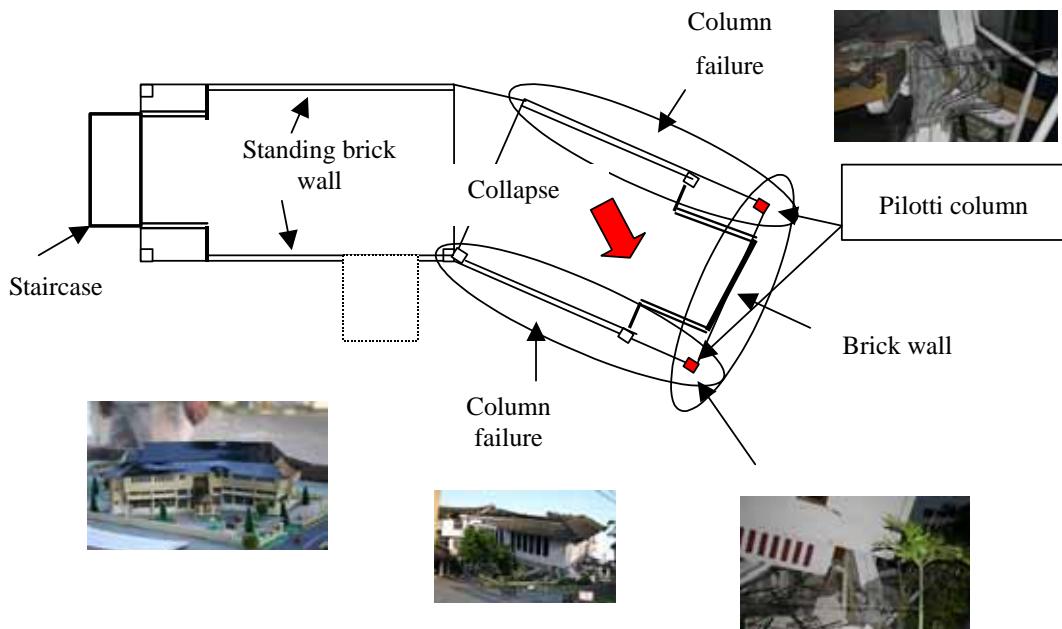
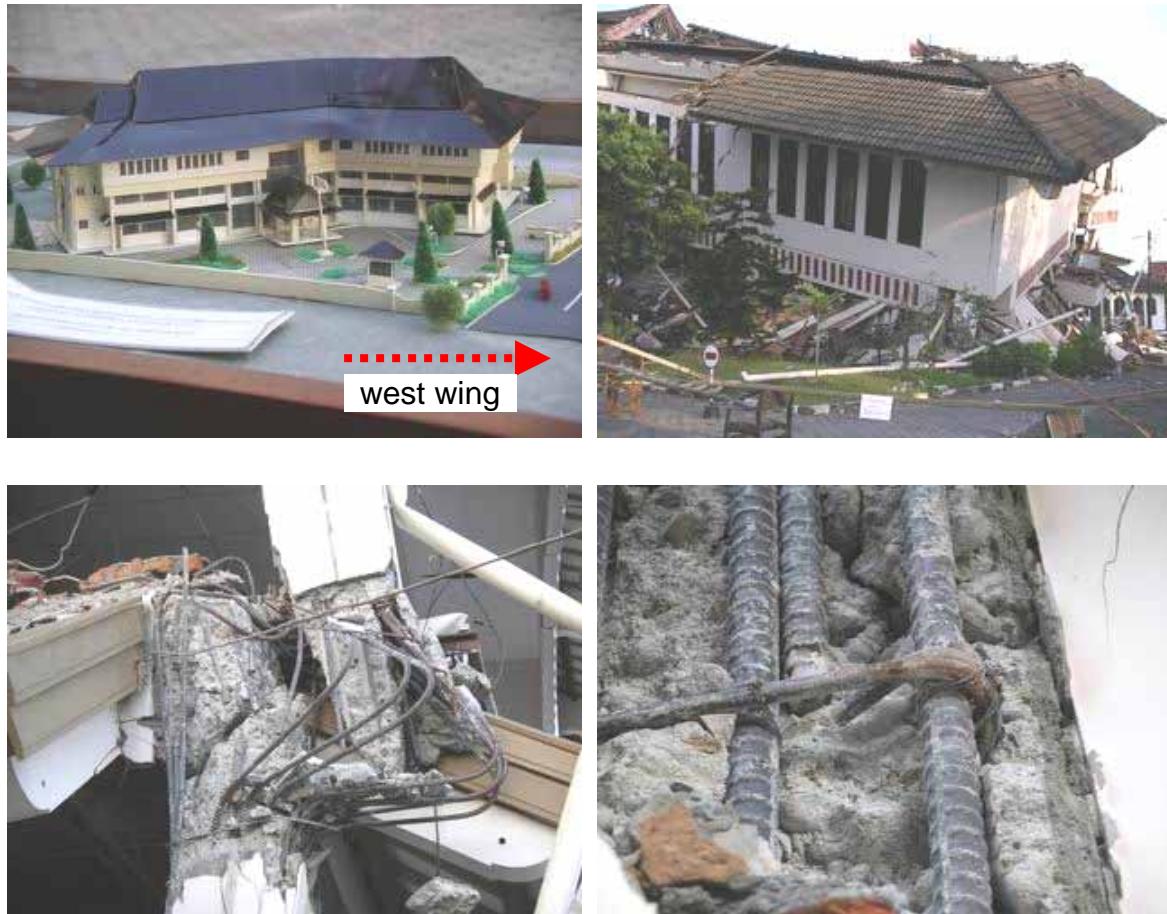
Finance and Development Audit Agency

A 3 story RC building lost its first story in the west wing due to beam-column failure at the 2nd story while the east wing survived the shaking with damage to URM walls. Some reinforcing bars of the column were lap-spliced at the joints, resulting in failure. The lateral reinforcement was placed at a space of 25 to 30 cm with 135-degree hooks. The serious damage to the west wing may be attributed to large deformations of flexible columns supporting confined masonry walls above on the west-end exterior frame and torsional response effects.

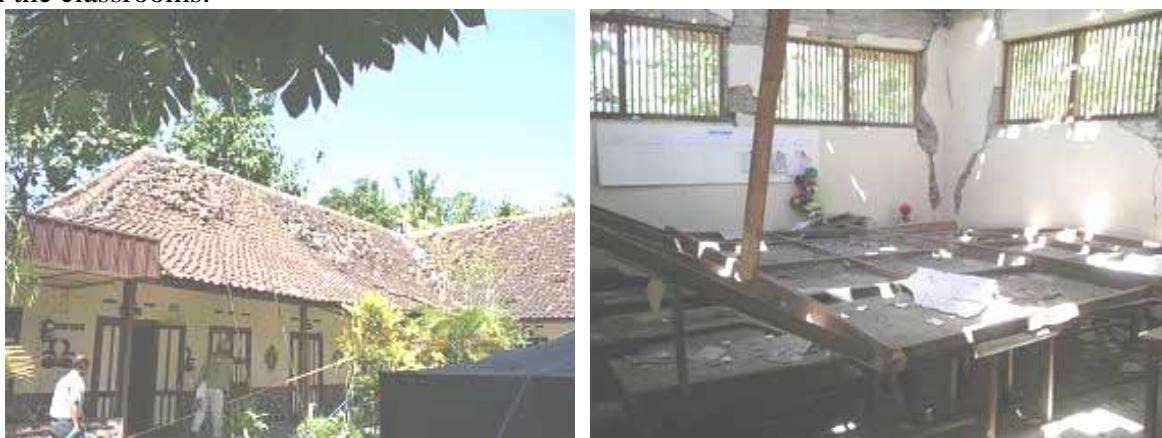
SD Tempel at Bambanglipuro, Kecamatan Baglipuro

No lintel beams were found and the roof truss was directly placed on URM walls. Major damage was found in URM walls and the timber roof truss, and some ceiling boards fell down in the classrooms.

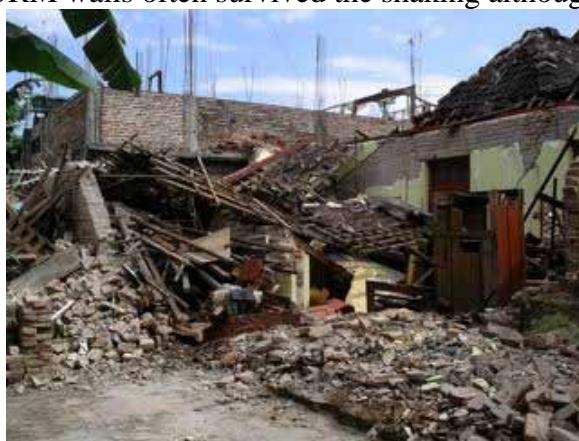
Houses in Imogiri were extensively devastated. They were URM structures with timber truss system and roofing tiles on it. URM walls were typically 20 to 25cm thick with 2 or 1.5 brick units, having a geometry size of 26cm x 12cm x 6cm. Since demolitions to reconstruct damaged houses had started in some damaged houses, it was not easy to identify which debris were due to shaking and which were not. Those with RC frames to confine URM walls often survived the shaking although they had some damage.

Devastated URM house

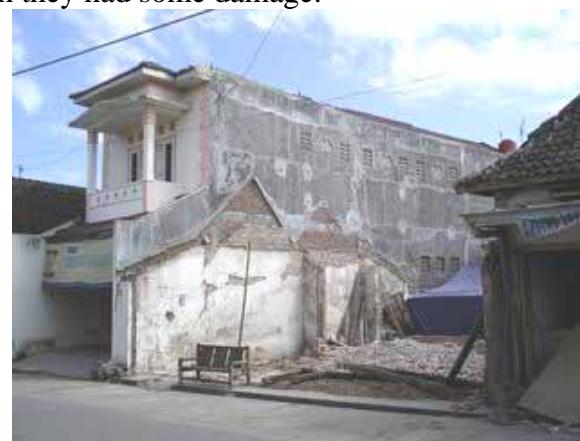
Survived house with URM and RC frame

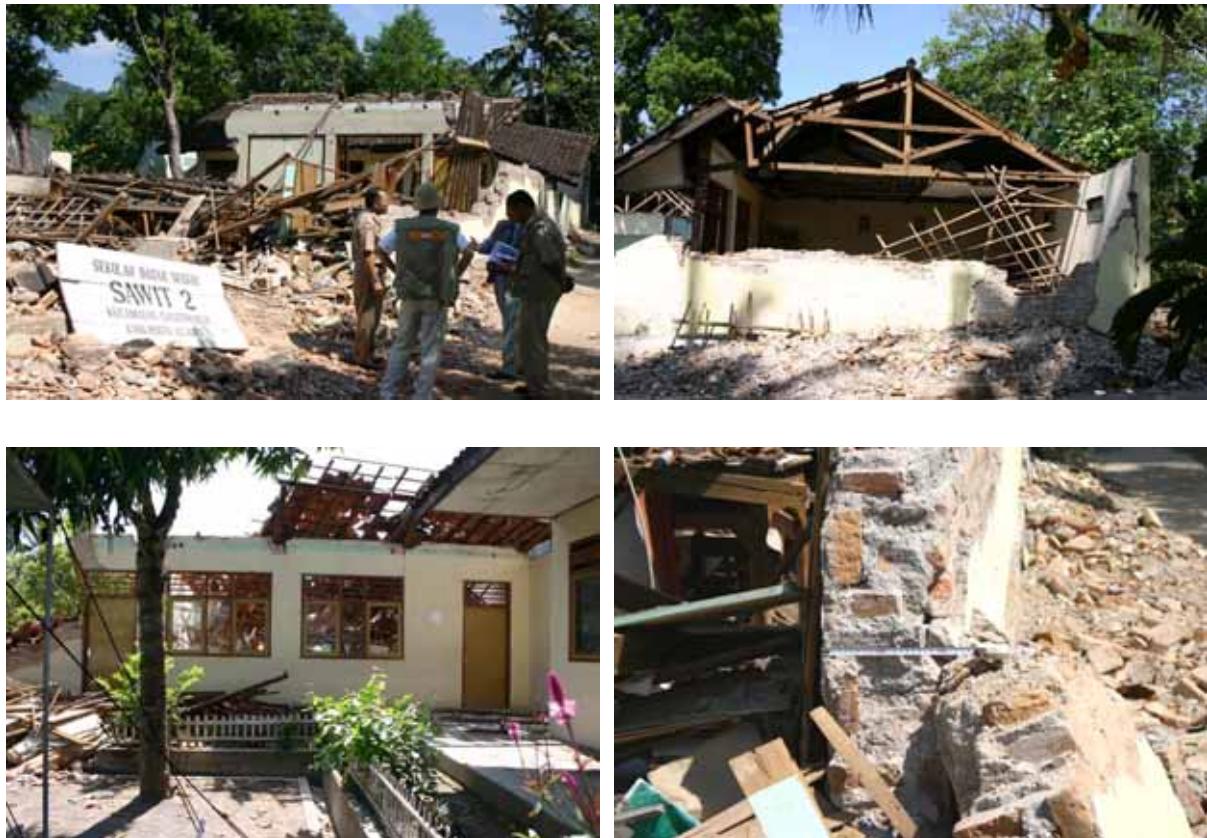
SD Sawit at Gantiwarno

The school building most probably had RC columns only at the 4 exterior corners but no columns in the middle of the structure. Each class had 2 bays and each bay were 3.5m long. Extensive damage was found in 20cm URM walls and the roof system.

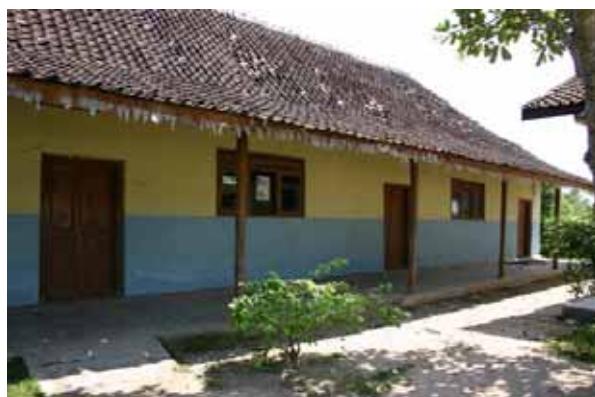
Building #2: Stone masonry structure

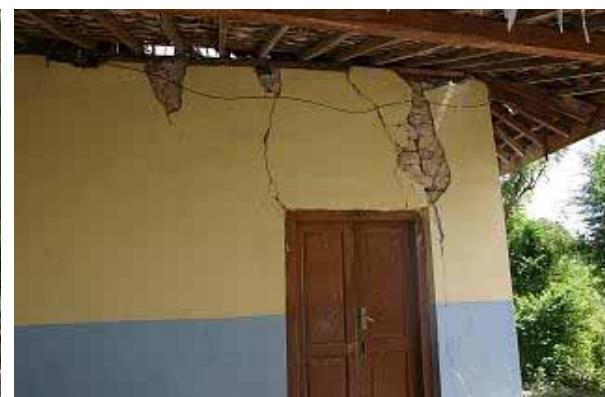
Damage to corner wall

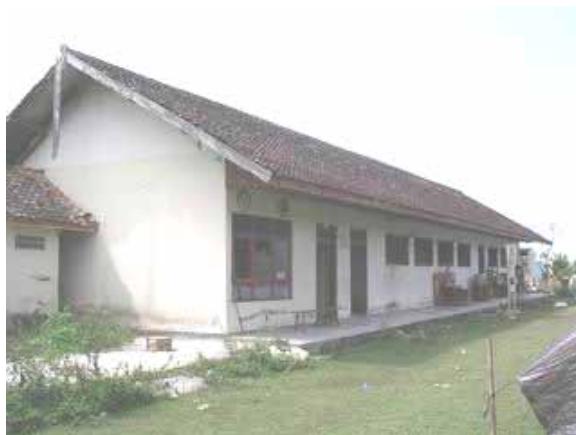
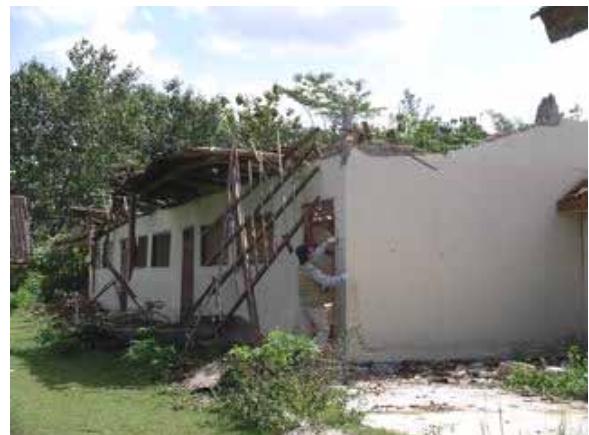
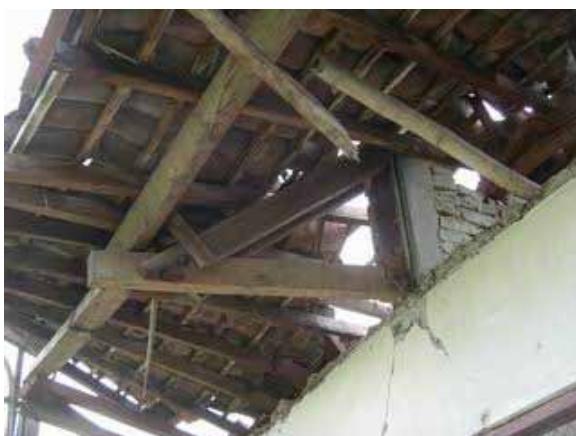
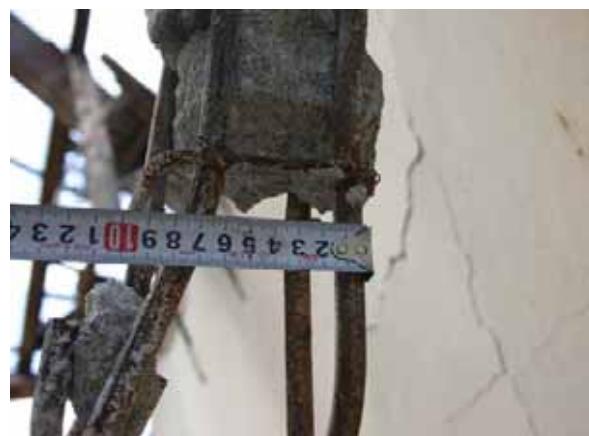
SD Pesu

The school had two buildings, one was seriously damaged in the roof system and the other survived the shaking. Columns having the 150mm x 150mm section with 4- $\phi$ 13 rebars and  $\phi$ 6 hoops were provided between classrooms. A mid-span wall was 150mm thick and 500mm wide. The roof was supported by the timber truss fastened to RC columns above.
