HOKKAIDO, JAPAN, M_w 6.7 EARTHQUAKE OF SEPTEMBER 6, 2018 LIFELINE PERFORMANCE

The Council of Lifeline Earthquake Engineering
TCLEE No. 4

G&E Report R98.23.01 Revision 1, March 18 2019

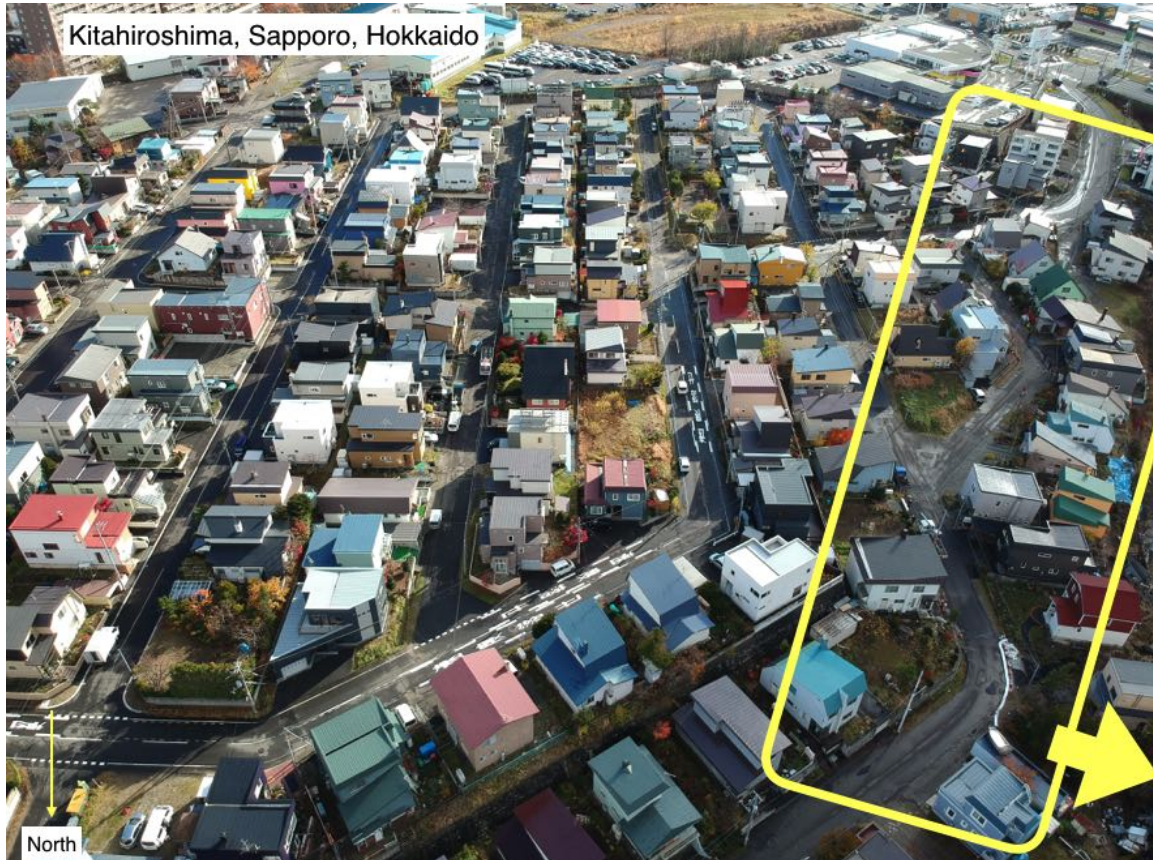
Figure 2-16. Landslide zone in Kita (near Southeast Sapporo)

Figure 2-16 shows the effects of landslide / embankment failure along the street highlighted in yellow. Several of these houses moved sideways and downslope by a meter or more; several buildings were "red-tagged".

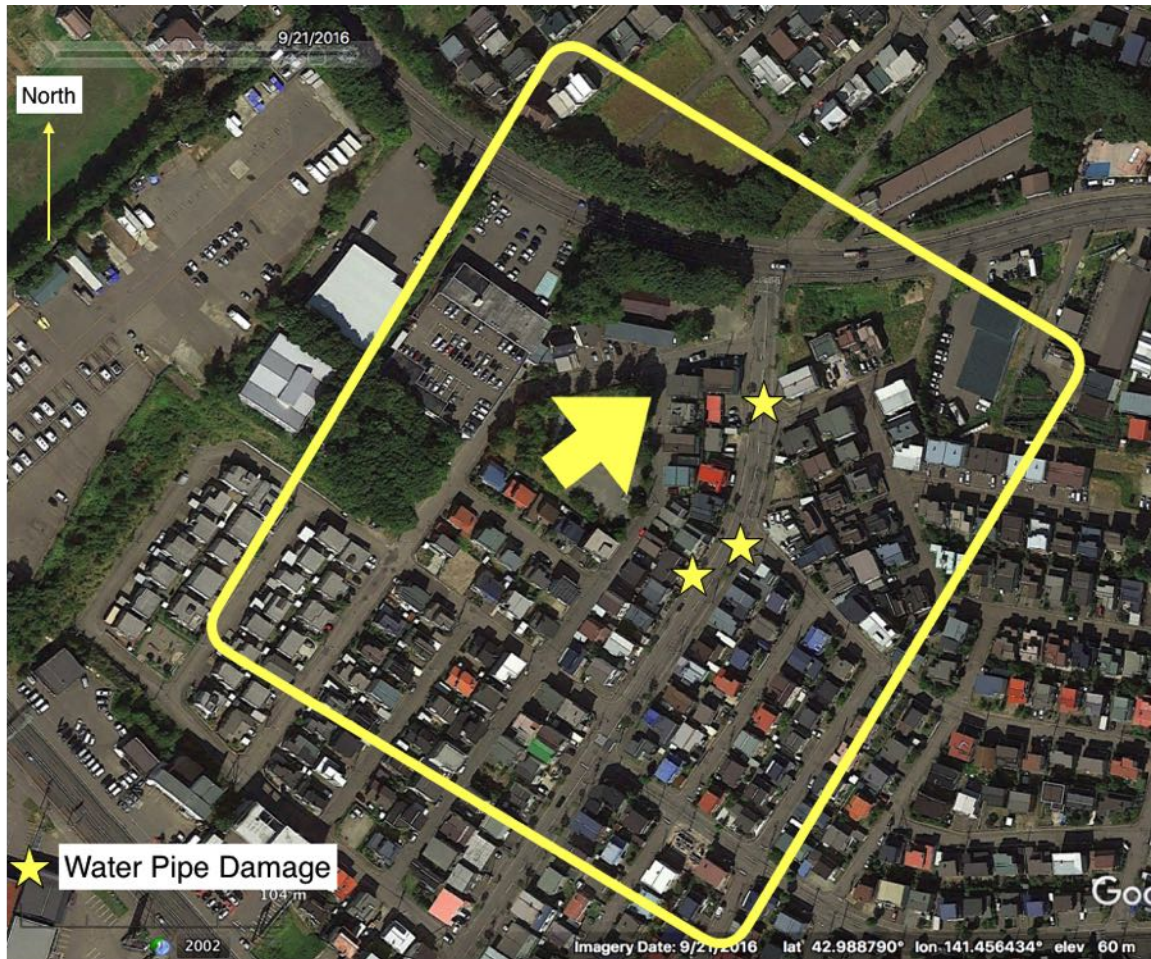
Figure 2-18. Liquefaction zone in Kiyota-Ward (latitude 42.9888 long 141.4564)

Figure 2-18 shows as aerial view taken two years prior to the earthquake. The three yellow stars show the locations of broken water pipes (see also Figure 5-7).

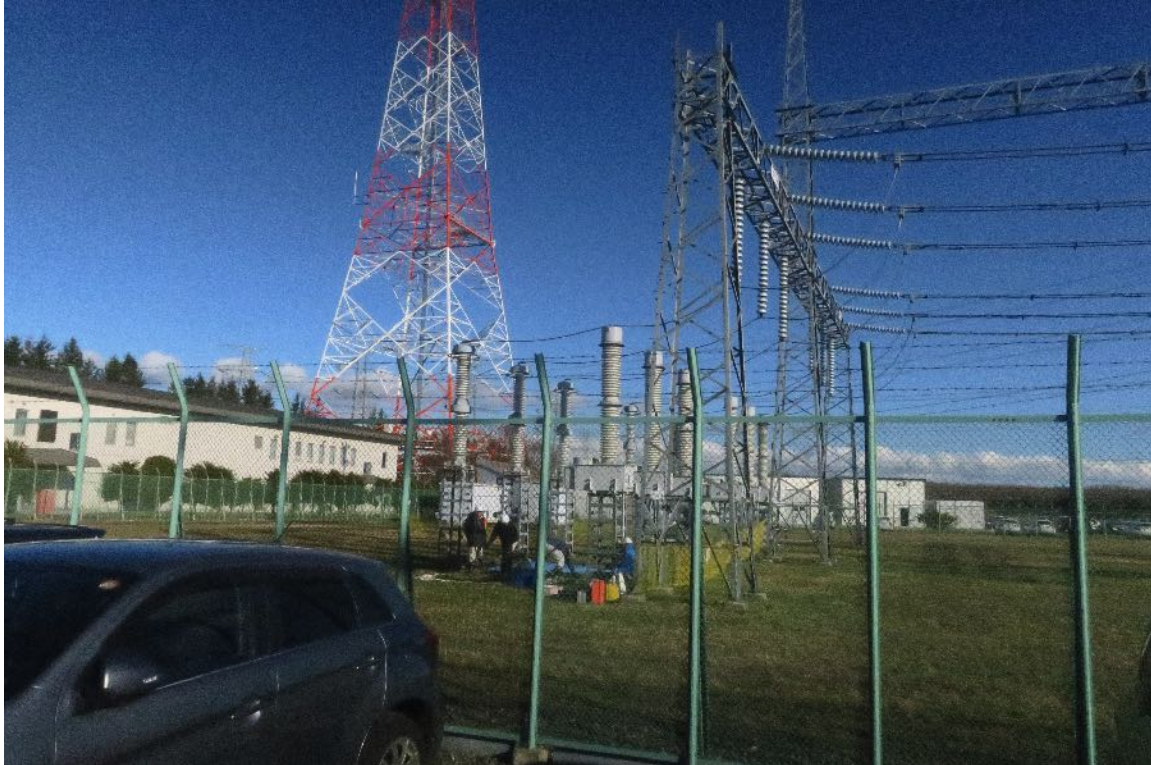
Figure 3-8. Minami 187 kV CCVTs

In November 2018, CCVTs in the 187 kV yard were being modified by a field crew, see Figure 3-8. Piles for a new 187 kV – 66 kV transformer bank were being driven. No other earthquake-related damage is known to have occurred at this yard; detailed documentation is suggested. It is recommended that a seismic inspection of this yard be conducted, and the inventory and style of equipment catalogued to identify what is apparently good seismic design detailing and good seismic performance at PGA ~ 0.35g.

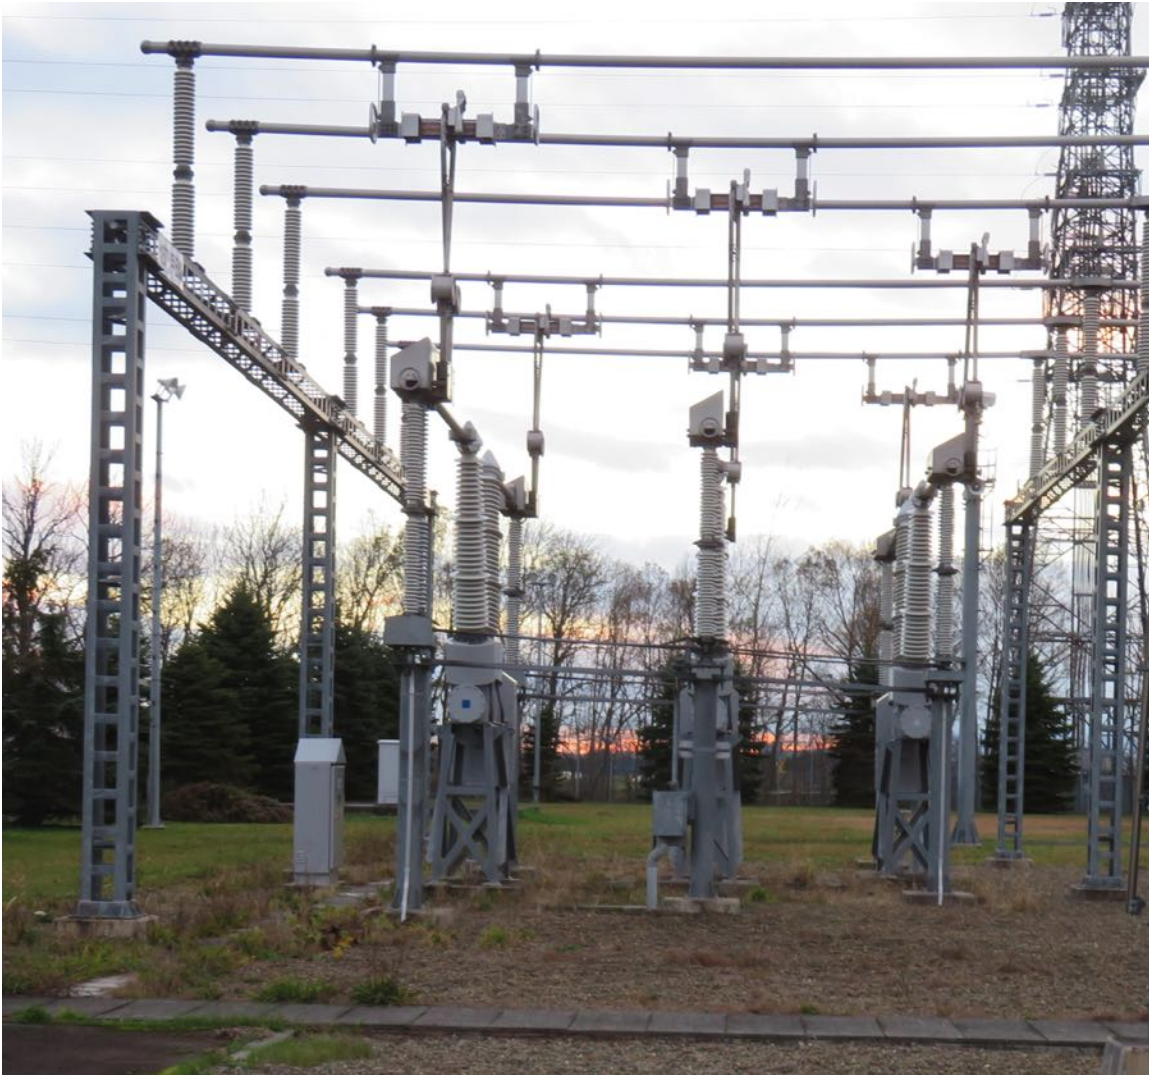
Figure 3-11. Eniwa 187 kV Substation. 187 kV Pantograph Switches

Most disconnect switches are panto-graph type (scissor-type), connected to the primary and secondary 187 kV busses, see Figure 3-11. None of these switches are known to have been damaged. Given the different relative stiffness of the rigid busses and the switches, one would expect that earthquakes that generate high motions would result in a significant and un-planned force at the connecting bus bar: this was the case in the Kumamoto 2016 earthquakes, where many high voltage switches in a similar arrangement collapsed, (ref. TCLEE No. 2). The fact that none of the switches collapsed in this earthquake is possibly mostly due to the relatively modest level of shaking at this yard (perhaps PGA ~ 0.20g), rather than specific aseismic detailing.

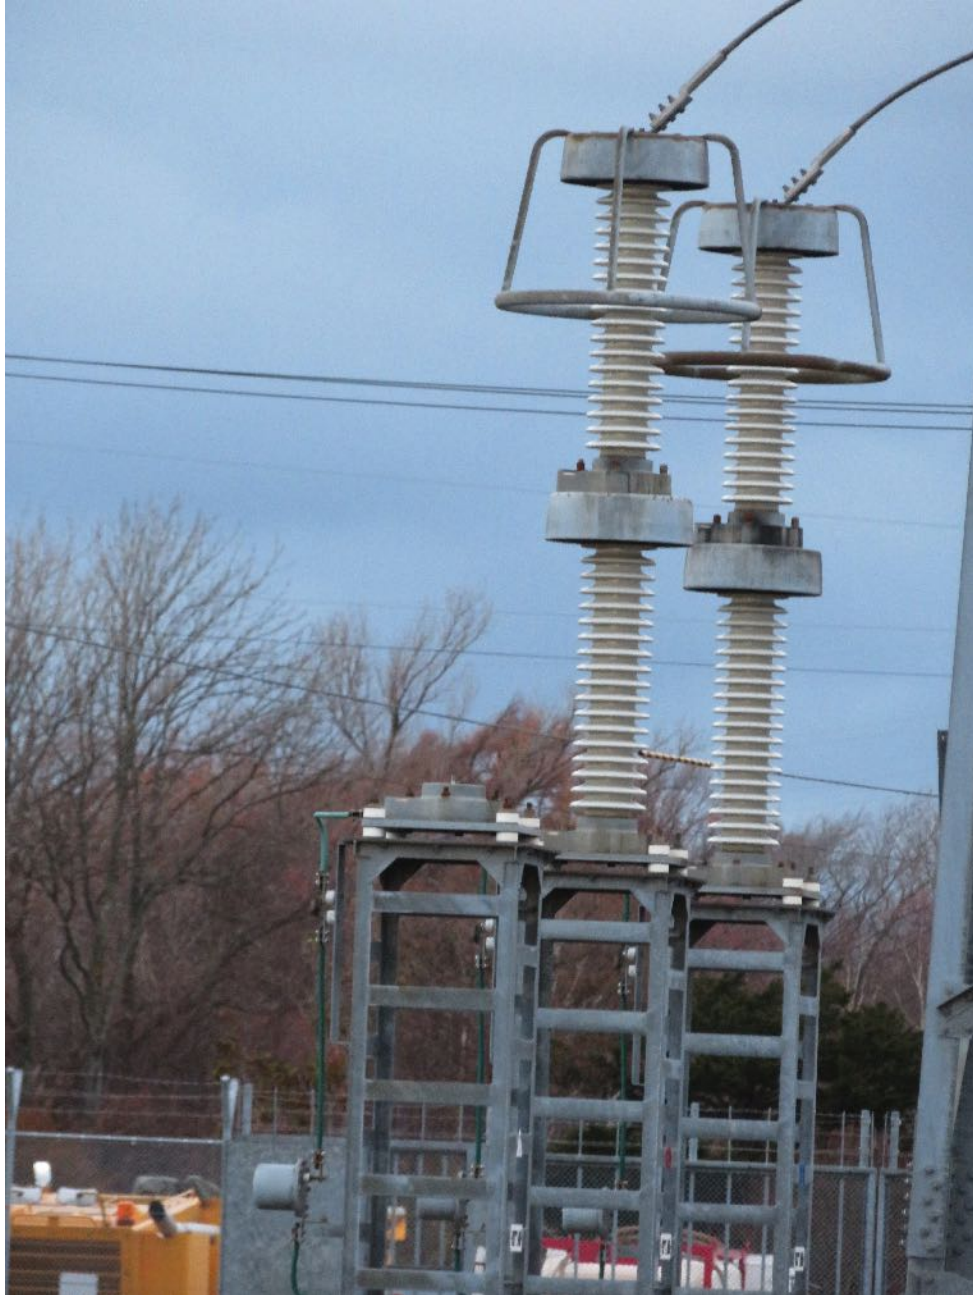
Figure 3-12a. Eniwa 187 kV Substation. Location of Damaged Surge Arrester

Figure 3-12a,b shows the position where one of the 187 kV lighting arrestors collapsed. This surge arrester in one of three serving the right-most transformer in Figure 3-9. Inspection of the attached conductors suggests that the failure was not due to the conductors having insufficient slack; rather, it was an inertial overload. During the earthquake, the surge arrester broke at its base, and swung sideways (towards the right in this photo, see Figure 3-12b). Fortunately, the arrester did not impact anything (it was more than 10 meters away from the 187 kV transformer bushings), so the net result was at most a temporary line fault that could be cleared once repair men could de-energize and safely cut away the broken surge arrester. The photo in Figure 3-12a was taken on November 14 2018, more than 2 months after the earthquake, and a replacement surge arrester has not yet been installed.

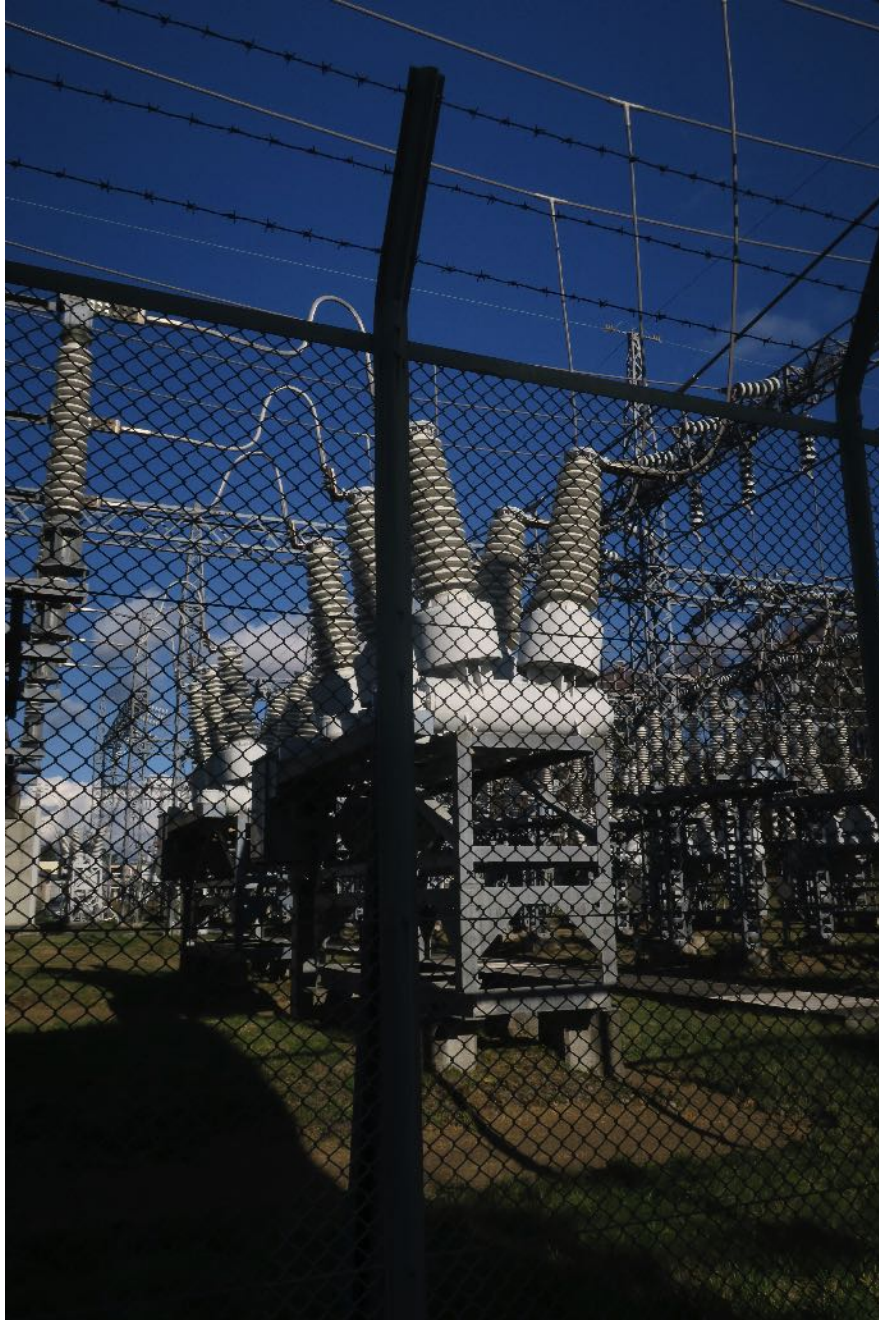
Figure 3-14. Hayakita 66 kV SF6 Circuit Breaker

Figure 3-14 shows one of the many similar circuit breakers at this yard. All breakers were SF6-type, and all had suitable flexible loops to adjacent equipment positions. This demonstrates that HEPCO has implemented good seismic detailing.

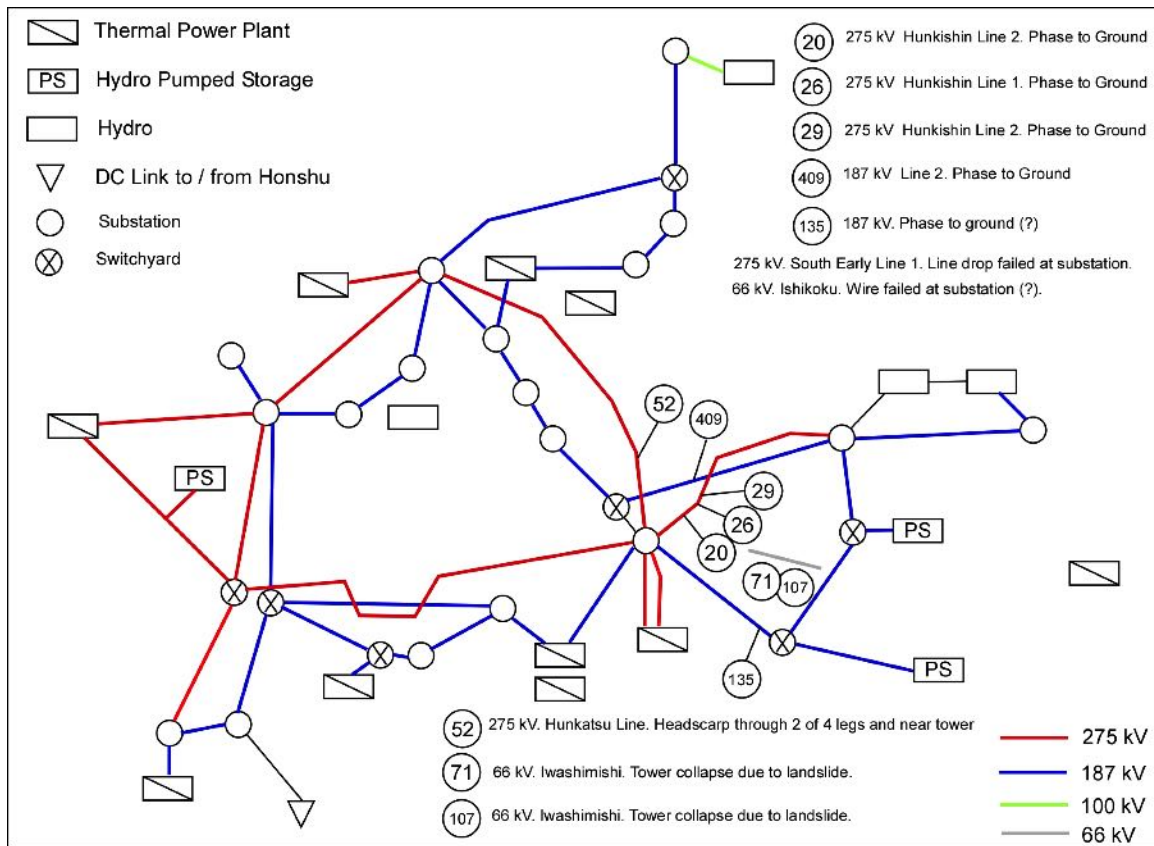
Figure 3-17. Locations of Transmission Tower Damage

Figure 3-17 shows the locations where transmission lines were damaged. The 2-digit or 3-digit number refers to HEPCO's tower numbering system, usually beginning with "1" at the substation and incrementing higher for each tower along the transmission line. Figure 3-17 shows locations of damage at 8 transmission towers; 2 other transmission lines were faulted due to damage of equipment at substations. A portion of the single circuit 66 kV Iwashimishi line is shown, to highlight the relative locations of collapsed towers due to landslides. At least one other tower was exposed to landslide movements; but not so severe as to fault the line or warrant immediate repair.

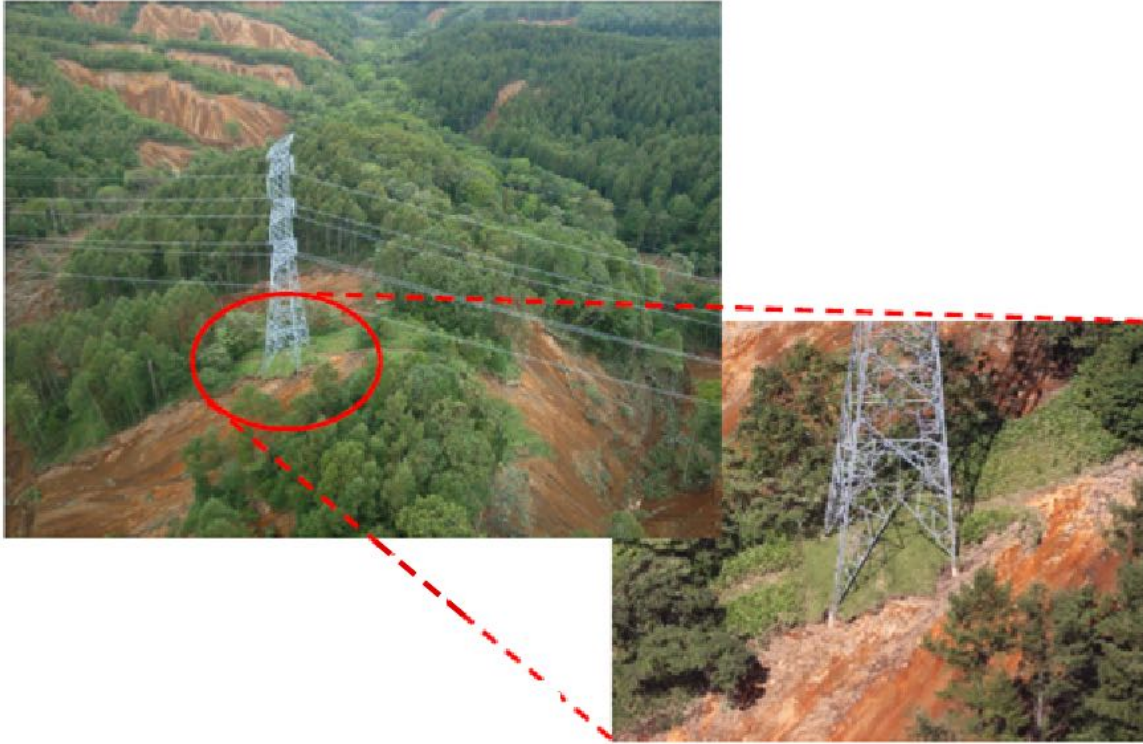
*Figure 3-18. Landslide at 275 kV Tower (Photos taken Sept 11 2018, Courtesy HEPCO)
(latitude 42.7804, longitude 141.9745)*

Figure 3-18 shows a 275 kV double circuit transmission tower with overhead ground wires, tangent suspension-type.

This tower is located in a remote area, located about 1.5 km from the nearest paved vehicle road. There were many landslides that can be seen in Figures 3-18. Figure 3-19 shows the many landslides mapped in the vicinity of this tower (red polygons) and the Apporo reservoir (blue lake, see also Figure 5-22). The head scarp of the landslide extended through the two southern legs of the four legs of this 4-legged lattice structure.

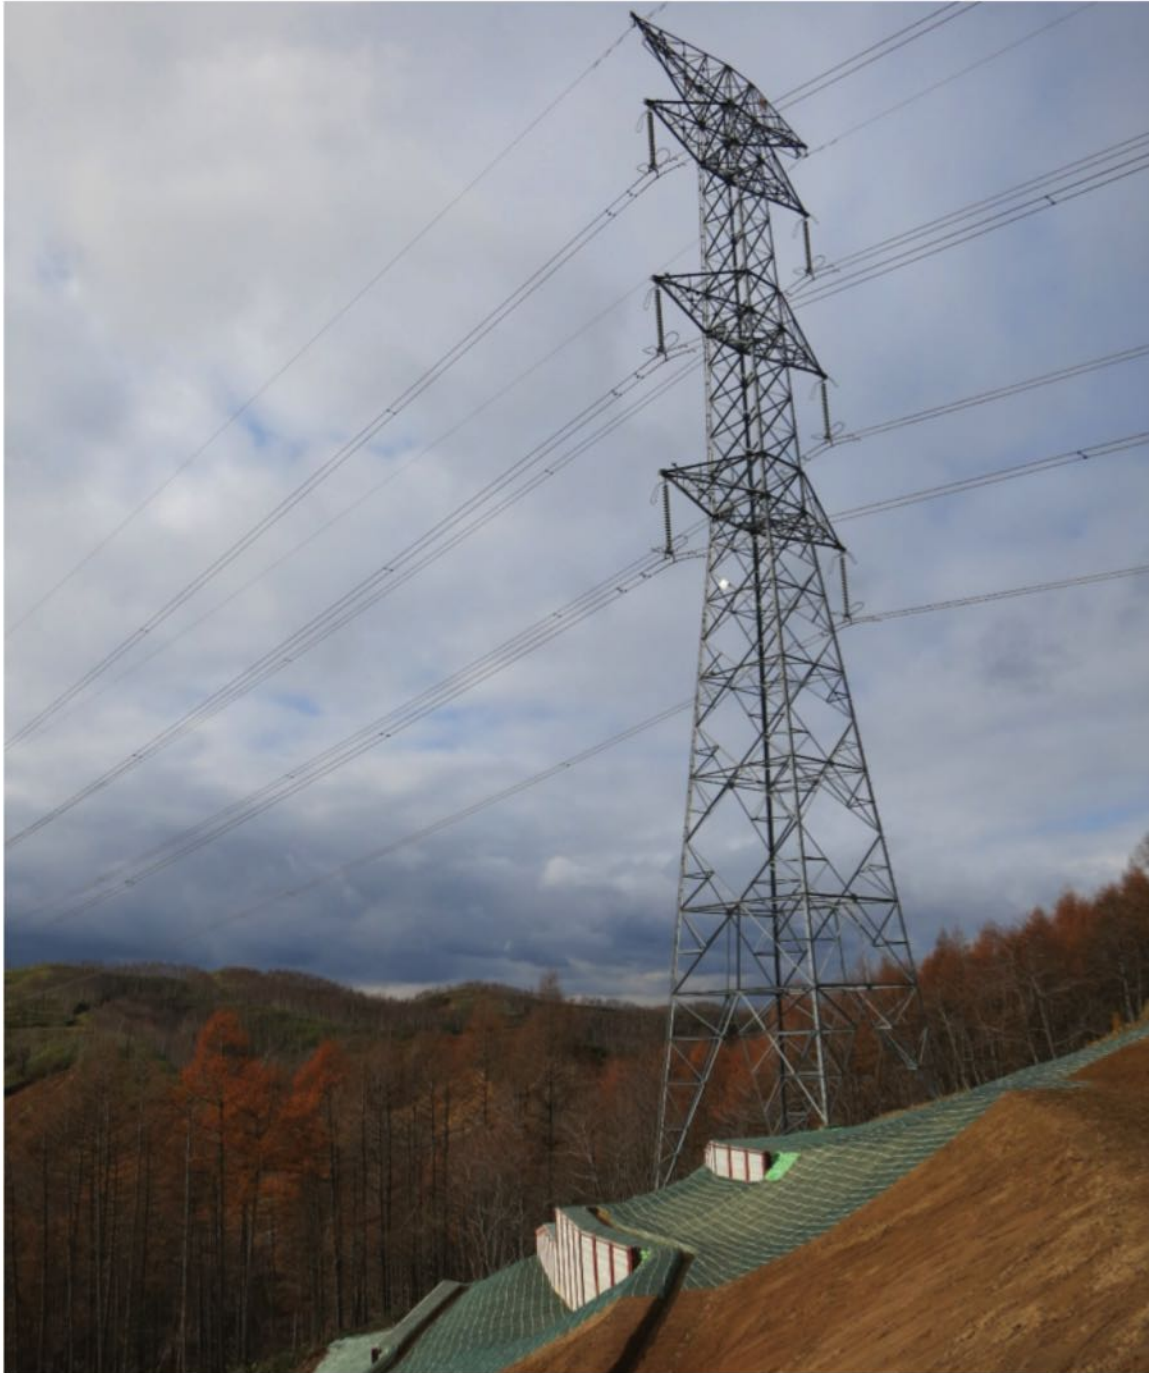
Figure 3-20. Repaired 275 kV Tower (Latitude 42.7804, Longitude 141.9745)

Figures 3-20 through 3-25 are photos that were taken on November 14 2018, after HEPCO had completed some landslide mitigations. At the time of this inspection, we did not observe any damage to the tower: no primary or secondary member appeared to be buckled or otherwise distorted.

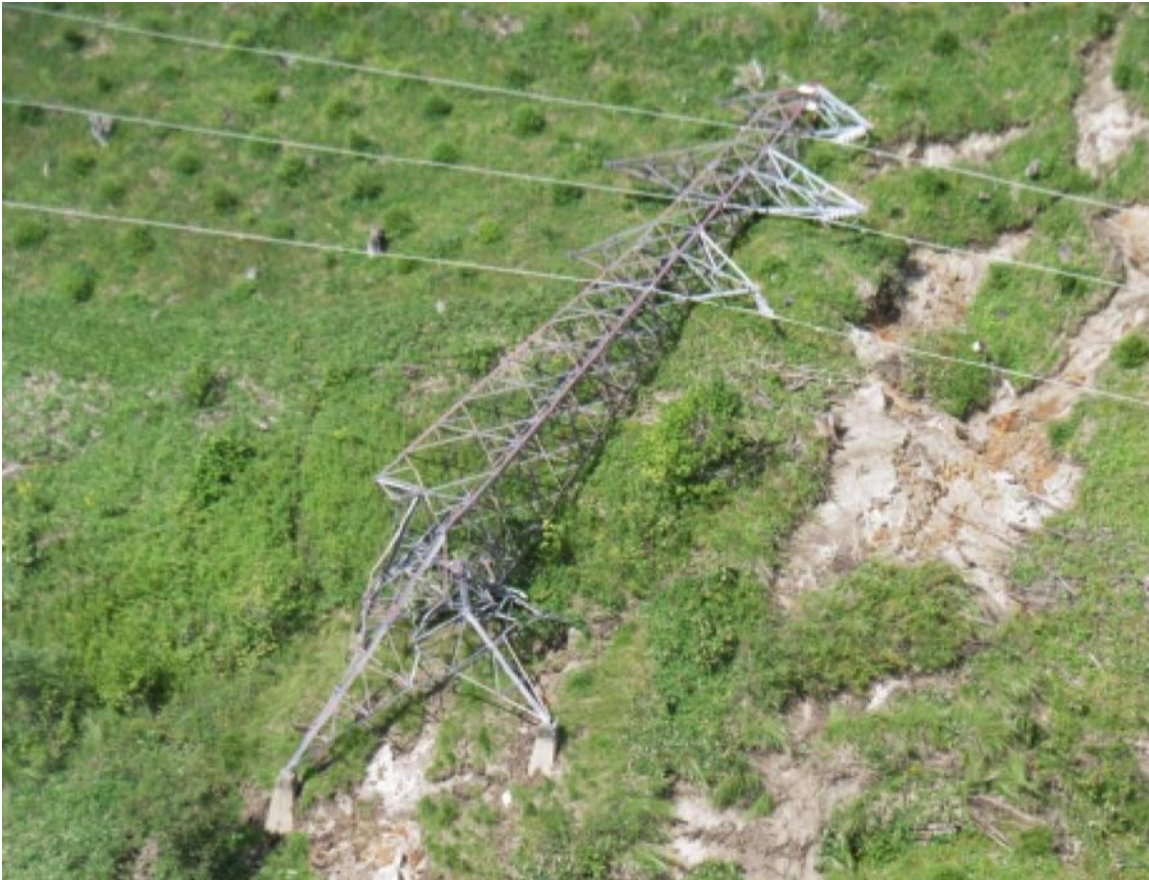
Figure 3-26. Collapsed 66 kV Tower 107 on Iwashimishi Line (credit: HEPCO)

Figure 3-26 shows the collapsed 66 kV tower on the Iwashimishi sub-transmission line.

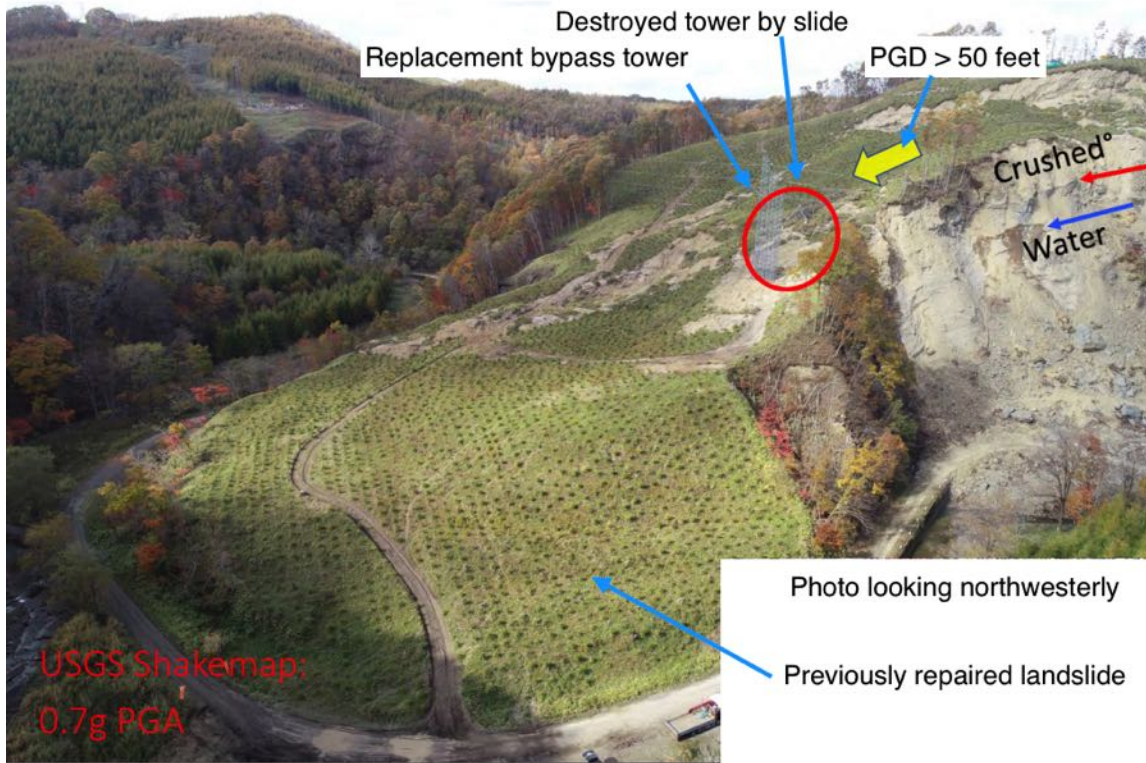
Figure 3-27. Collapsed 66 kV Tower (107) on Iwashimishi Line (lat 42.7188 long 142.1512)

Figure 3-28 shows two geoscientists examining the strata within the head scarp in Figure 3-27. This photo shows size of the head scarp and massive nature of the layered strata.

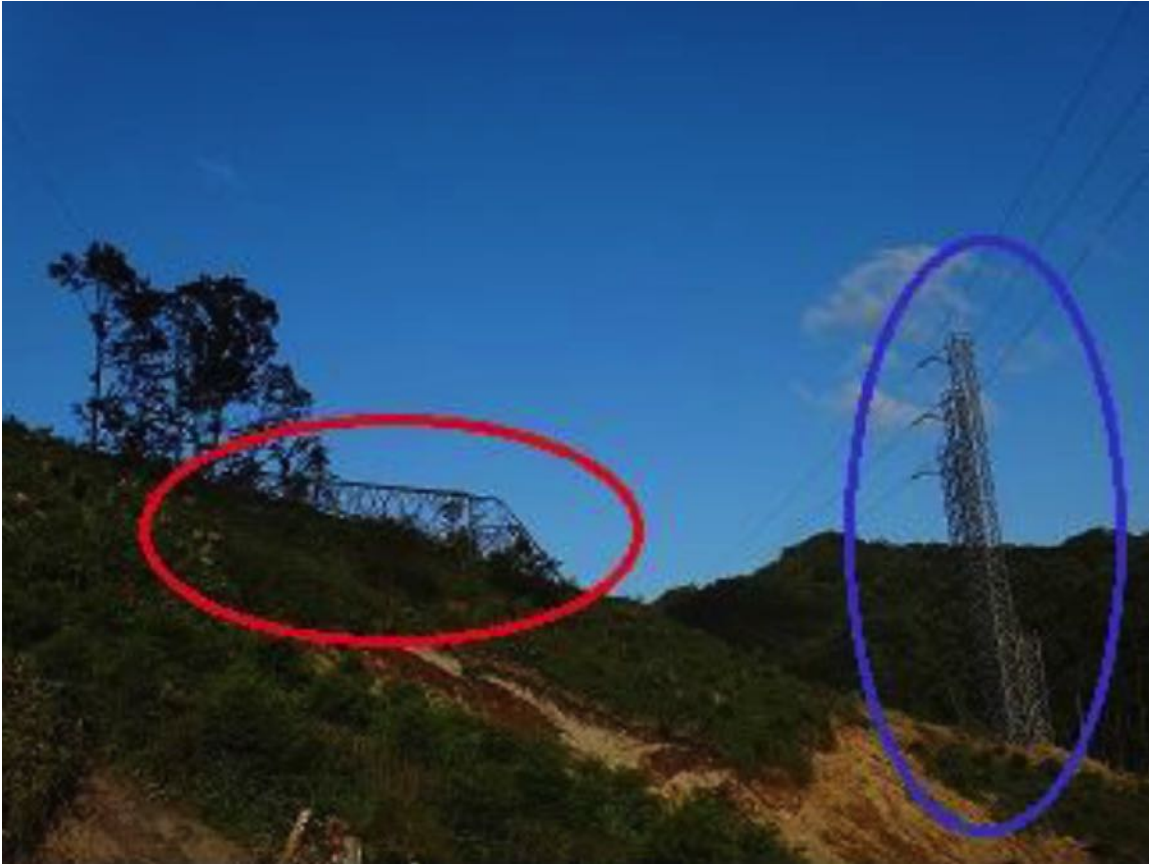
*Figure 3-29. Collapsed Tower 107 (Red Circle) and Replacement Tower (Blue Circle)
(photo: HEPCO)*

Figure 3-29 shows the collapsed tower (107, in red circle) and the replacement pole structure (blue circle).

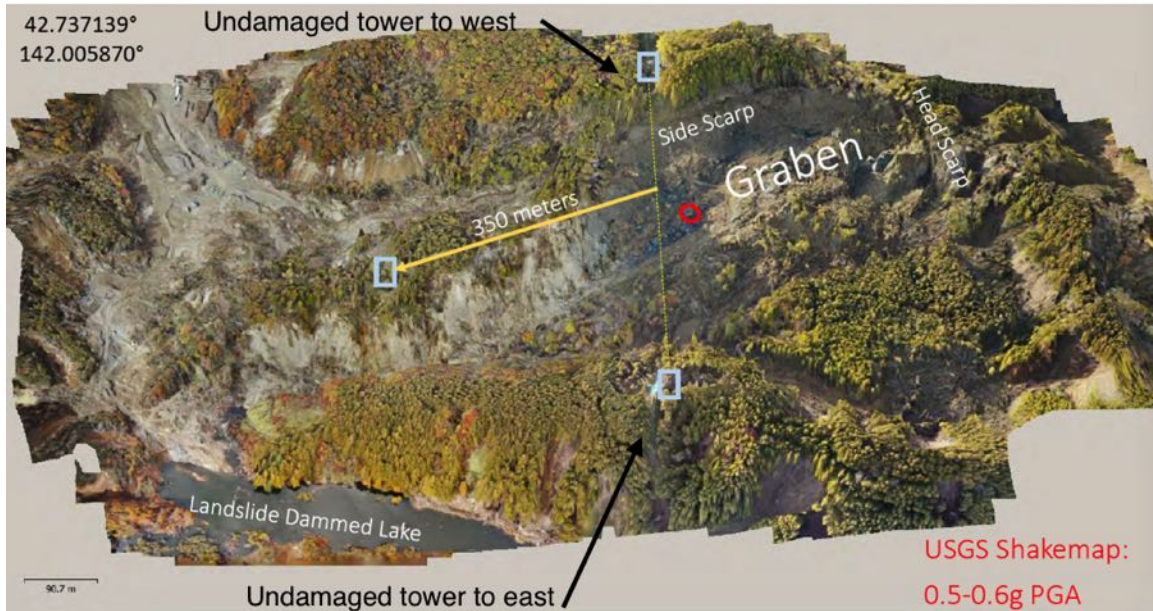
Figure 3-30. Collapsed 66 kV Tower (71) on Iwashimishi Line (latitude 42.7371 longitude 142.0058)

Figure 3-30 shows another collapsed landslide along this same 66 kV Iwashimishi circuit (tower 71). In this location, the landslide has moved as much as 350 meters downslope, entirely destroying the four-leg lattice tower. The two adjacent towers outside the slide were undamaged and it is understood that the long term fix is to move those towers back, raise them, and span over the landslide zone.

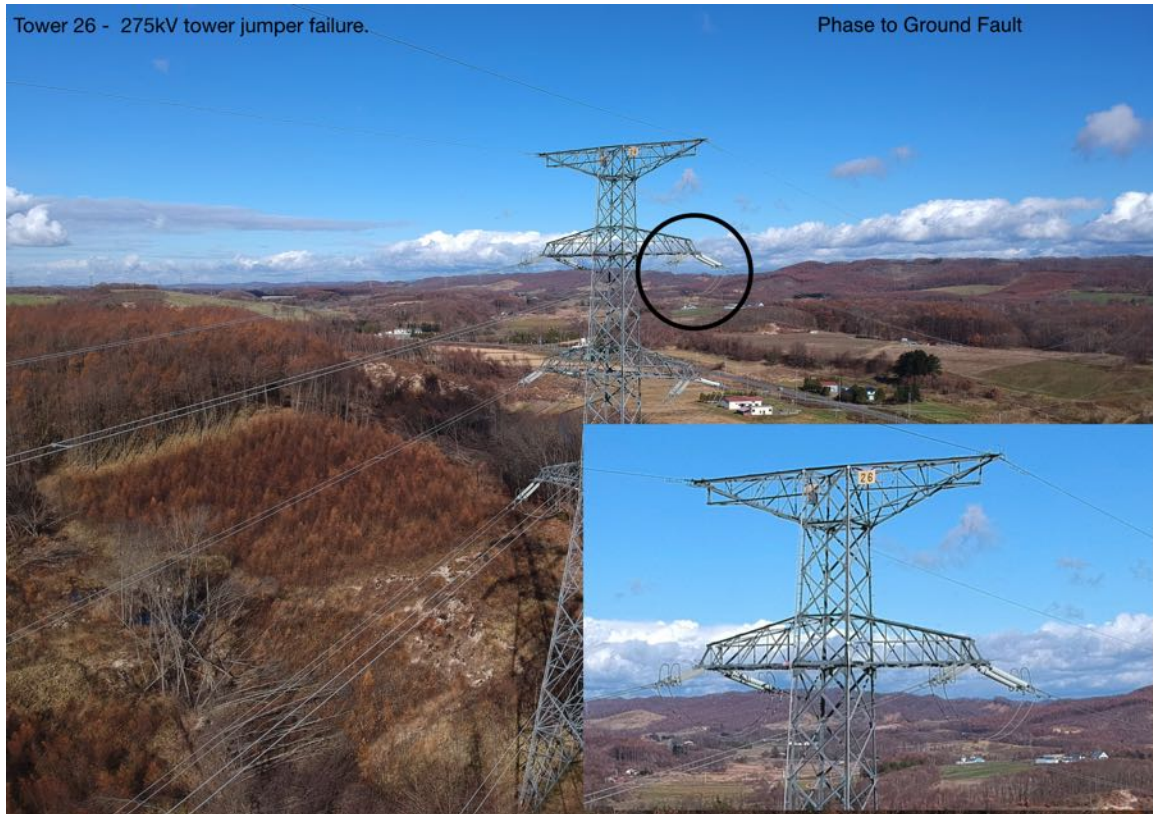
Figure 3-35. Tower 26, Line Fault

Figures 3-35 and 3-36 show Towers 26 and 29 on the 275 kV Karikatsu lines (see Figure 3-17 for location). The line jumpers and string insulators in the black circles moved during sufficiently during the earthquake to cause phase-to-ground faults.

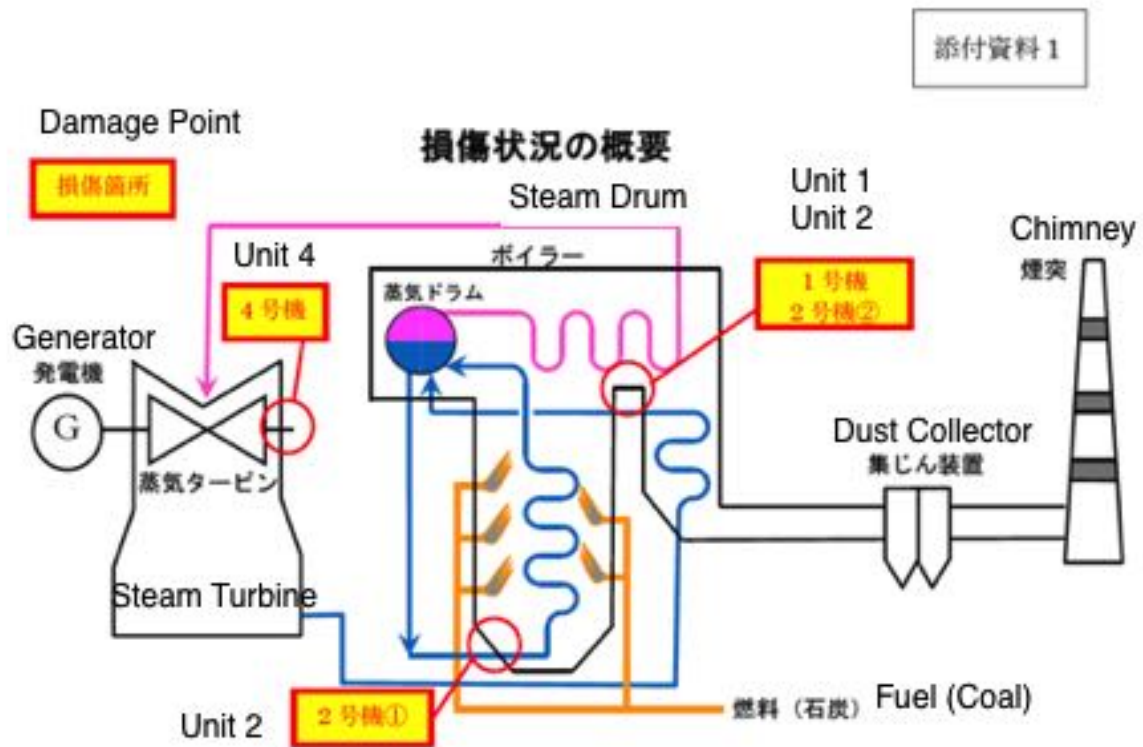
Figure 3-38. Outline of Damage at Tomatoh-Atsuma Units 1, 2, 4 (photo: HEPCO)

Figure 3-38 shows a schematic of the damage for Tomatoh-Atsuma Units 1, 2 and 4.

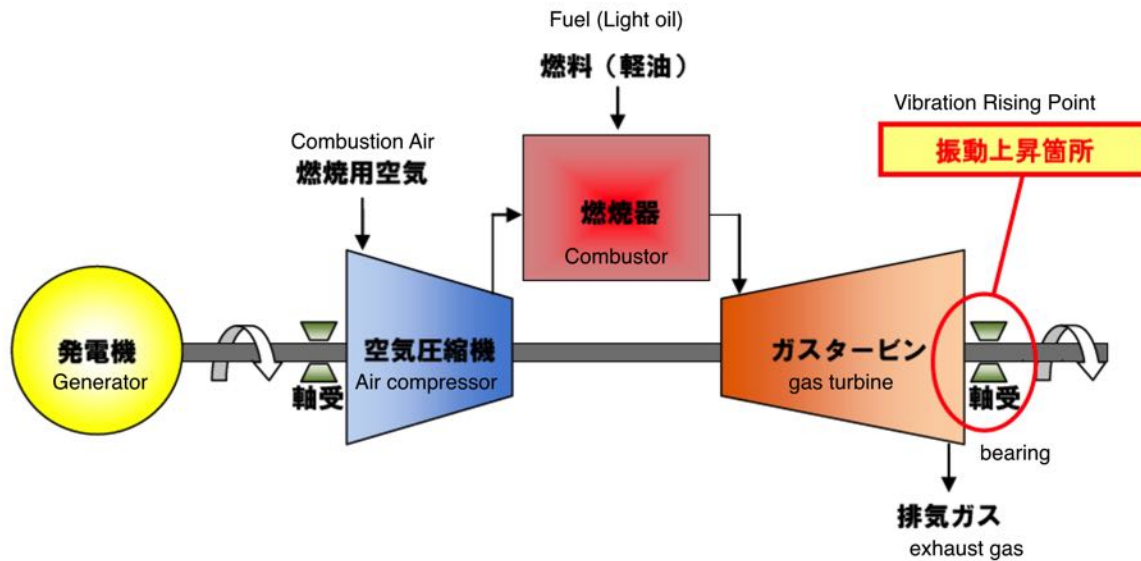
Figure 3-41. Excessive Vibration, Unit 2 (photos: HEPCO)

Kushiro City is located about 150 km east of the epicenter, along the southern coast of Hokkaido Island. HEPCO operates two oil power plants, called Onbetsu, located a few km west of the city. The 74 MW oil-burned power plant (Unit 2) was activated on September 11 2018, after the earthquake, to help with the island-wide supply of power. Upon start-up, excessive vibration was noted at a bearing on the gas turbine (Figure 3-41).

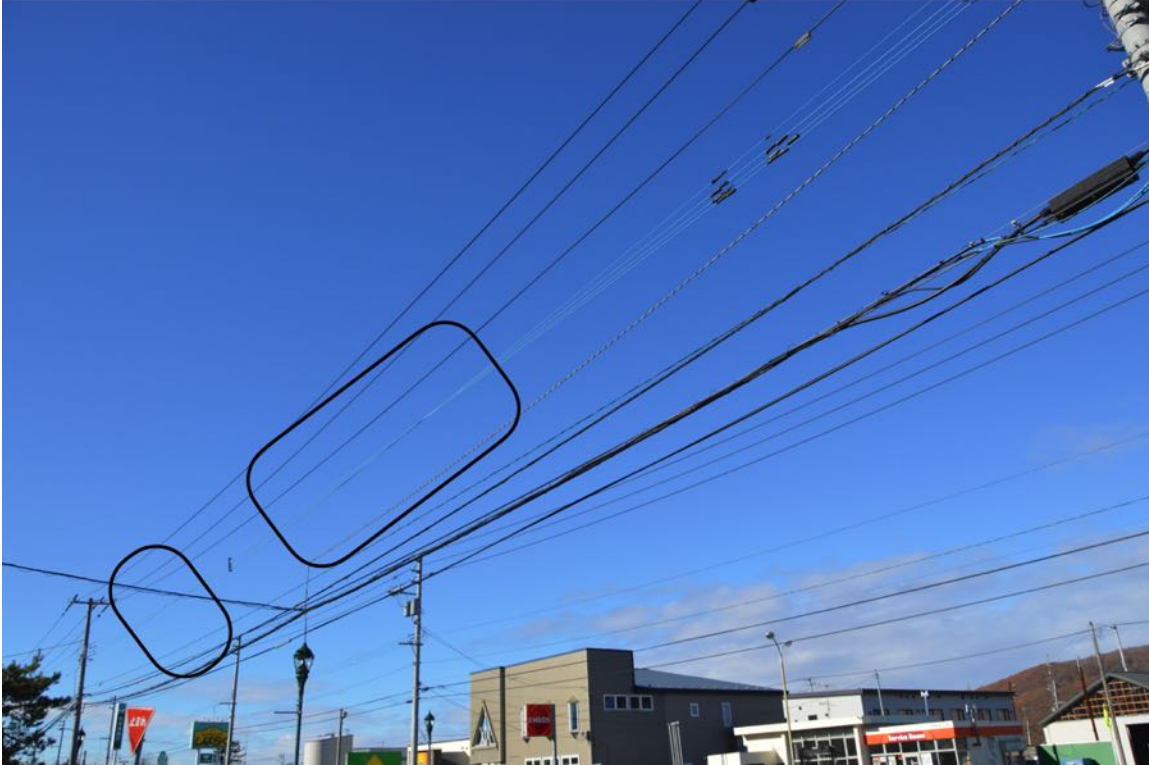
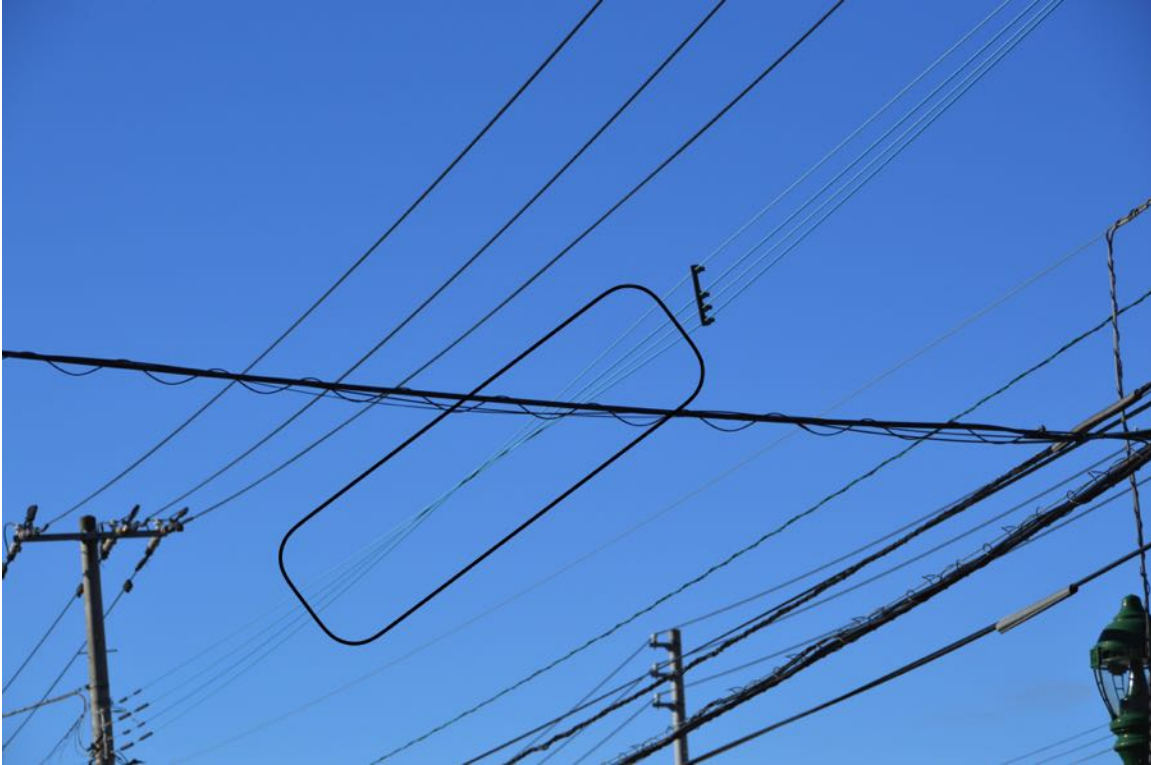
Figure 3-42. Wire Entanglement

that sometimes produces icing and snow build up on the wires; hence the entanglement does not result in a line fault. The example entanglement⁴ was observed at only one span, out of more than a hundred spans in this general area. It might have been that more such entanglements occurred, and that these had already been repaired; or possibly this entanglement was unique.

⁴ It has been speculated that the observed entanglement of these insulated wires possibly reflects a "design feature" by HEPCO; this is thought unlikely and remains an open question.

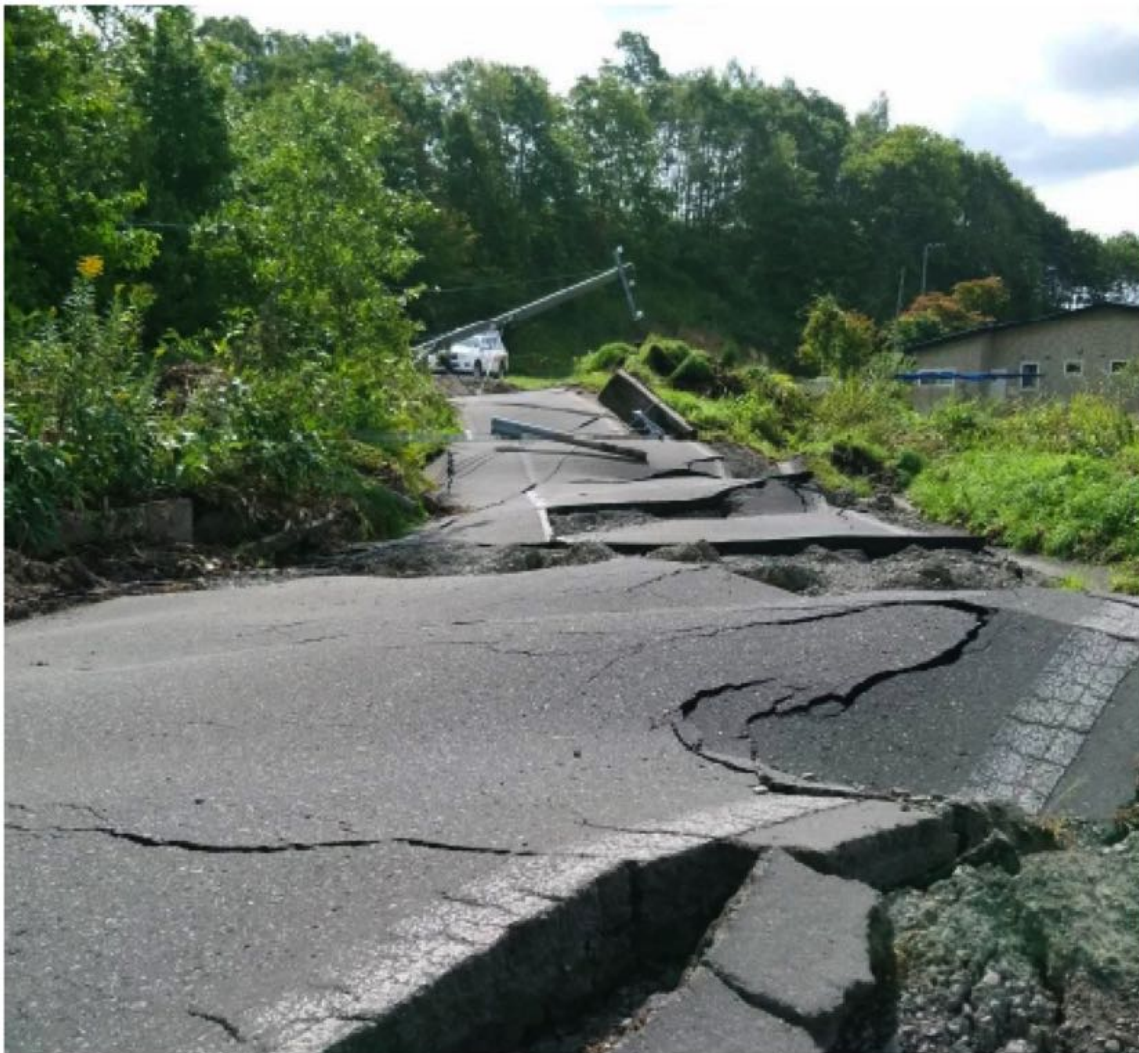
Figure 3-44 shows a toppled distribution pole due to major PGDs along a road.

*Figure 3-44. Toppled Distribution Pole due to PGDs along a Road (Atsuma-Cho)
(Credit: HEPCO)*

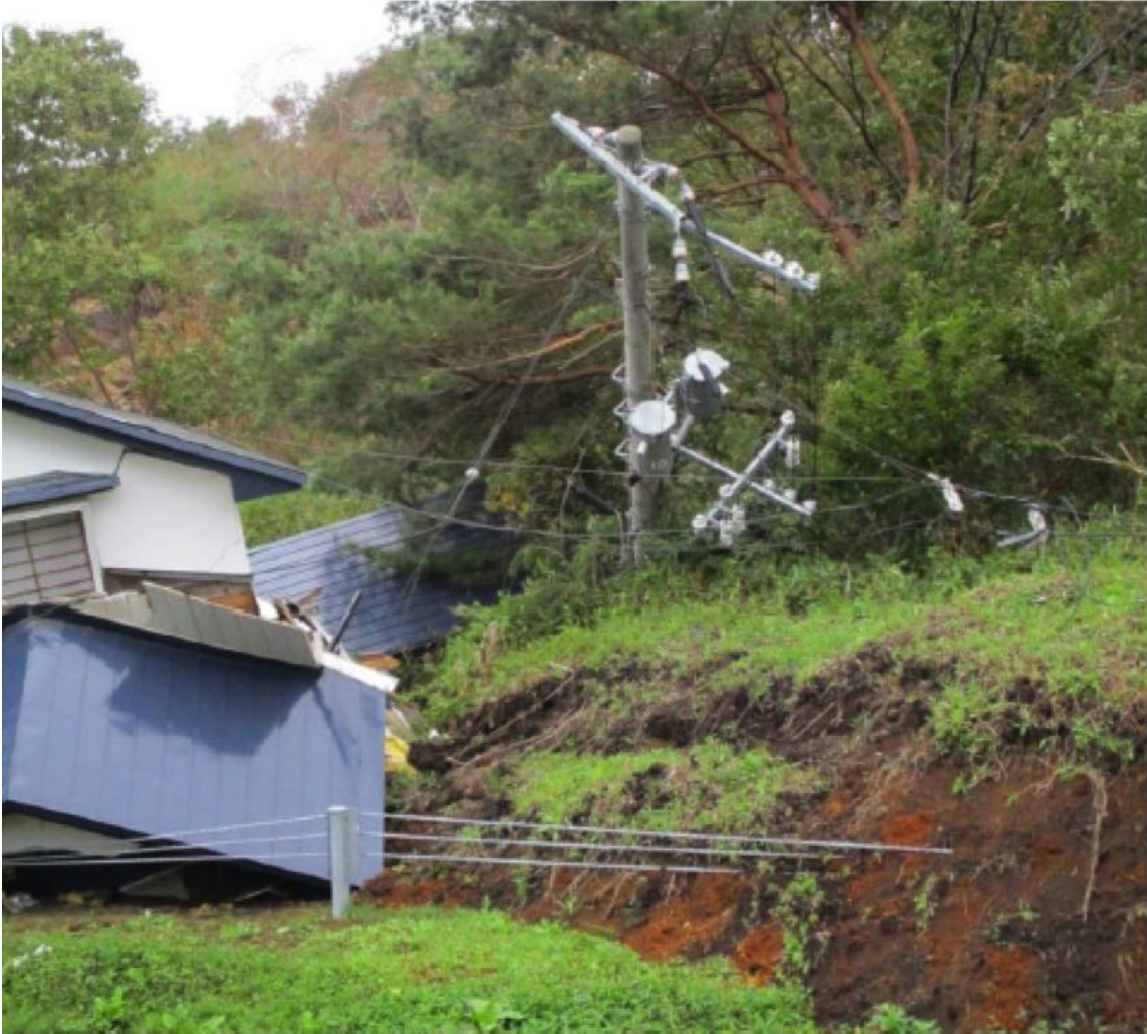
Figure 3-45 shows a toppled distribution pole with "tilted" transformers. The underlying cause is PGDs due to a landslide that also destroyed a house. Figure 3-46 shows two other toppled / tilted poles.

Figure 3-45. Toppled Distribution Pole due to PGDs (Atsuma-Cho) (Credit: HEPCO)
