HOKKAIDO, JAPAN, M_w 6.7 EARTHQUAKE OF SEPTEMBER 6, 2018 LIFELINE PERFORMANCE

The Council of Lifeline Earthquake Engineering
TCLEE No. 4

G&E Report R98.23.01 Revision 1, March 18 2019

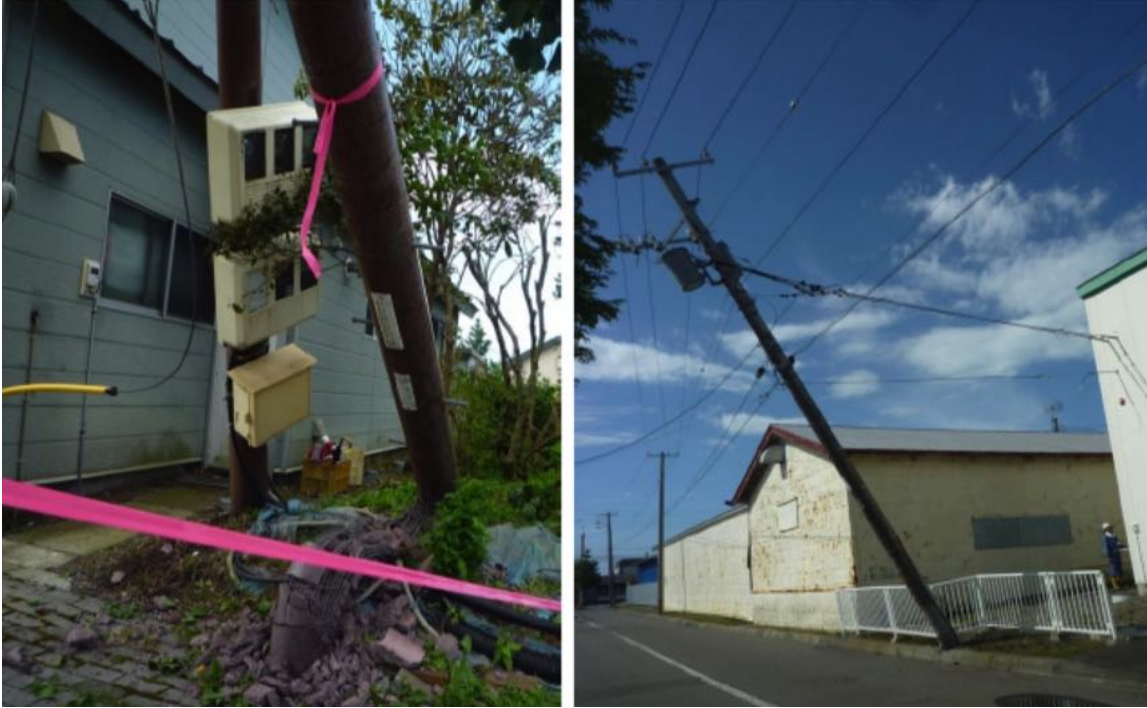
Figure 3-45 shows a toppled distribution pole with "tilted" transformers. The underlying cause is PGDs due to a landslide that also destroyed a house. Figure 3-46 shows two other toppled / tilted poles.

Figure 3-46. Toppled and Tilted Distribution Poles (Credit: HEPCO)

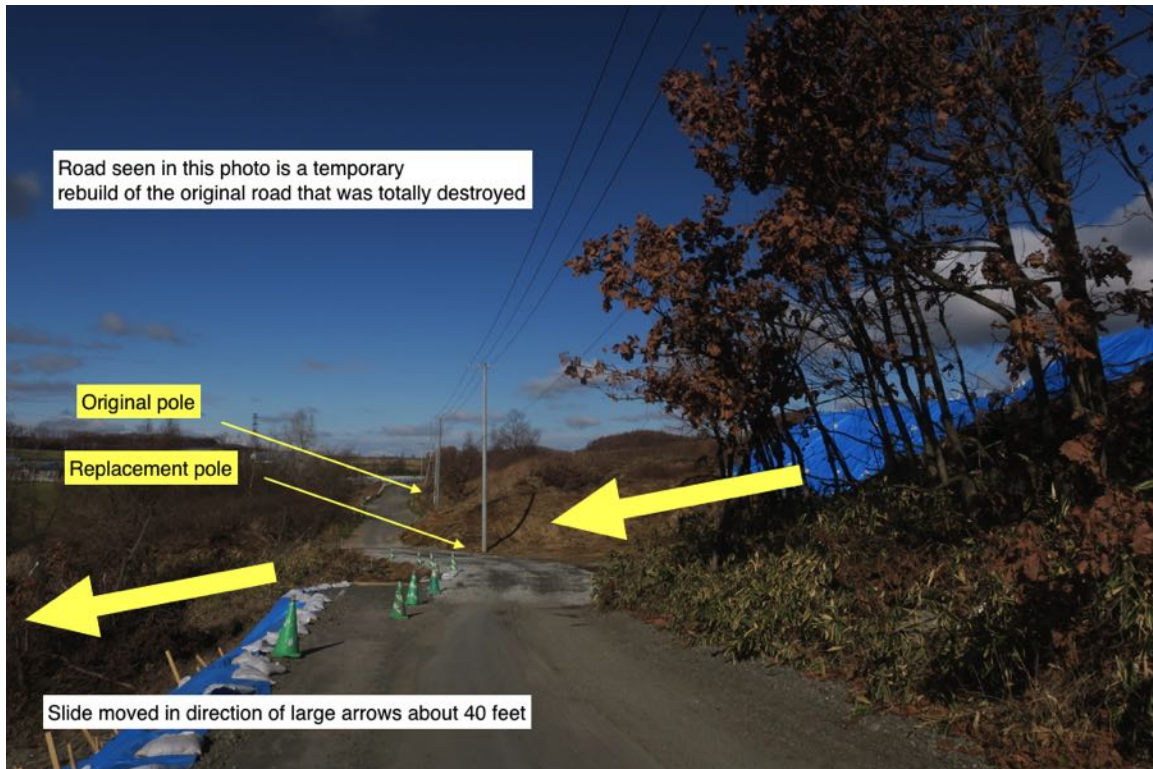
Figure 3-47. Original and Replaced Power Distribution Poles

Figure 3-47 shows two distribution power poles. A landslide moved about 40 feet to the left (direction of large arrows in this photo), and destroyed both the road and the pole that was at the "replacement pole" location. This photo was taken November 14 2018, and by that time, the road had been partially rebuilt, and the destroyed pole has been replaced. Of interest is that while the destroyed pole moved some 40+ feet to the left, there was no damage to the adjacent non-replaced poles. The feeder circuit at the top of the poles was repaired. The communication cables at mid-height of these poles had not yet been repaired as of November 14 2018.

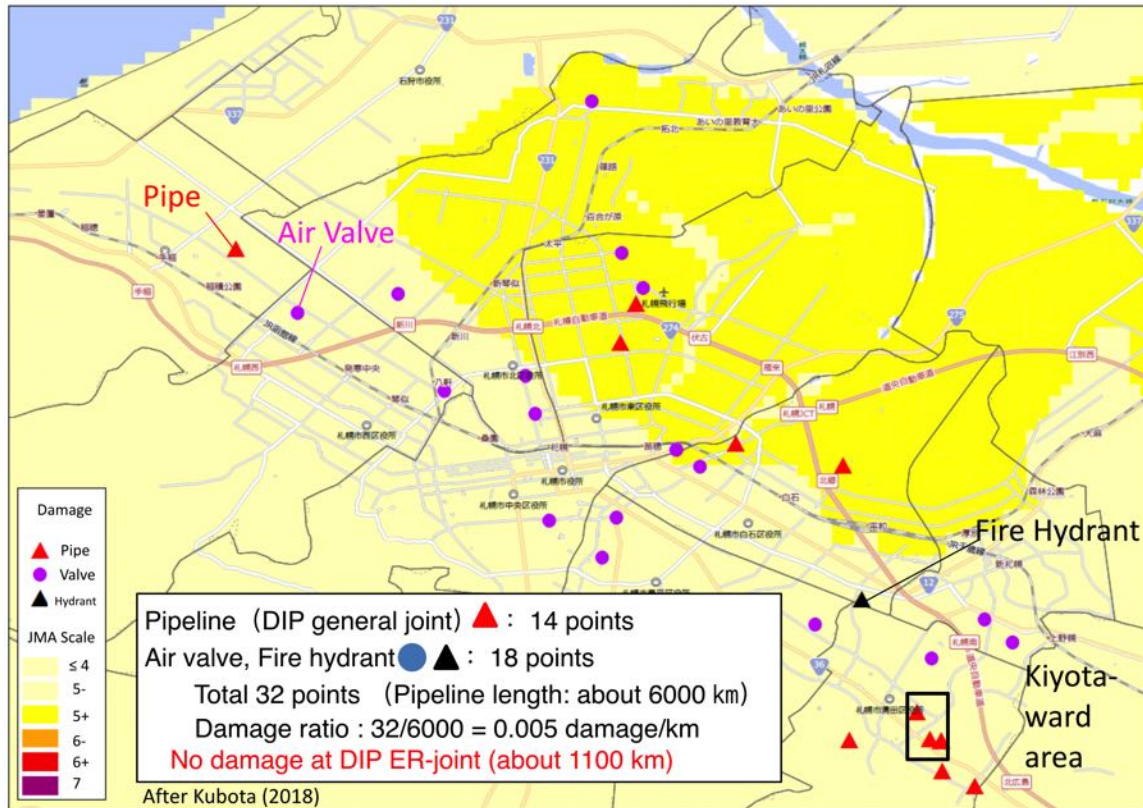
Figure 5-4. Location of Pipeline Damage

The September 6 2018 earthquake damaged water mains (150 mm to 500 mm diameter) at about 14 locations (latest count as of mid-November 2018). The approximate locations of the pipeline and appurtenance damage is shown in Figure 5-4.

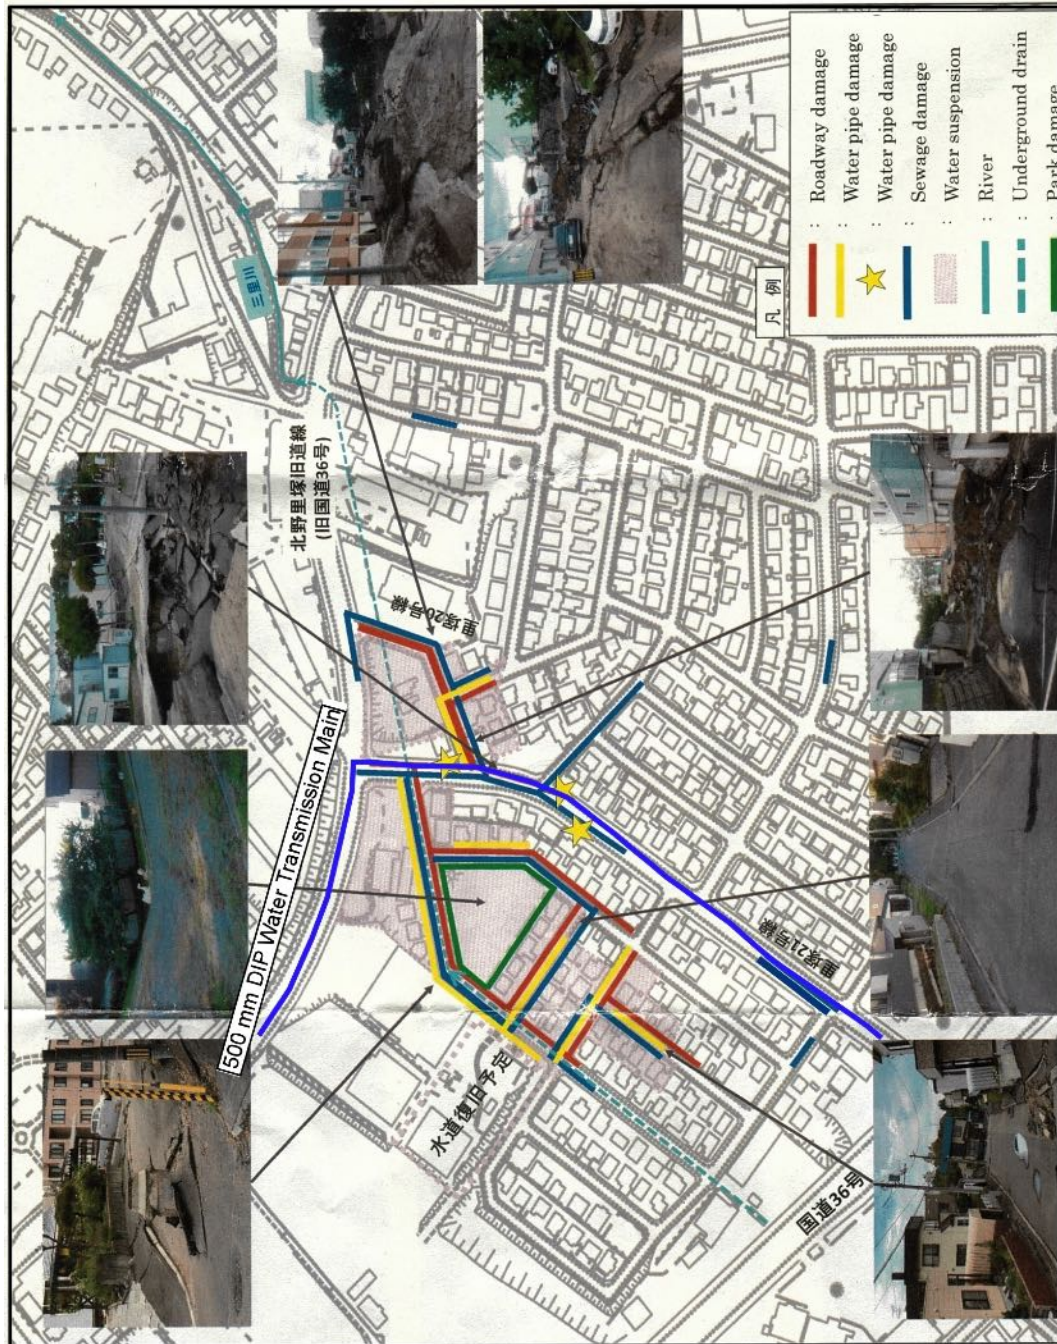
Figure 5-6. Damage in the Liquefaction Zone

Figure 5-6 shows a map of the Liquefaction Area (area highlighted in Figure 5-5).

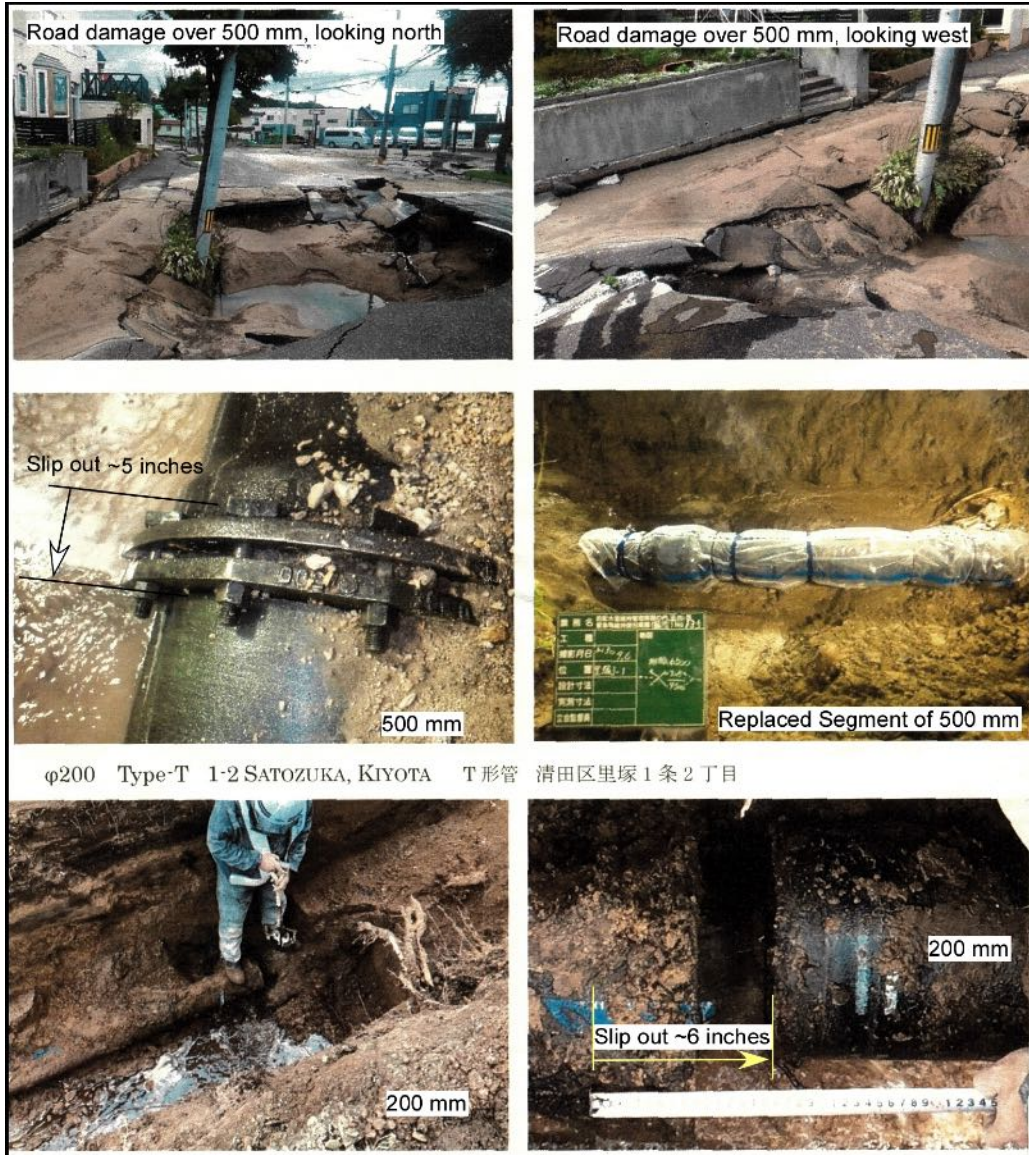
Figure 5-7. Pipe Damage in the Liquefaction Zone (credit: City of Sapporo)

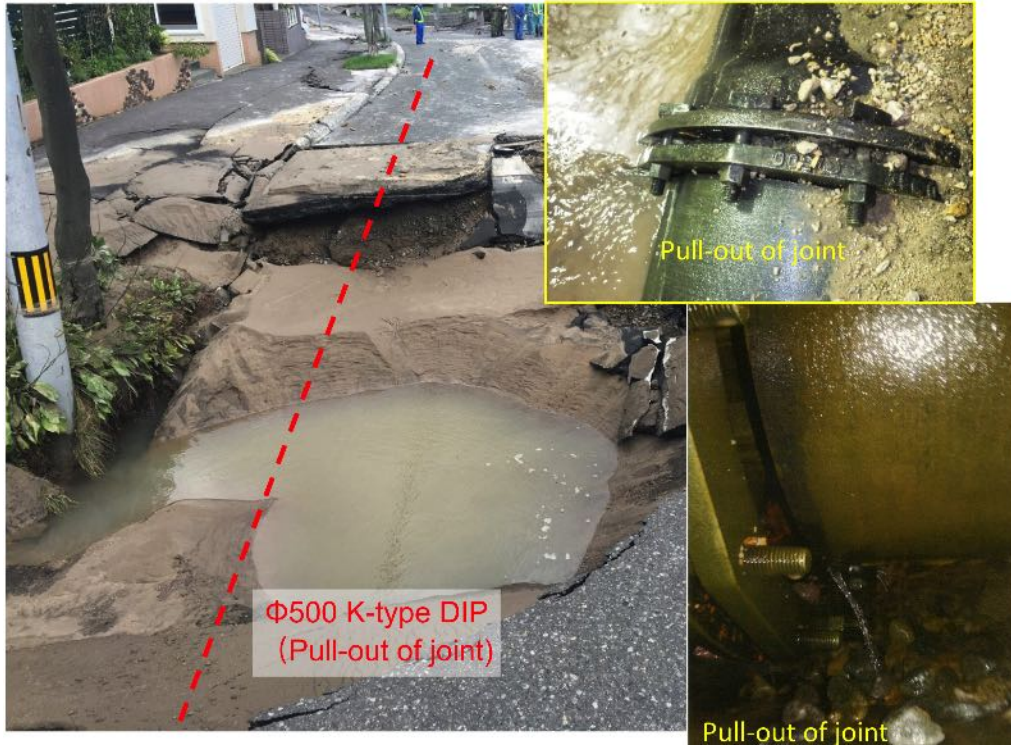
Figure 5-8. Damage to 500 mm DIP Pipe (credit: Kubota)

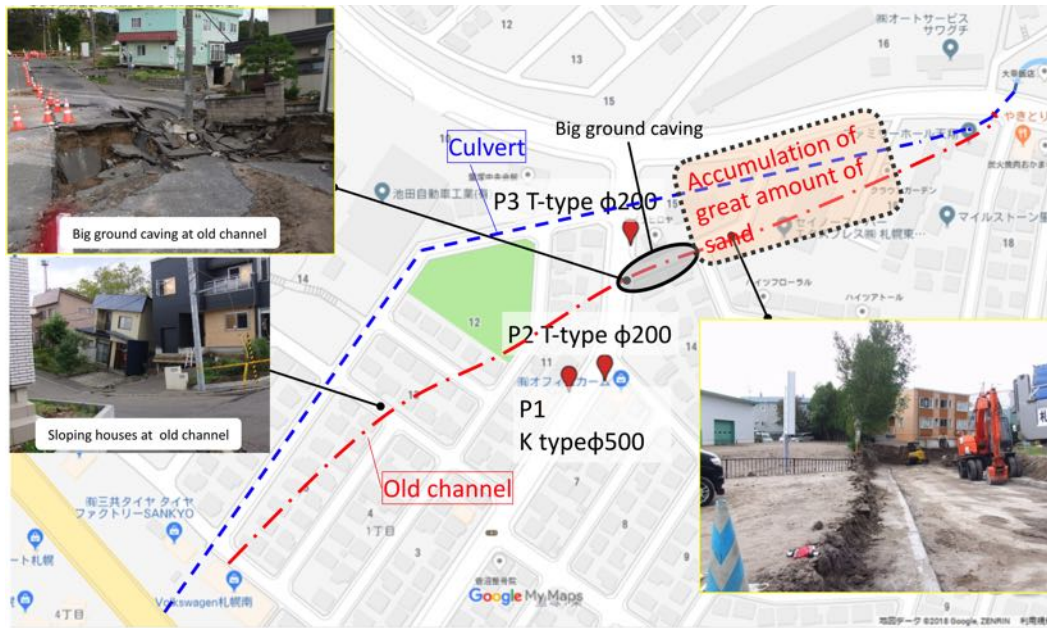
Figure 5-11. Pipeline Damage in Liquefaction Zone (credit: Kubota)

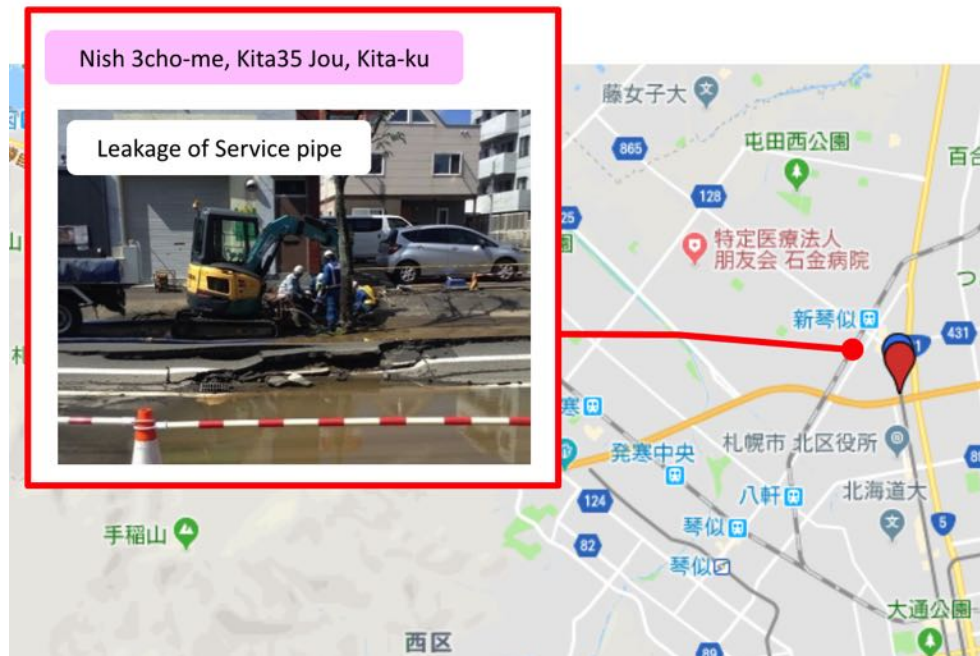
Figure 5-13. Service Line Repair, North of JR Sapporo Station (credit: Kubota)

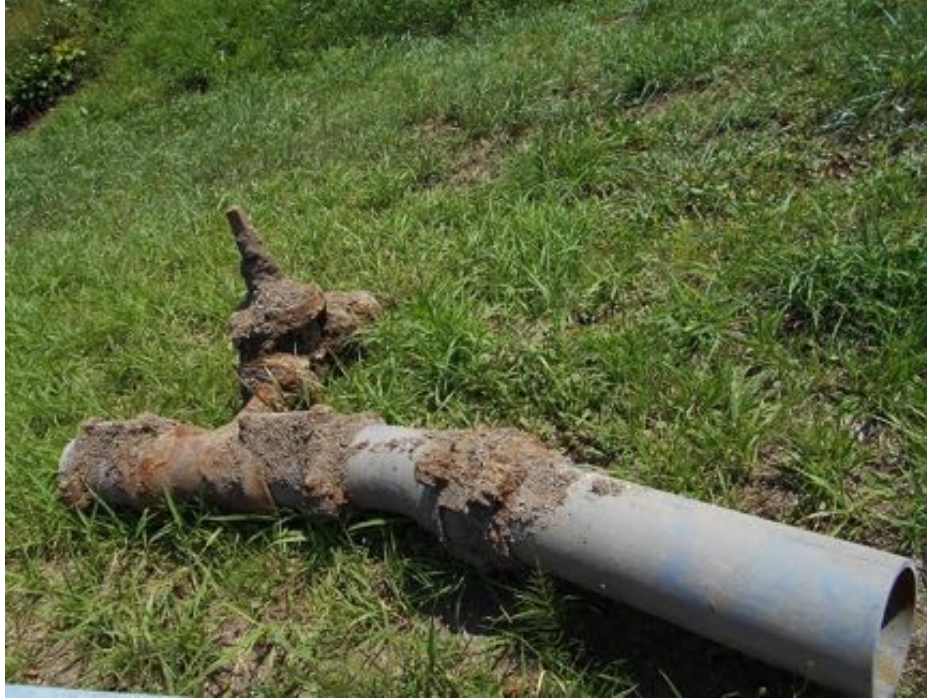
Figure 5-19. Removed 150 mm PVC Pipe (credit: Kubota)

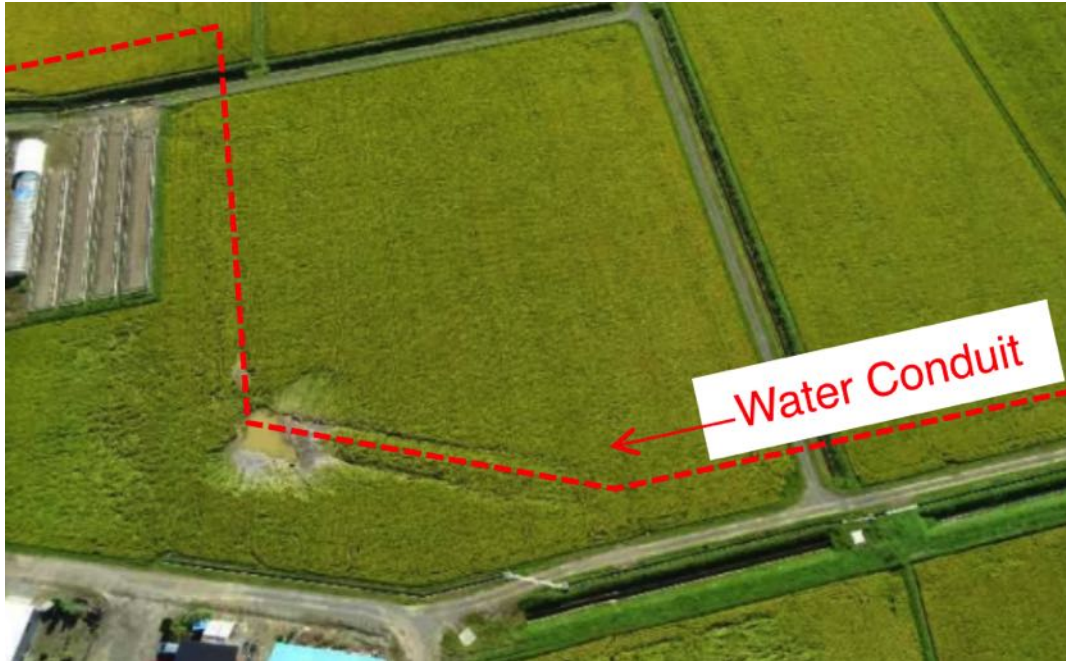
Figure 5-23. Pipe Failure (Photo 1) (Credit: MILT)

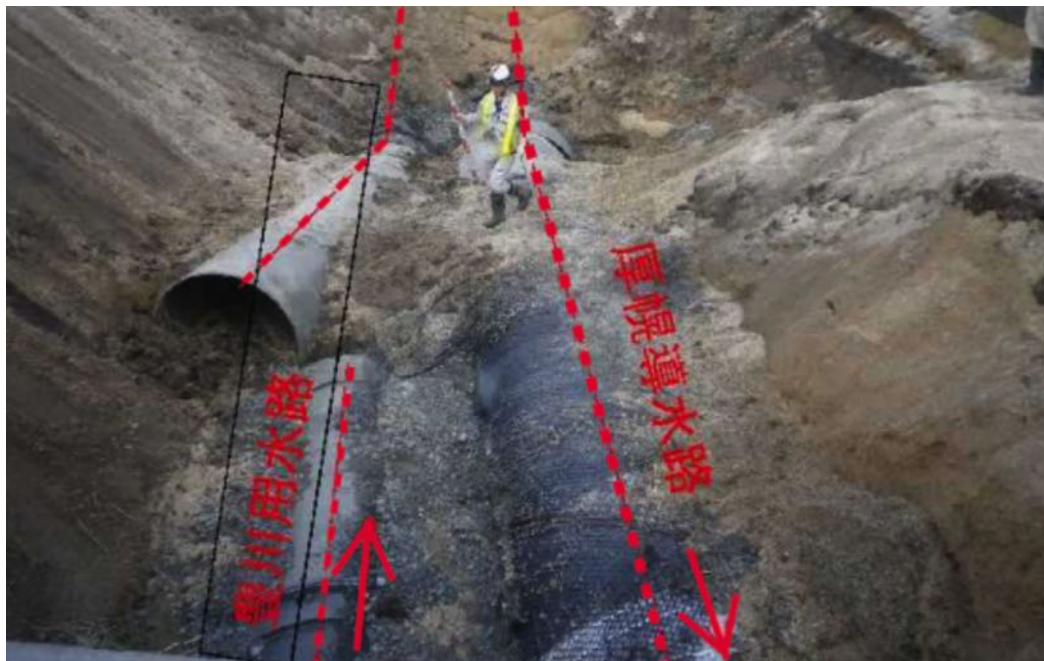
Figure 5-24. Pipe Failure (Photo 2) (Credit: MILT)

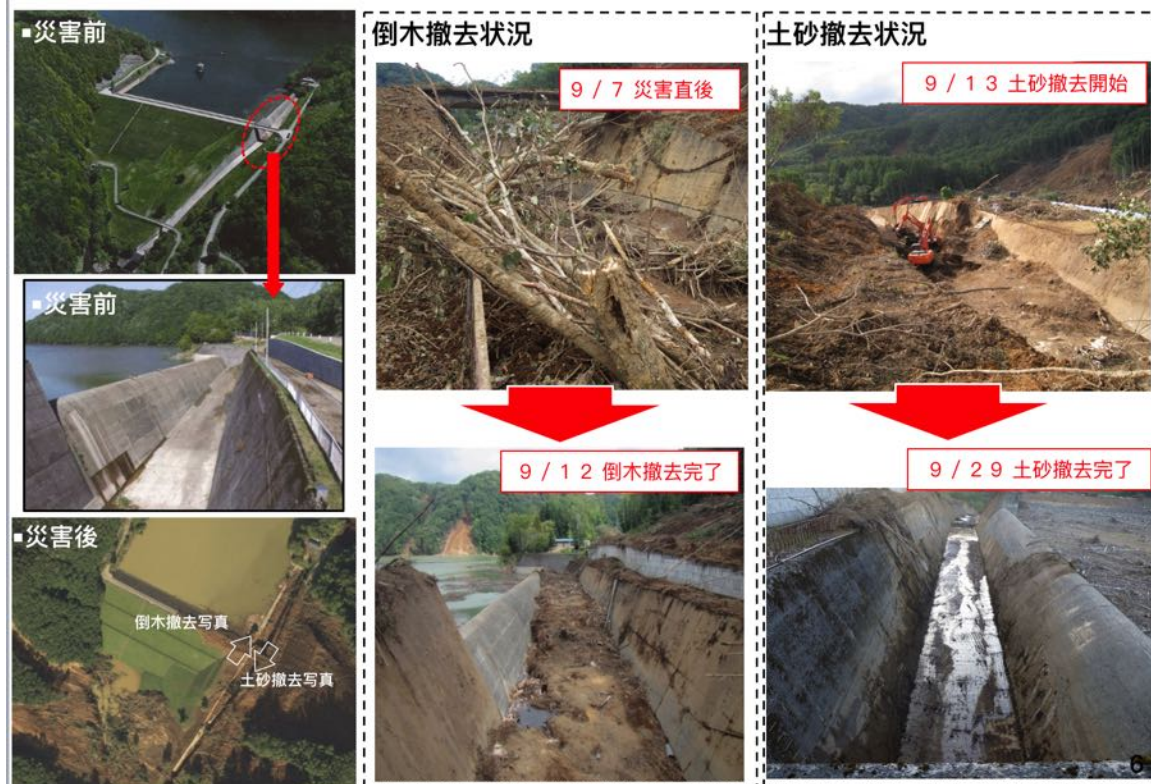
Figure 5-26. Repair of Spillway, Upper Atsuma Reservoir (Credit: MILT)

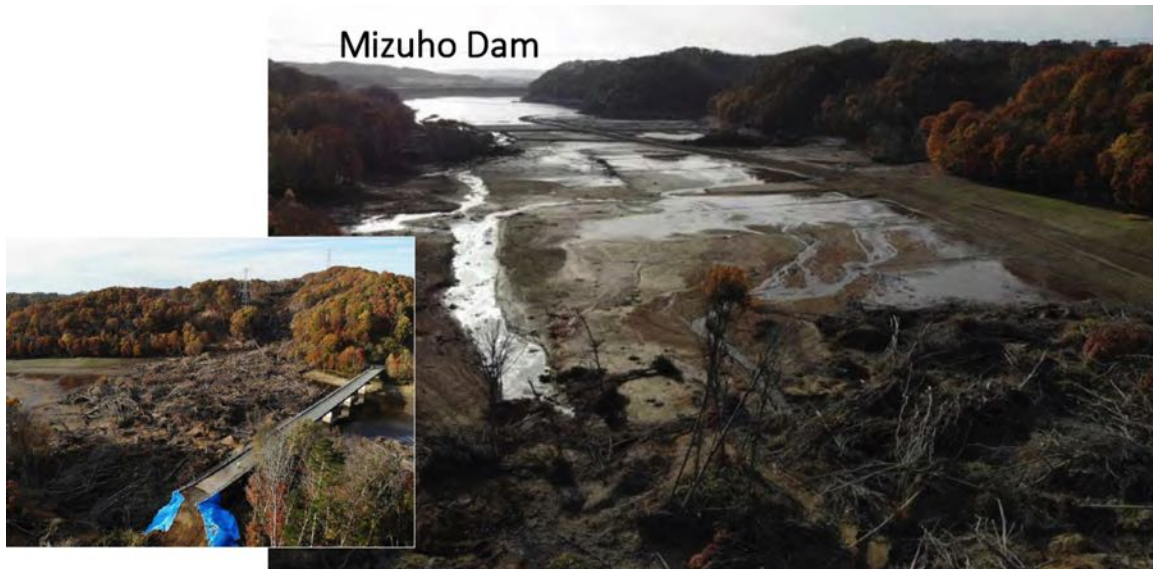
Figure 5-29. Landslide Inundation into Mizuho Reservoir (photo: PG&E)

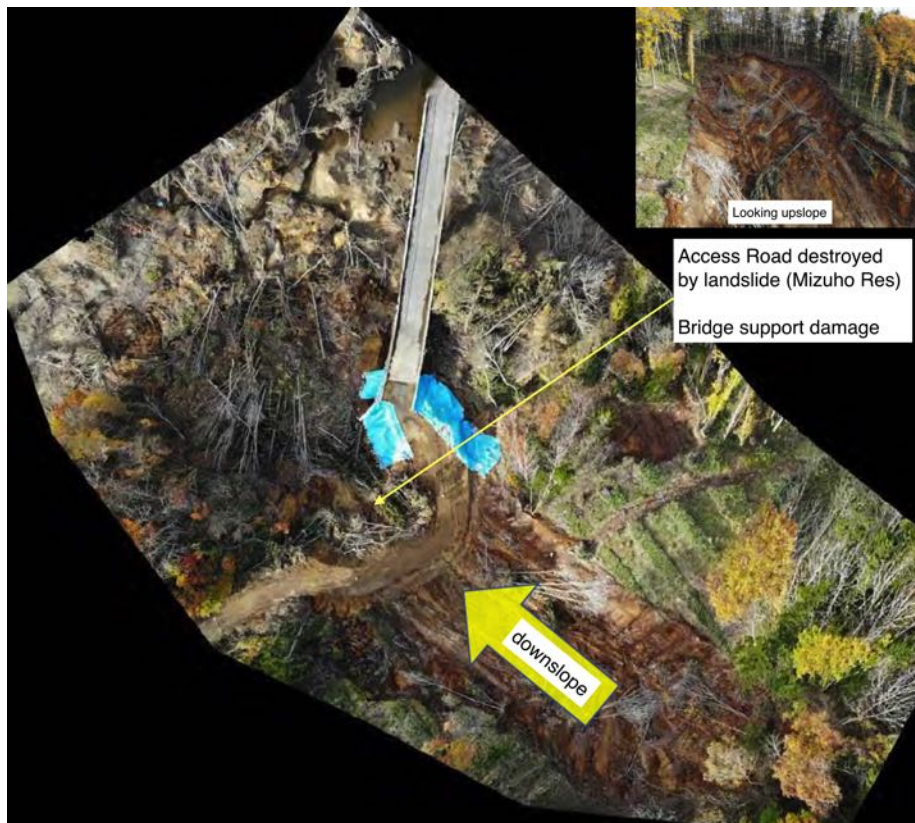
Figure 5-30. Access road destroyed by landslide at Mizuho Reservoir (photo: PG&E)

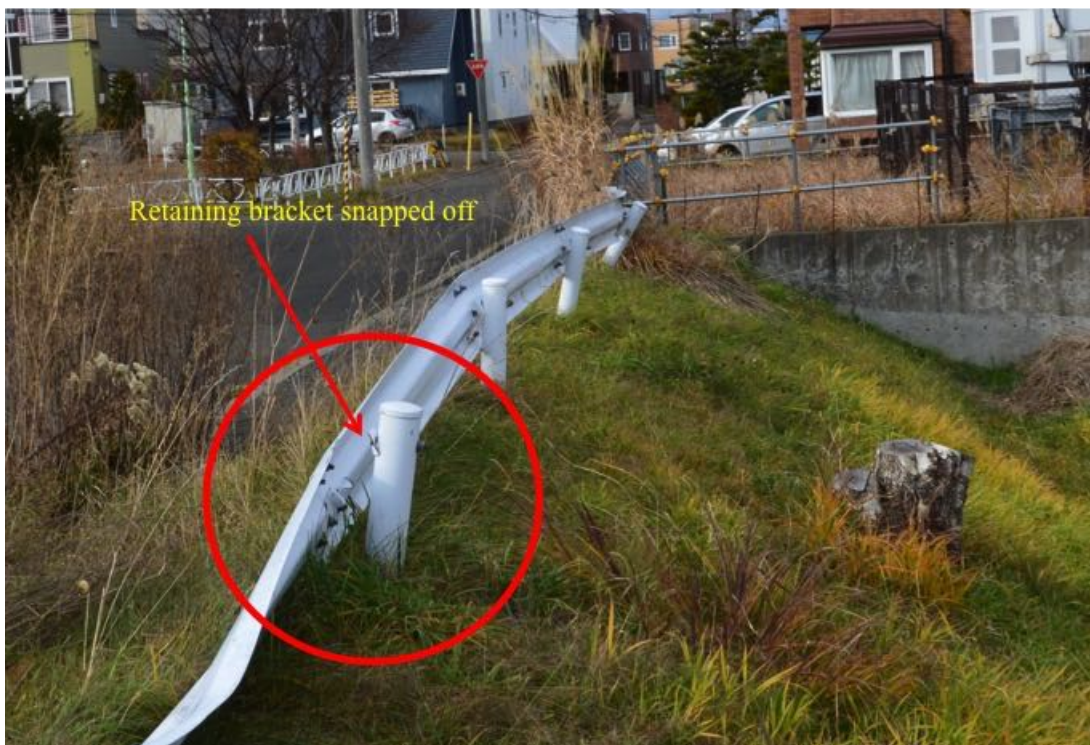
Figure 6-16. Retaining bracket broken from the anchor on the pole.

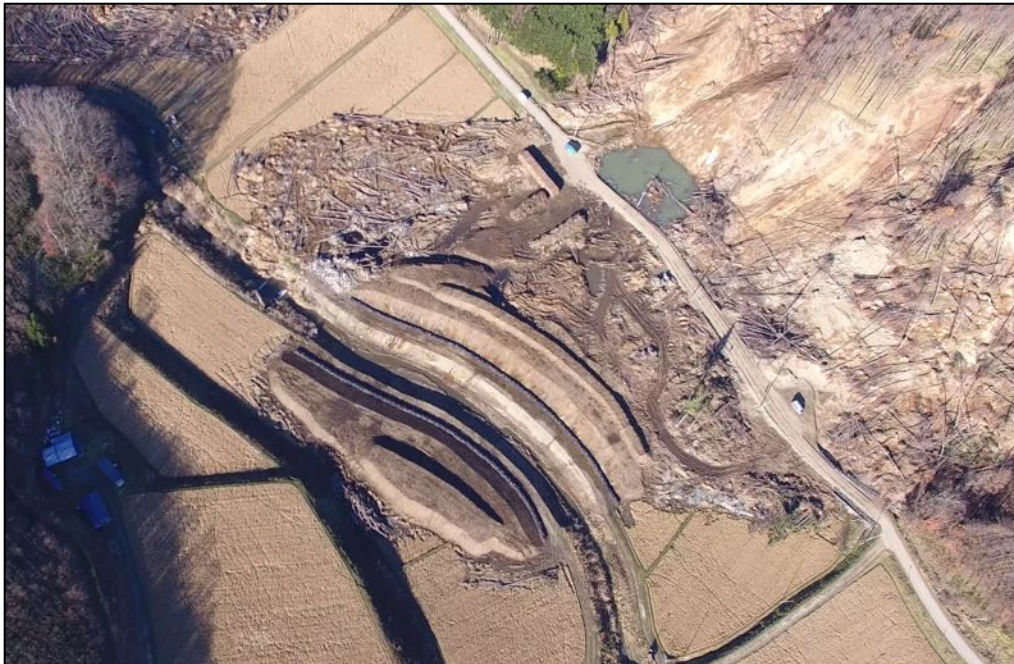
Figure 7-24. This shows the extent of the landslide damage. The road was covered by the creek was also blocked. A retaining wall was temporary built to prevent mud flowing to creek. (Source: Masataka Shiga)

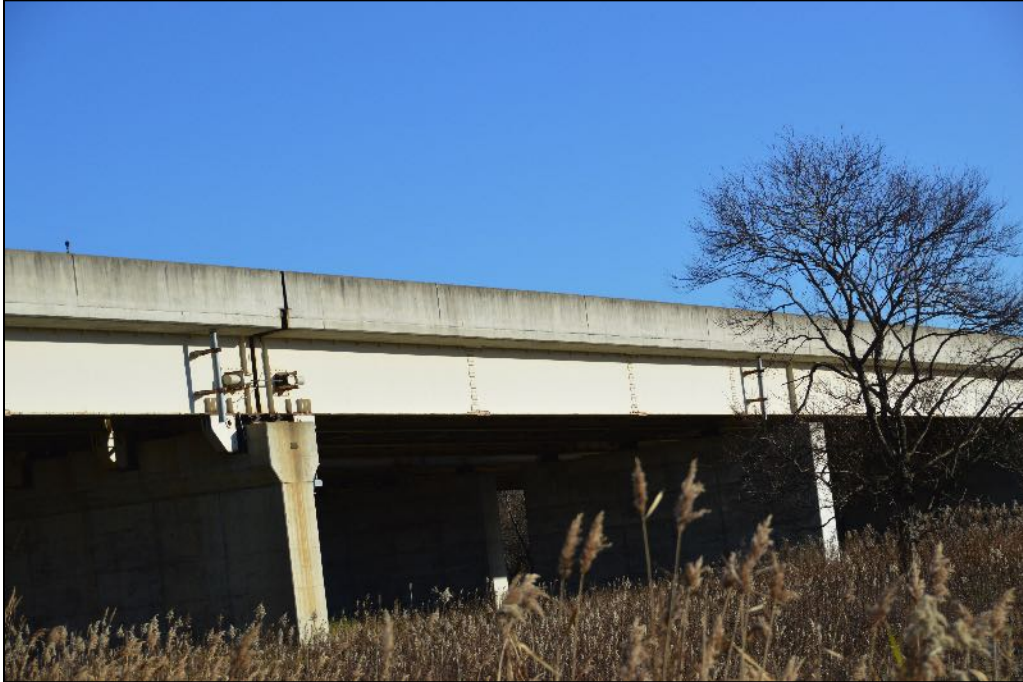
Figure 7-25. The deck slide prevention key and the cable tying the decks provided a suitable measure to avoid unseating of the road decks at this location

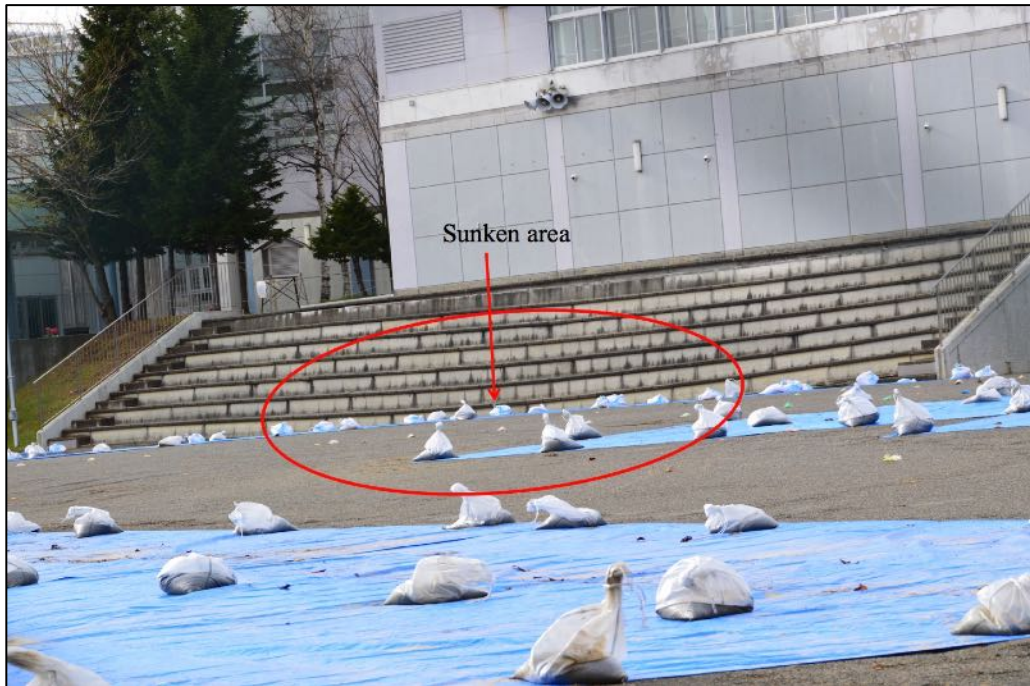
Figure 9-7. Outdoor sports field damaged due to permanent ground deformation

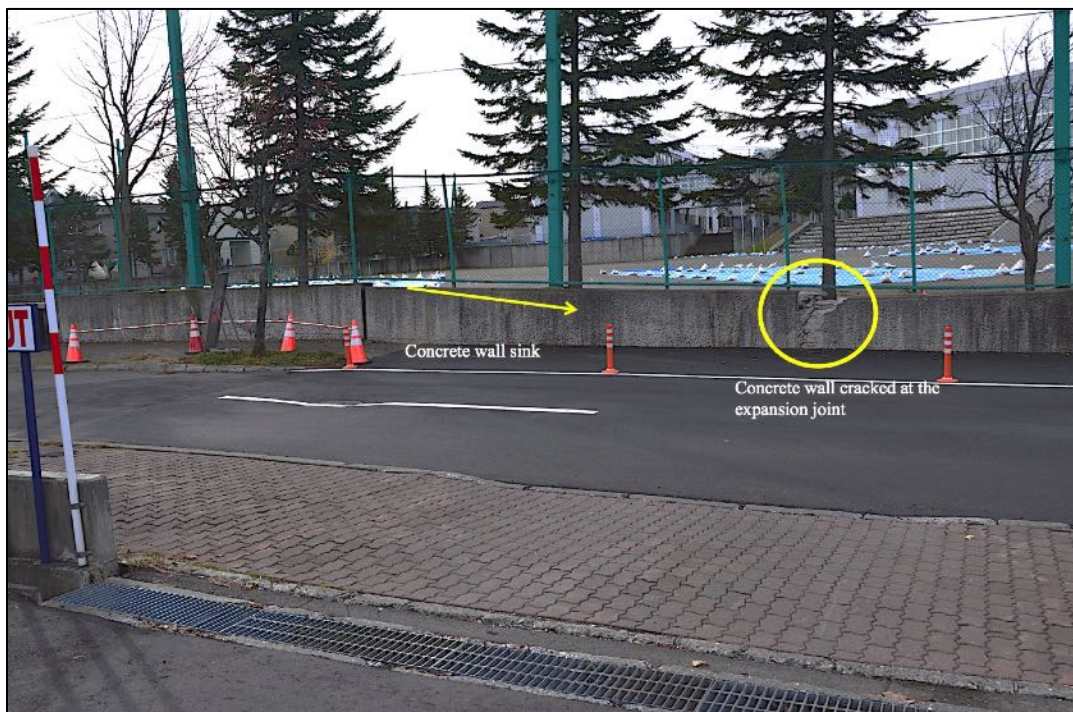
Figure 9-8. Concrete wall broken due to permanent ground deformation
