Japan Society of Civil Engineers
Yotsuya 1, Shinjuku-ku, Tokyo 160-0004
<http://www.jsce.or.jp/>

2. LANDSLIDES

The January 13, 2001 Off the Coast of El Salvador Earthquake

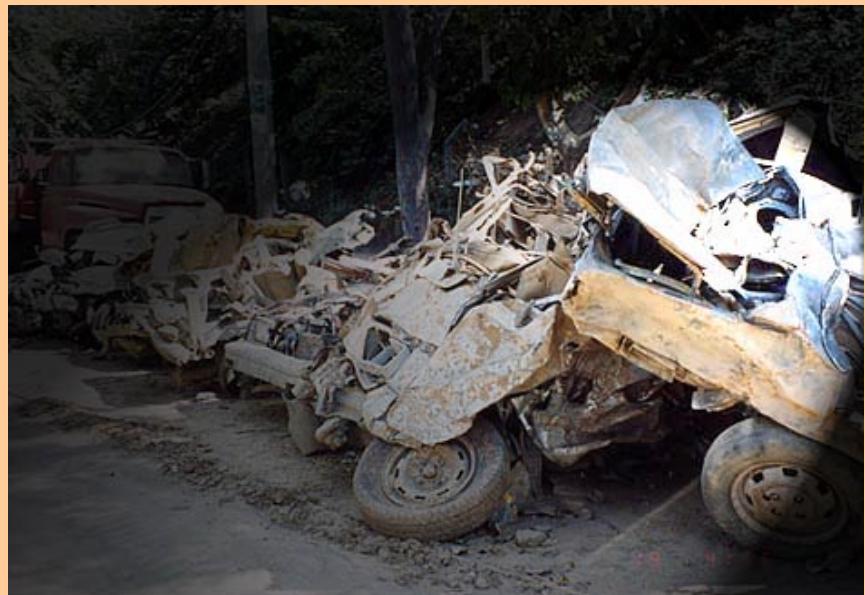
Cars destroyed in the slid soil mass, Las Colinas

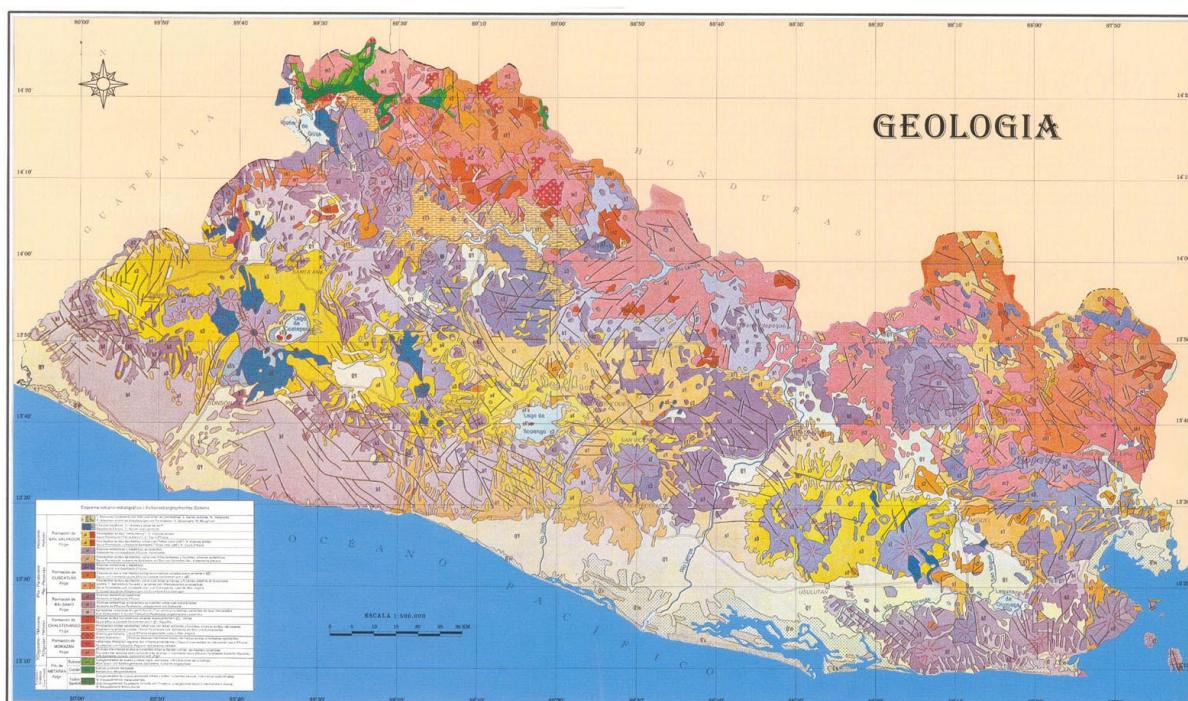
Figure 2.1 Geological map of El Salvador (Ministerio de Economía, 2000)

Figure 2.1 is a surface geological map of El Salvador (Ministerio de Economía, 2000). The oldest formation in El Salvador from the Jurassic period (208 ~ 146 Ma) is found around Metapan, a city in the northern part of El Salvador, while the youngest formation at San Salvador is from the Holocene period (after 0.011 Ma). The geology of El Salvador can be outlined as follows: The formations spreading over both the south coastal region and the mountainous region north of the San Salvador (Morazan group) are from the Holocene period, and they were formed during the Oligocene to the Miocene periods. The middle region of the country consists of the Balsamo group formations from the Pleistocene period. Volcanic and igneous rocks are distributed nation-wide in El Salvador. Basalts, andesites, rhyolites, lavas and pyroclastic rocks are found in mosaic. Alluviums are found spread only along the southern part of the coastal region. Granites and limestones are found isolated in a small region at the northwest end of the country.

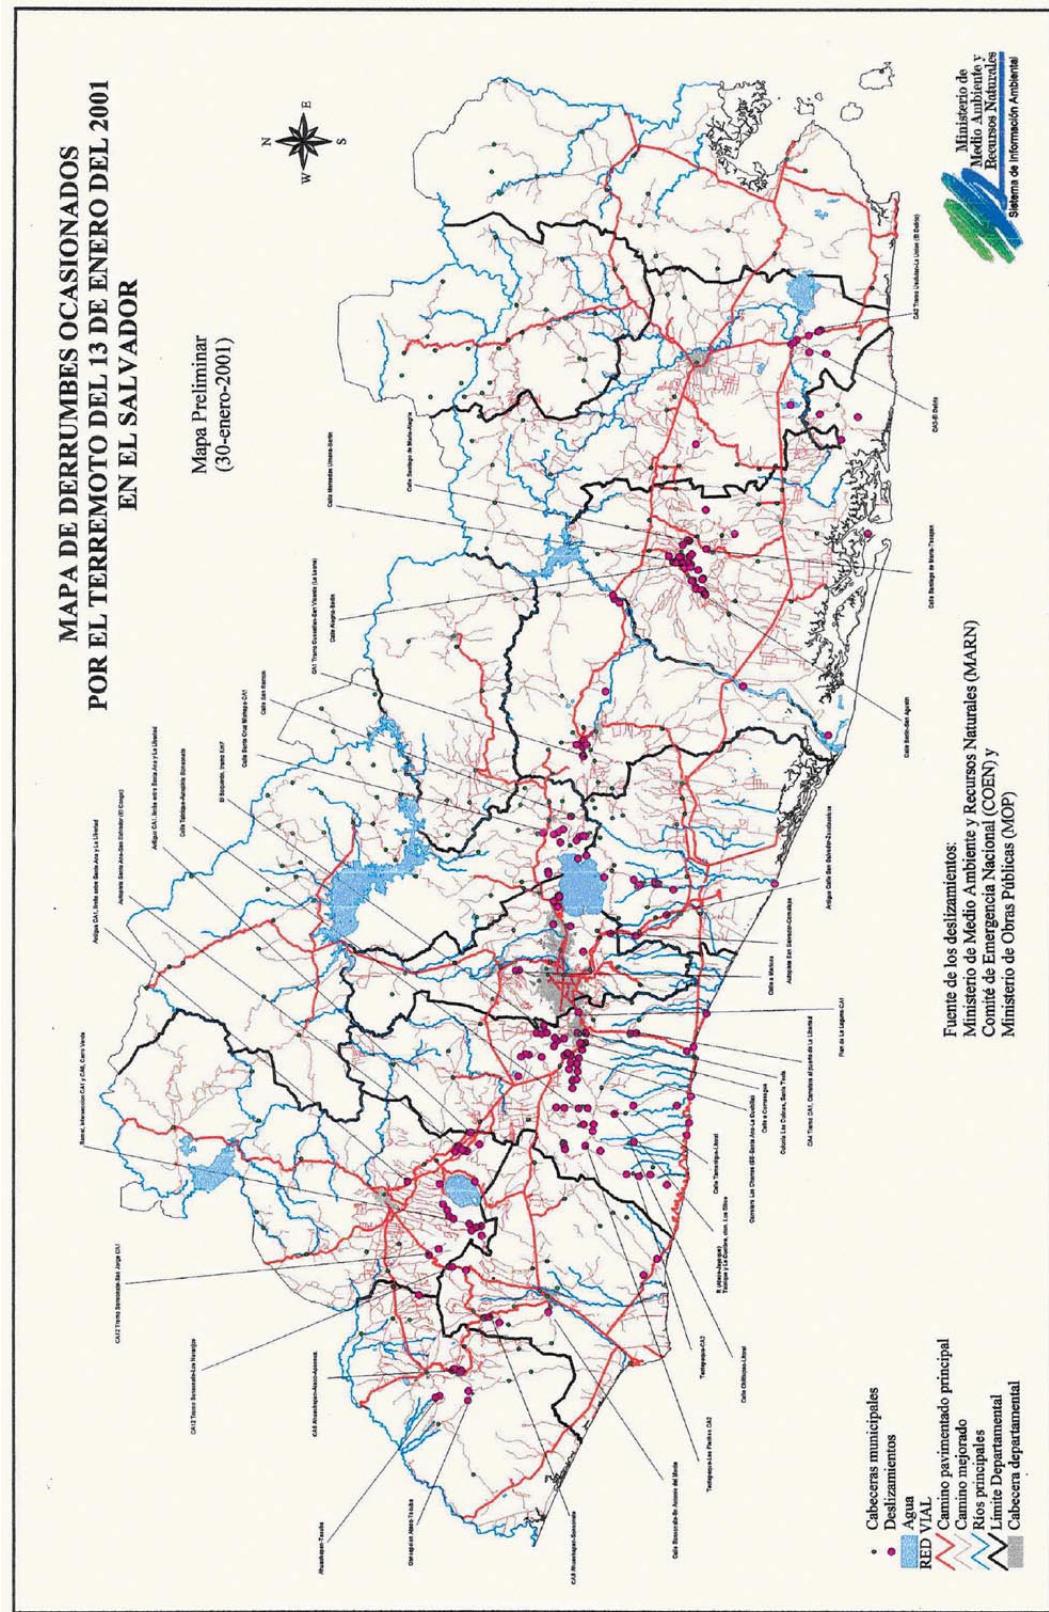
Figure 2.2 Distribution of landslides
(Ministerio de Medio Ambiente y Recursos Naturales, 2001)

Ministry of Environment, MARN (Ministerio de Medio Ambiente y Recursos Naturales) built up a GIS (Geographical Information System) database of earthquake-inflicted landslides (**Figure 2.2**) immediately after the Jan. 13 event. The database describes landslides in terms of their locations, scales, instabilities and diagnoses. The database covers the information not only from MARN, but also from COEN and MOP (Ministerio de Obras Públicas). In **Figure 2.2**, purple dots show the locations of all registered landslides on the GIS database (January 30, 2001). Both **Figures 2.3** and **2.4** show locations of landslides on topographical and geological maps, respectively (Ministerio de Medio Ambiente y Recursos Naturales, 2001). The landslides are mostly found:

1. on some mountainsides of such volcanoes as Santa Ana, San Salvador, Chichontepec and Tecapa, and thus,
2. on some pyroclastic and/or volcanic epiclastic deposits such as "tierra blanca" and "tobas color cafes".

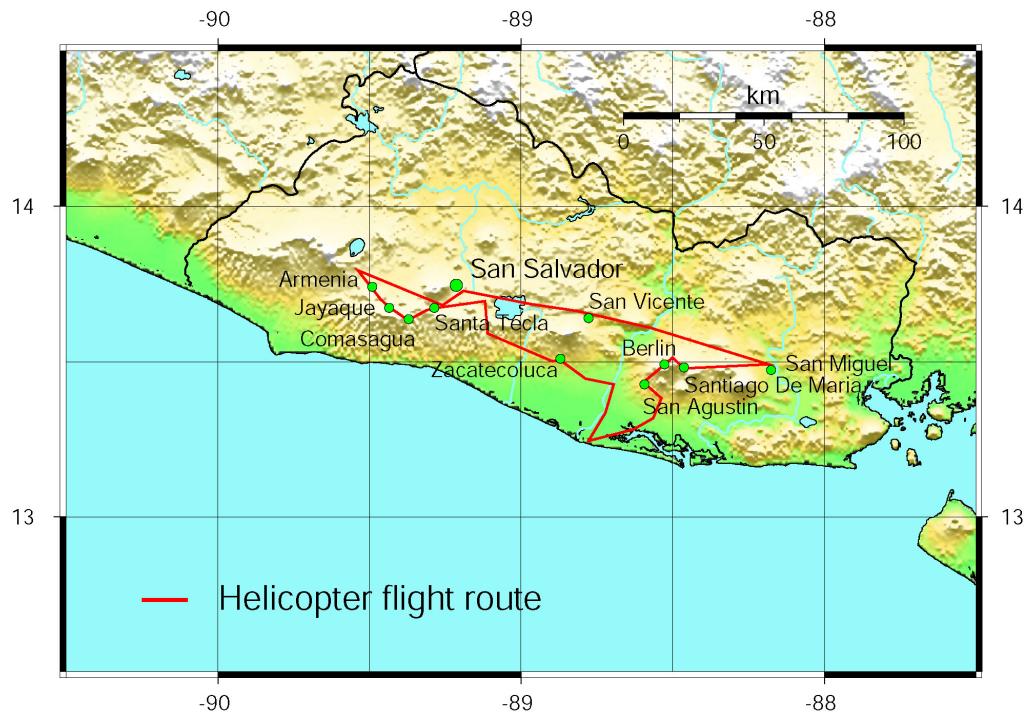
Figure 2.6 Helicopter flight route

Some members of the JSCE reconnaissance team made a quick inspection with a helicopter provided by the Salvadorian National Army on February 3 to get an overview of the nationwide geo-hazards, damage to buildings and infrastructures. The team, after departing from San Salvador military base, took the path shown in **Figure 2.5** counterclockwise first toward San Miguel and then back toward Armenia. They flew over some large cities including Santa Tecla, San Salvador, Zacatecolca and San Miguel as well as some small towns such as Jayaque, Comasagua, San Agustin and Santiago De Maria. Damage to buildings and infrastructure will be described in the following sections.

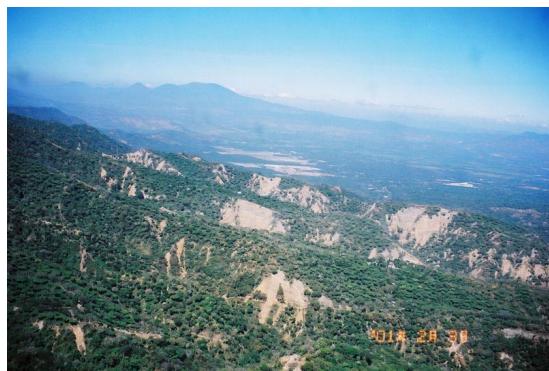
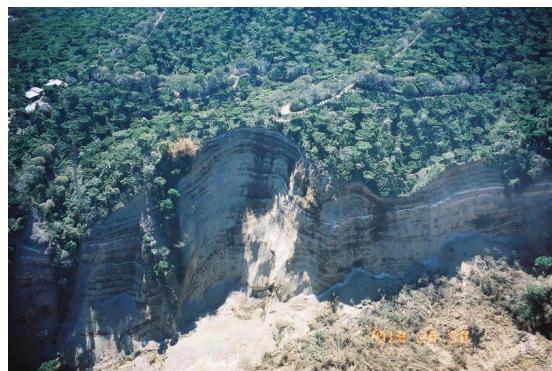
Figures 2.6 (left) and 2.7 (right).

1. Sonsonate: Small slides of rock and soil occurred around the Lake Coatepeque in a crater to the east of the Santa Ana Volcano.
2. La Libertad: Many landslides including Las Colinas landslide occurred around the San Salvador volcano and other mountains (**Figures 2.6** and **2.7**). Traffic on mountain roads leading to small towns was suspended by these slope failures. The western stretch of the Pan American Highway from San Salvador was blocked at several points in Los Chorros. **Figure 2.8** shows the Las Colinas landslide, which was responsible for the loss of more than 500 lives. Details of the Las Colinas landslide will be described in the next section.

Landslides on mountain slopes, La Libertad

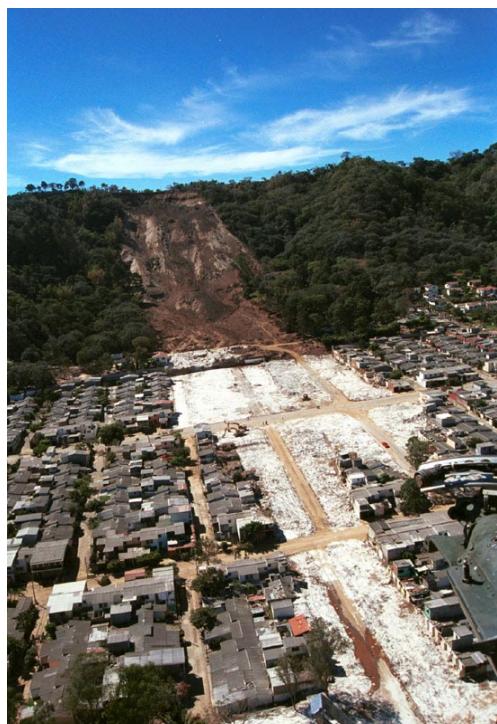
Figure 2.8 Las Colinas landslide,
La Libertad

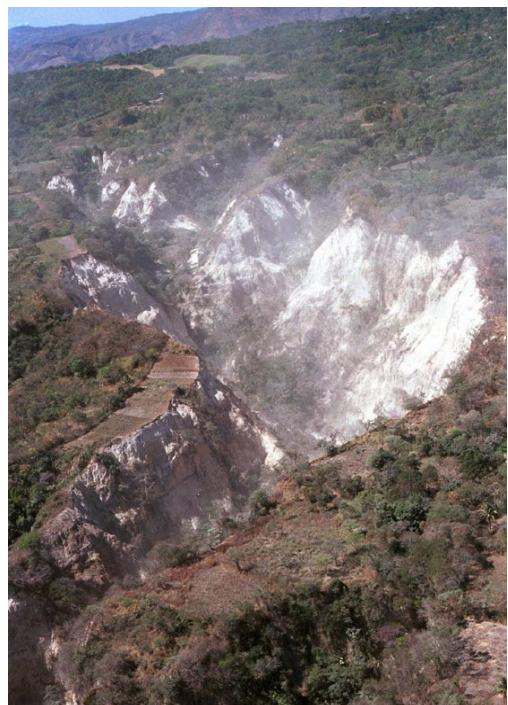
3. Cuscatlán: Young pyroclastic deposits ("tierra blanca") slid down steep crater walls of Lake Ilopango (**Figure 2.9**).
4. San Vicente: A great amount of soil mass blocked the Pan American Highway (**Figure 2.10**). Bulldozers were removing the slipped soil mass.

Figure 2.9 Steep slope failures
around Ilopango Lake, Cuscatlán

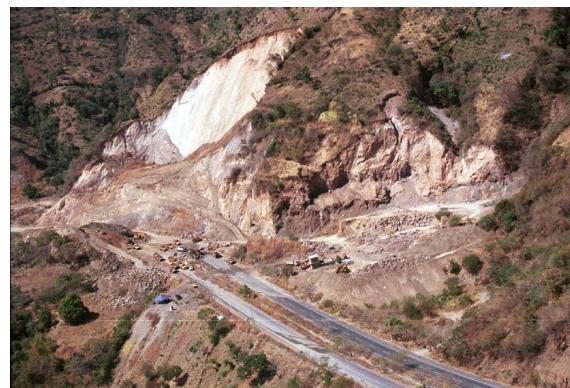
Figure 2.10 Blocked PanAmerican Highway, San Vicente
