Quick report of the 2008 Iwate/Miyagi Earthquake (Ver. 2.1)

Kazuo KONAGAI, Tomohiro FUJITA, Fumihiko, NOMURA, Yuriko TOMIYASU
Masaki DATE, Yoshimitsu TAJIMA and Toshihiko KATAGIRI

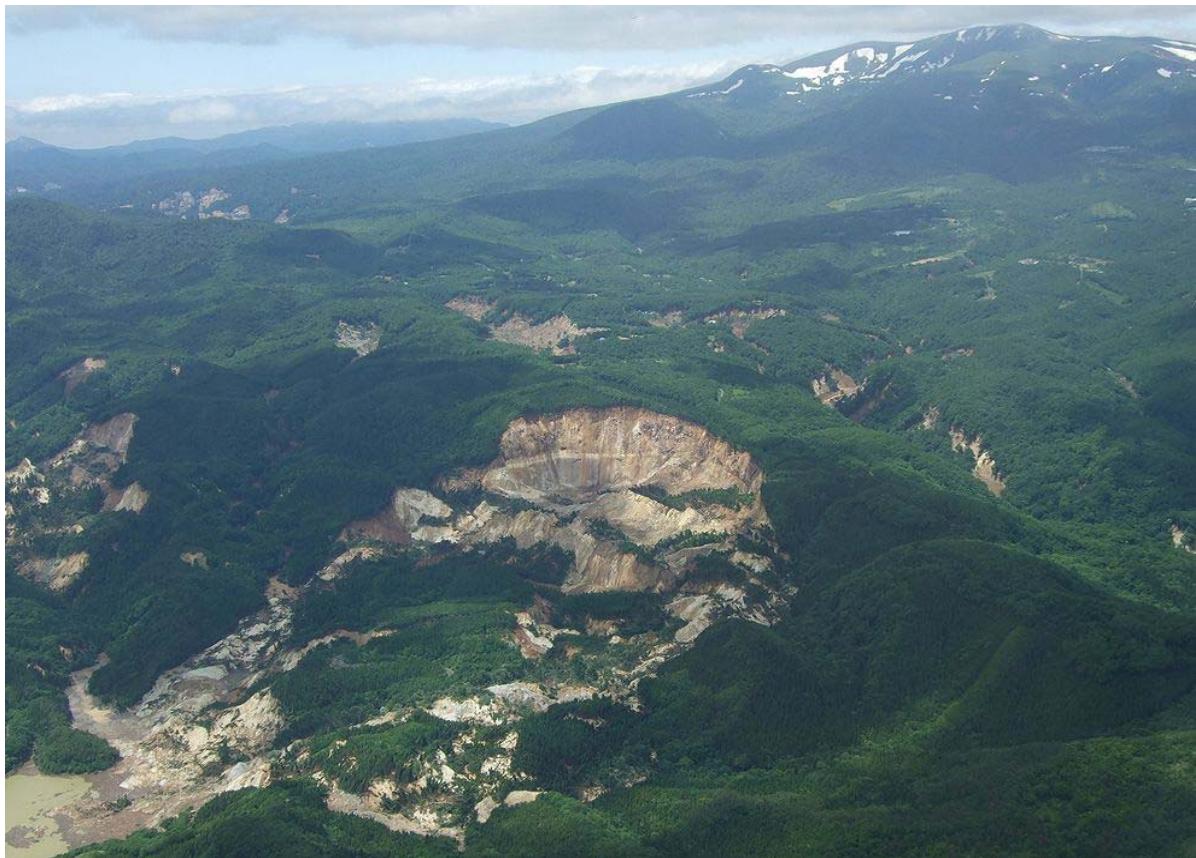
Fig. 1. Landslide at Aratosawa dam: Aerial photo of the largest landslide with Kurikoma Volcano rising behind. The terrain here is suggestive that similar landslides have been reactivated. A wide-spread and almost horizontal laminar structure of loose volcanic sands and ashes is being exposed on the escarpment. When wet, some pieces of light-gray rock fragments taken at the toe of the landslide mass smelled strong hydrogen sulfide (see Fig. 3). (Photo by K. Konagai)

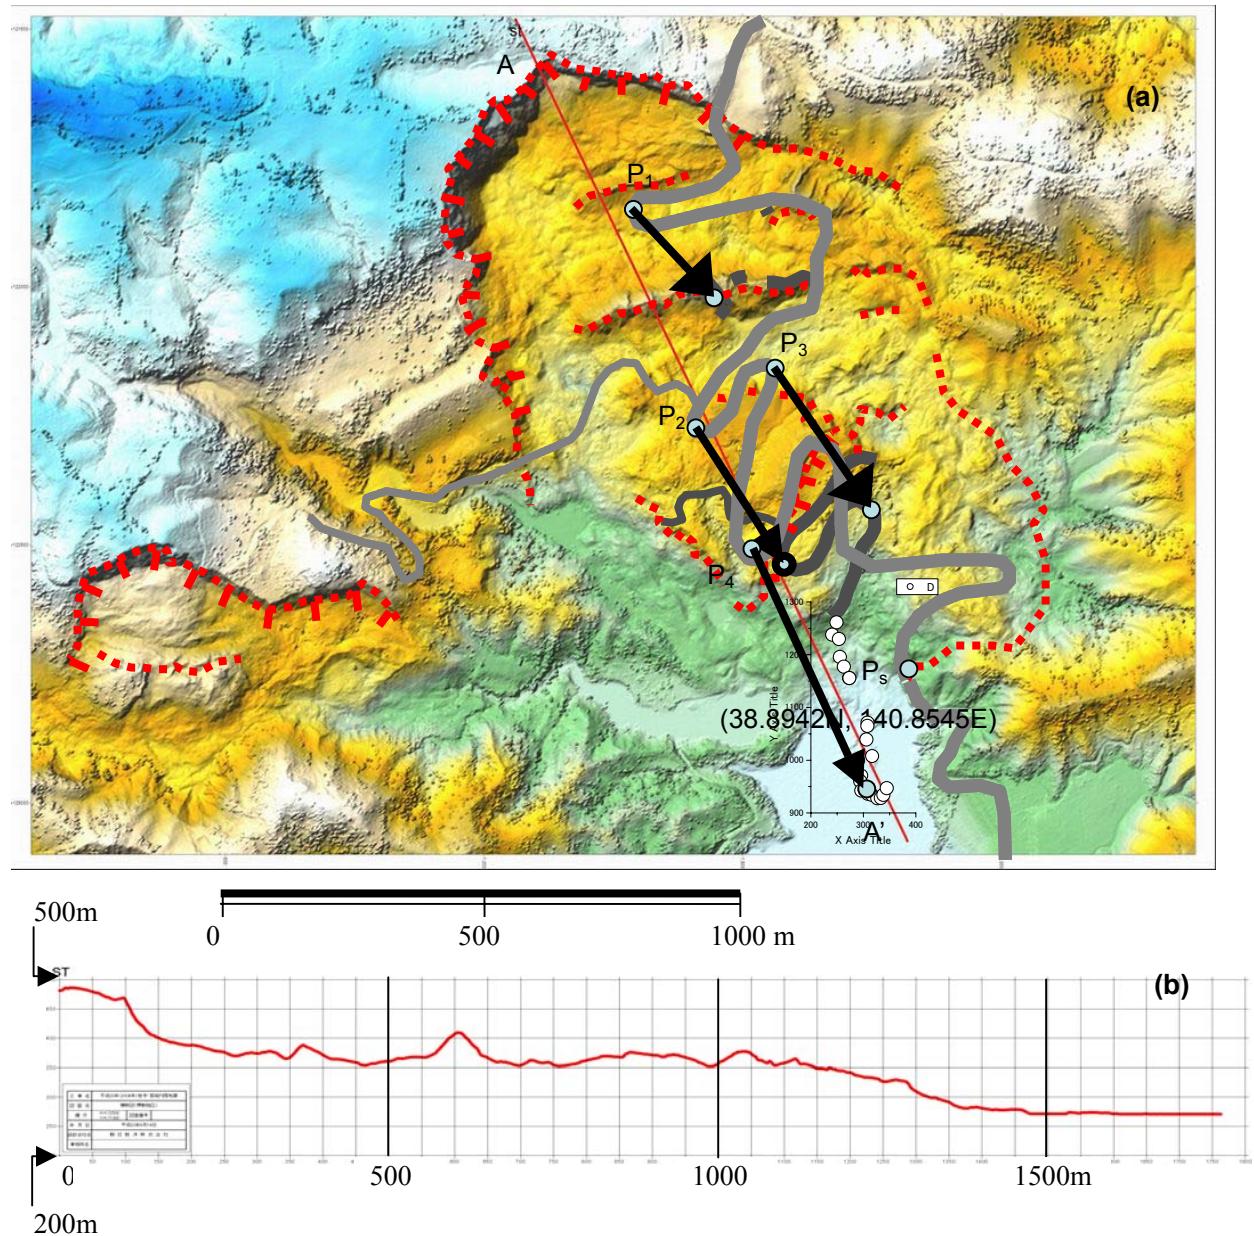
Fig. 2. Landslide at Aratosawa dam. The road locations after and before (gray) the earthquake were drawn upon the DEM by using images from helicopter survey, photos (black lines), and field GPS survey (open circles) etc. The arrows show that Points P₁ P₂ and P₃ have respectively moved about 200m, 300m and 500m SSE towards the dam lake. The slid blocks are lined up in a succession. The cross-section A-A' (Figure 2b) shows a gradient of about 3-4 degrees. Even though the base slope was very gentle the soil masses have moved some 200 to 500 meters. (Aero Asahi Co. provided the digital elevation model).

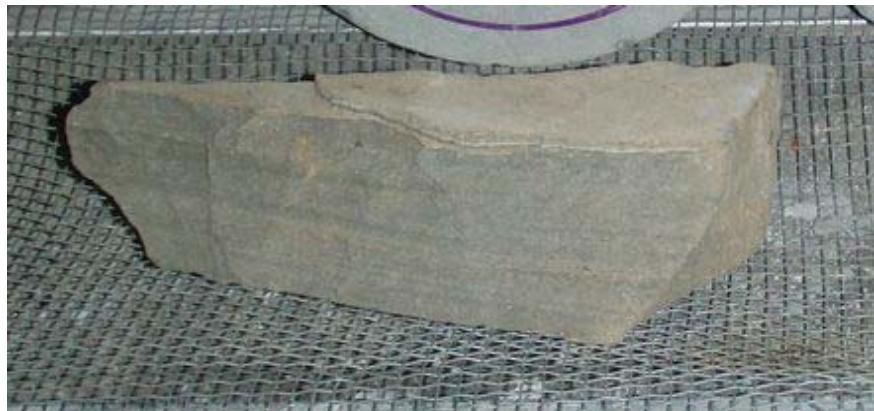
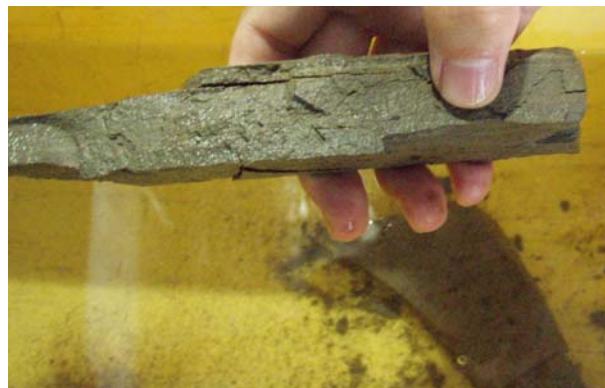
(a) Sample dried in oven

(b) Sample put again in water

Fig. 3. Rock sample taken from Point Ps in **Fig. 2**:

Location of Ps: 38.8942N, 140.8545E

Specific gravity immediately after the sample was taken (2008/06/16 18:00) = 1.78 g/cm^3

Specific gravity after the sample was dried one day at 105 degrees C in oven. = 1.18 g/cm^3

Specific gravity after the sample was again soaked up in water for three hours. = 1.69 g/cm^3

When soaked up with water, the sample smells hydrogen sulfide, evidencing that the materials were from volcanoes. It is remarkable that the specific gravity of the dried sample is quite small, indicating the presence of large volume of voids.

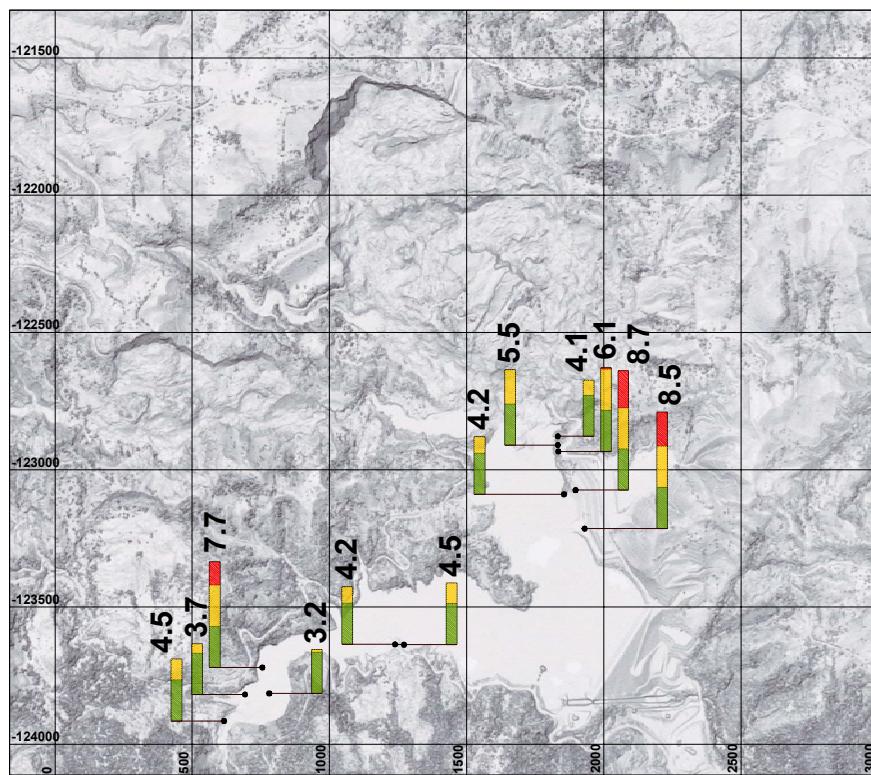
Fig. 4: Seiche high water marks above the lake elevation of 259.7m on July 12 and 13

As can be seen in Table 1 the lake elevation increased from 268.5 m before the earthquake to 270.9 m after the earthquake. This increase in lake elevation is due to the plunge of the landslide mass and possibly also due to some tectonic deformation.

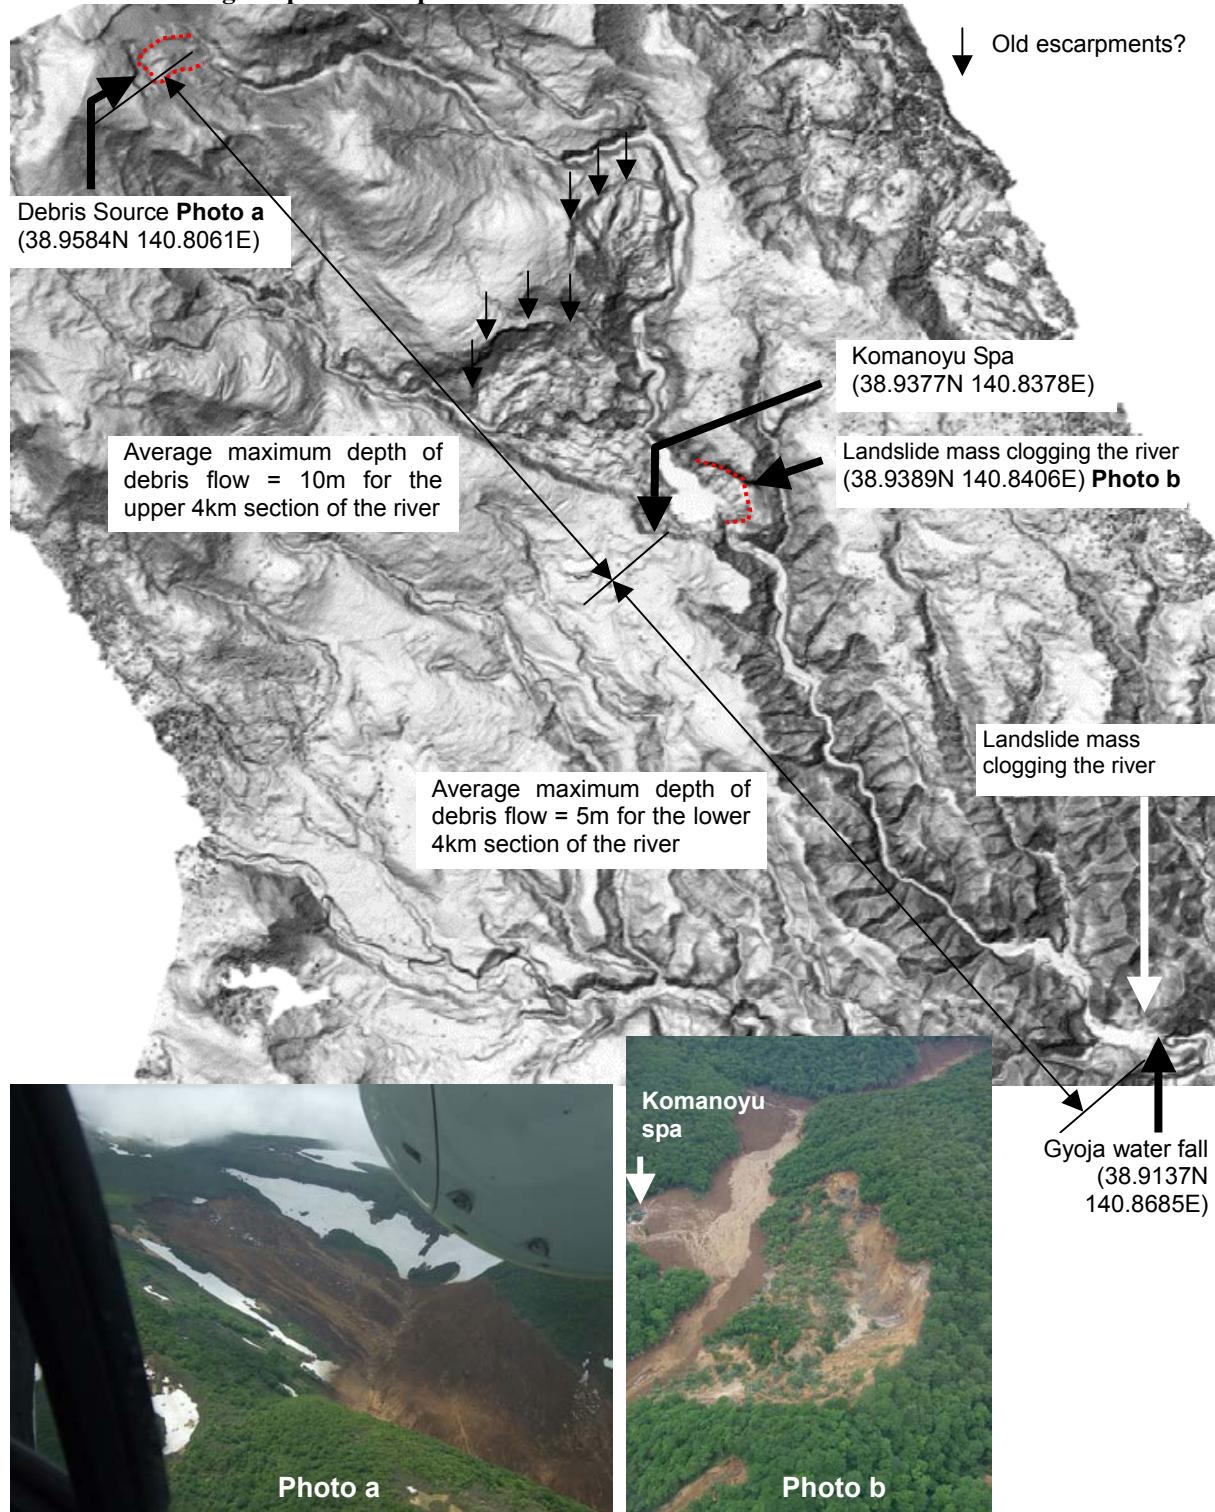
Fig. 5. Debris flow along Dozo and Ura Rivers: A deep scar was created immediately beneath the snow remaining near the eastern peak of Mt. Komagatake (**Photo a**, 38.9584N 140.8061E). The debris flow from this source swept into Dozo River, and scoured sediment and vegetation from along the channel. The mud flow, with its channel clogged with another landslide mass (**Photo b**, 38.9389N 140.8406E), surged up to a hot spa resort “Komano-Yu” (**Photo b**, 38.9377N 140.8378E), where seven people were trapped in soil and rubble. The average maximum debris flow depth for the 4km-long upper stream reach of Komanoyu spa was visually estimated to be about 10m, while it was about half for the lower stream reach probably loosing its momentum. The flow was stopped at Gyoja waterfall (38.9137N 140.8685E). (DEM provided by Aero Asahi Co.)

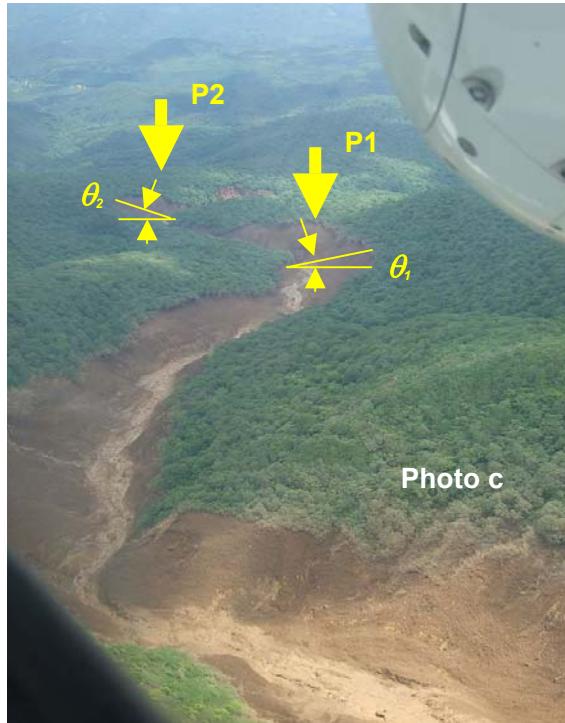
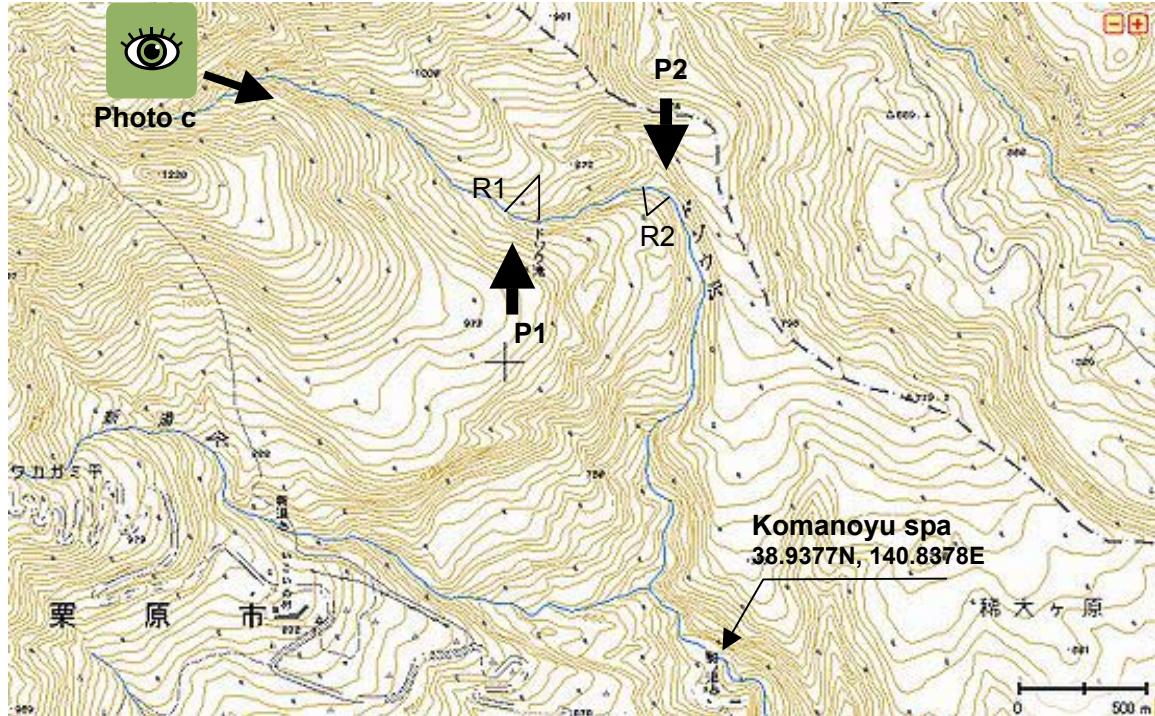
Fig. 6. Estimation of debris flow velocity v : This wet flow along a curved channel had enough momentum to surge up along its outer wall (See photo). Assuming that walls of the channel covered with mud show the inclined mud flow surface, the following equation is obtained.

Necessary parameters for Eq. (2) at Points #1 and #2 are roughly made out from the photo (left) and the topographical map (below) as:

$$\theta_1 \cong 0.12, \quad R_1 \cong 200 \text{ m},$$

$$\theta_2 \cong 0.3, \quad R_2 \cong 120 \text{ m},$$

$$v \cong \sqrt{Rg\theta} = 15 \sim 19 \text{ m/s} \quad (3)$$

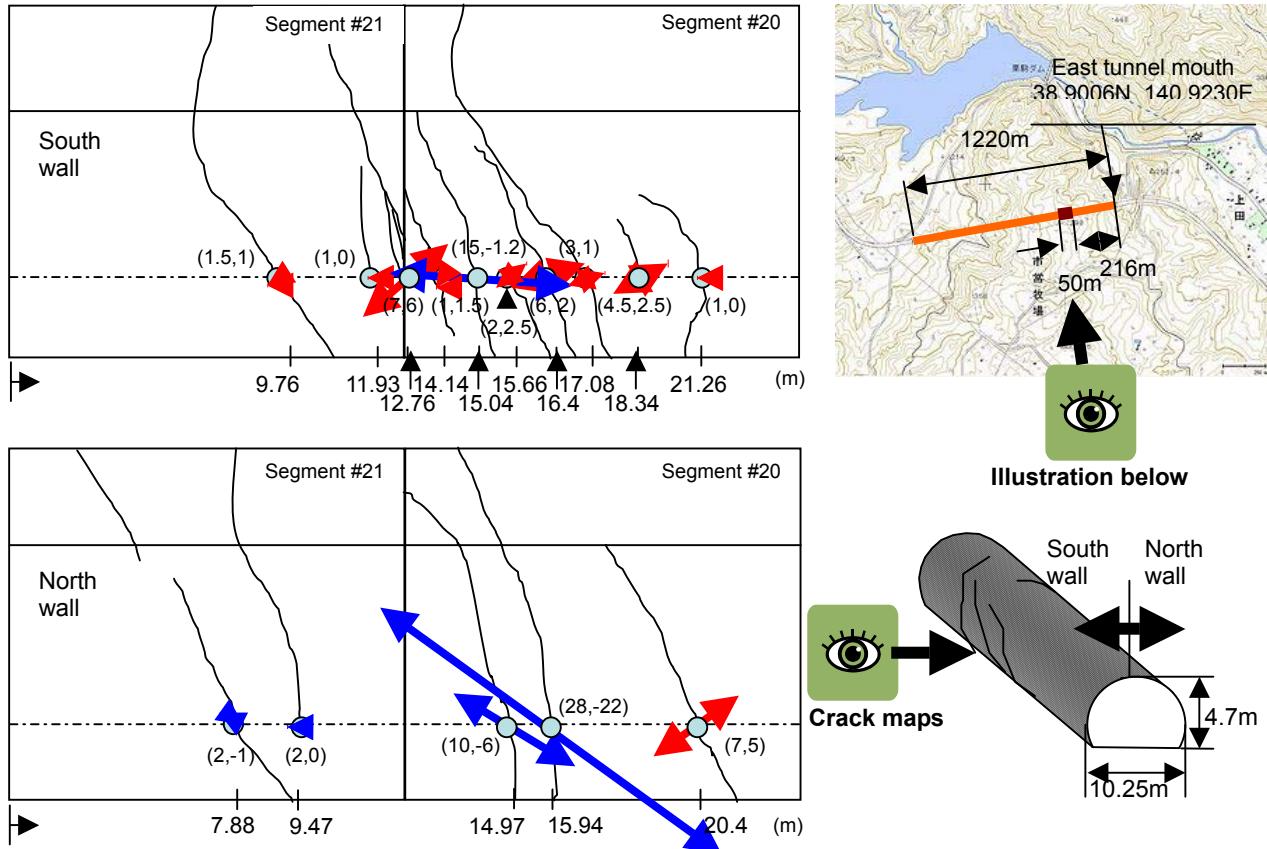
Fig. 7. Cracks in Shin-Tamayama Tunnel: A 36m-long segment 216m inside the eastern mouth (38.9006N, 140.9230E) of the total 1220-m-long tunnel was diagonally cracked. The above two figures show projections of the cracked south and north walls on a virtual screen put north behind the tunnel. These cracks were all opened. Blue arrows show that the eastern segment moved down with respect to the western segment, while red ones show the opposite. Numbers in parentheses show these relative displacements in mm. If a deep-sheeted landslide was the cause, long-term monitoring will be a must for rational repairs.
