2.5 LAS COLINAS LANDSLIDE

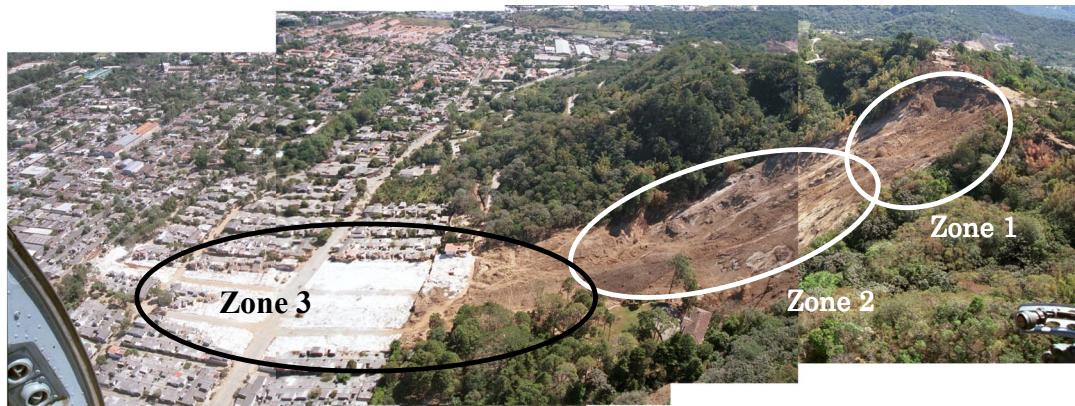
Figure 2.11 Bird's eyes view of the Las Colinas landslide

The failure surface can be roughly divided into three zones in **Figures 2.11** and **2.13**. The uppermost zone (**Zone 1**) is a hollow of about 100m in diameter, which was caved in some 10-20 m from the original ground surface. North beyond the hollow, there appears a steepest slope (**Zone 2**) which becomes gradually gentle as it comes close to the toe (**Zone 3**). The inclination of the slope is about 26 degrees above the elevation of 960 m in **Zone 2**, and is about 9 degrees below the level in **Zone 3**.

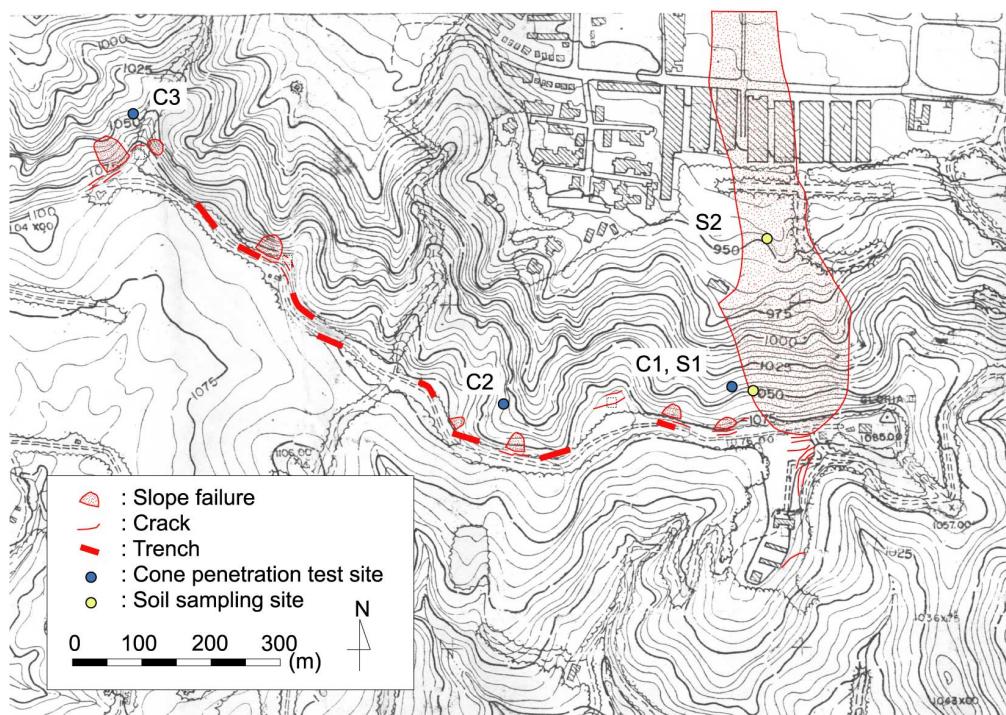
Figure 2.12 In-situ tests and sampling sites in Las Colinas
(Topography: Ministerio de Obras Públicas, 1970)

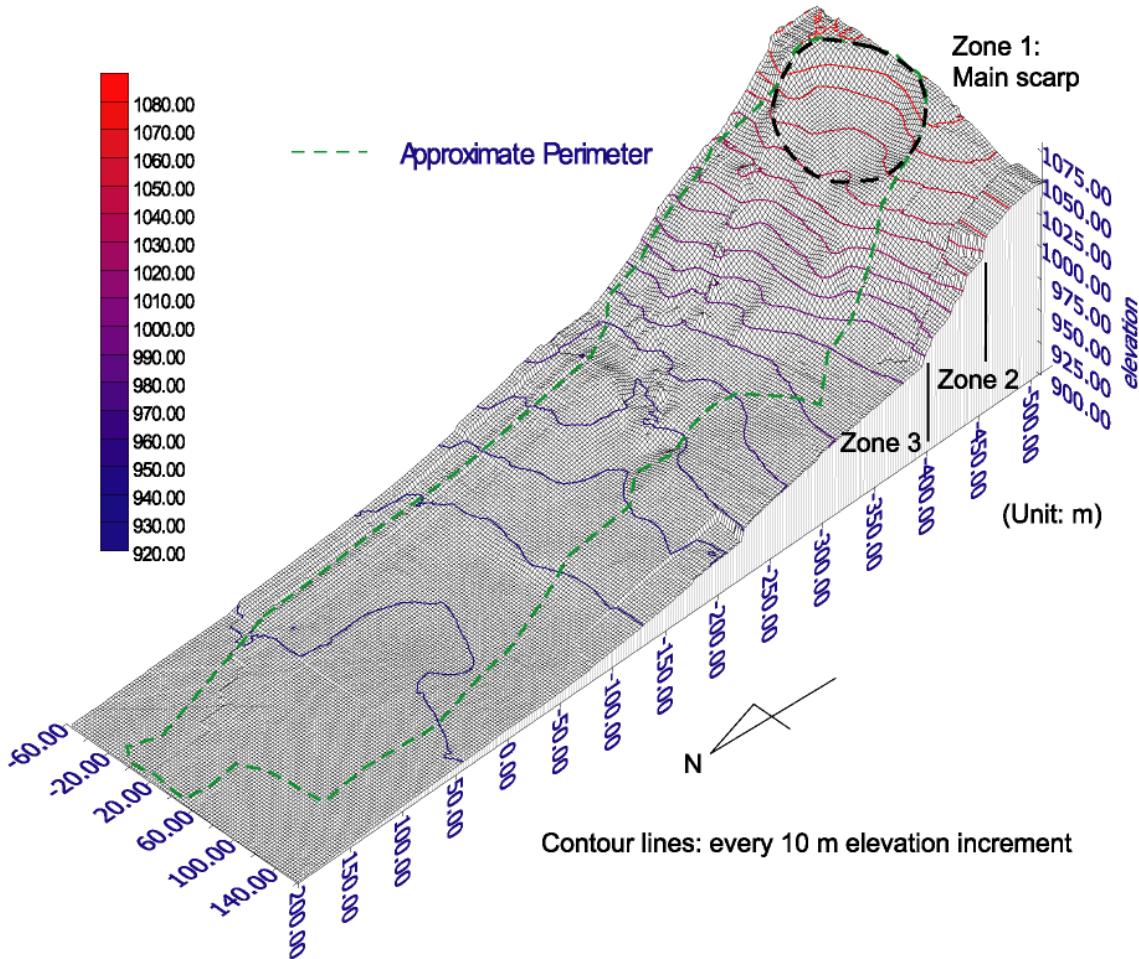
The surveyed slope was plotted with the map software SURFER (see **Figure 2.13**). The distances from the top end of the scar to the toe of the slope and to the farthest reach of the soil mass are 480m and 700m respectively. The elevation of the head-scarp and the toe of the slide are 1080m and 920m, respectively, namely, there is an average gradient of 160 m over 700 m distance in the damaged area. The average inclination from the top of source area to the toe of the deposit is about 13 degrees.

Figure 2.13 Surveyed Slope plotted with surfer with green dashed perimeter.

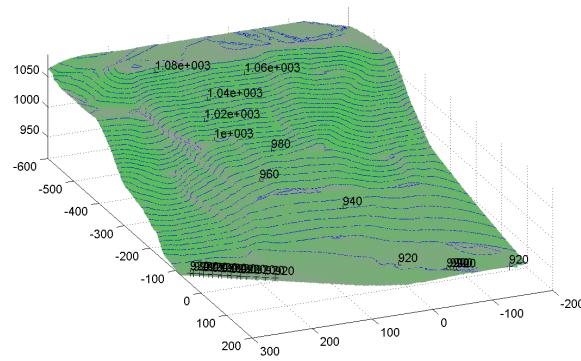
Figure 2.14 Original Slope plotted with Matlab, as seen from the North East.

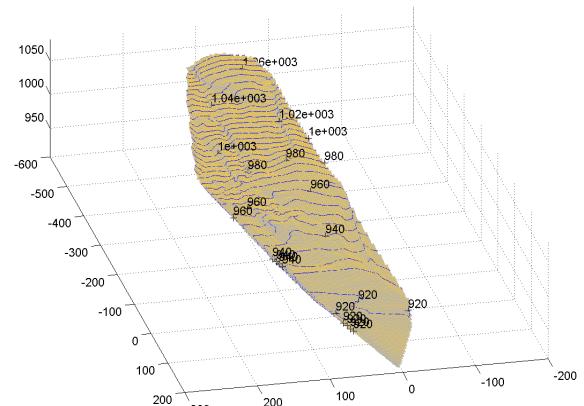
Figure 2.15 Surveyed slope plotted with MATLAB. The slope is in the North-South direction with higher elevations in the south.

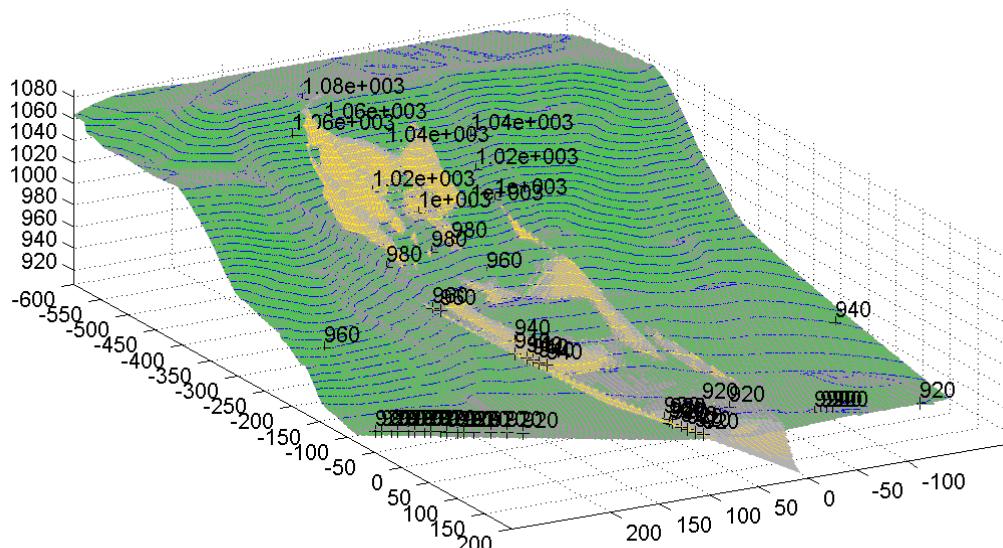
The slope data was interpolated to an x-y grid with 2.5 meters spacing and the surveyed slope height i.e. the z-coordinates were subtracted from the original slope z-coordinates. Since the surveyed slope was slightly higher than the original slope in some areas (see yellow areas in **Figure 2.16**), these areas were excluded from the volume calculation by only considering positive values of the slope height differences between the original and the surveyed slope data. The slope height differences were added together and finally multiplied by 6.25 (2.5x2.5) to obtain the volume. The total slide volume is estimated to be about 200,000 cubic meters.

Figure 2.16 Survey and Original Plot over lap. Volume was estimated from regions where original slope lies above the surveyed slope.

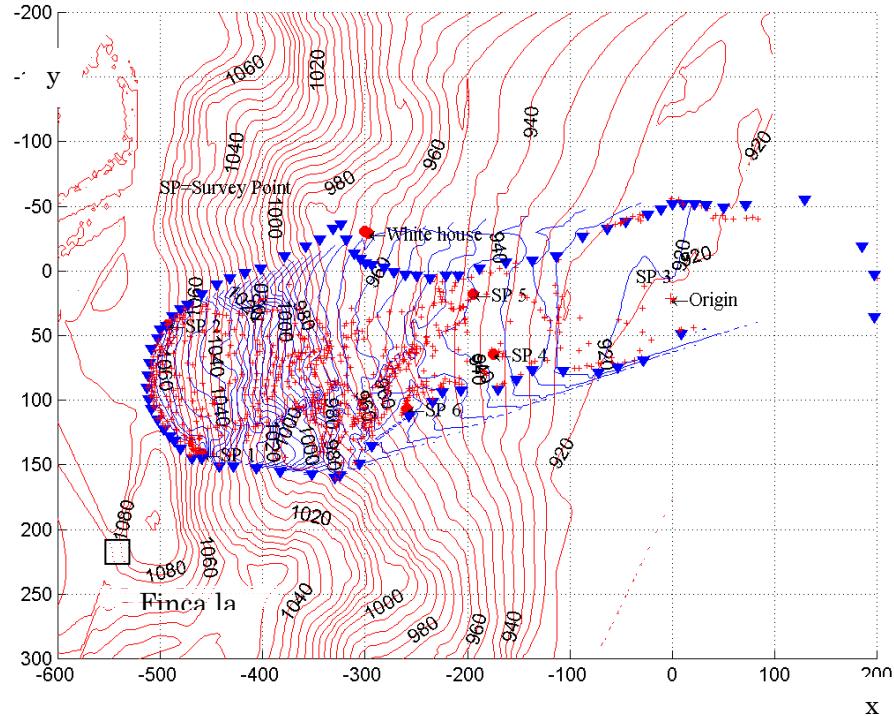
Figure 2.17 shows contour plots of the original and surveyed slopes. In the figure the locations of the survey points (**SP1-6**: red solid circles), surveyed points (red crosses) and the slope perimeter (blue upside-down triangles) can also be seen.

Figure 2.17 Original Slope with Surveyed slope slide perimeter (blue triangles), Red dots are Survey Points, red crosses are surveyed points.

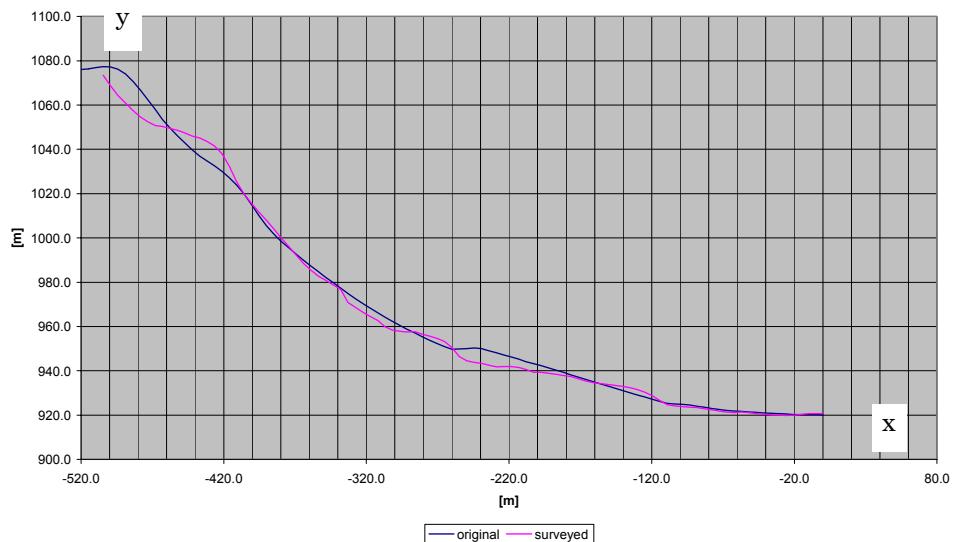
A section plots of the surveyed and original slopes are shown in **Figure 2.18**. The baseline of the cross section was drawn from point $\{0,0\}$ to $\{-520, 100\}$. In the plot, the heights (z-coordinates) are plotted against the x-coordinates. The steep slope configuration in zone 2 after the earthquake roughly remained unchanged as mentioned before.

Figure 2.18 Section of original and surveyed slope(s). The three black lines correspond to the surveyed slope and the shifted positions.
