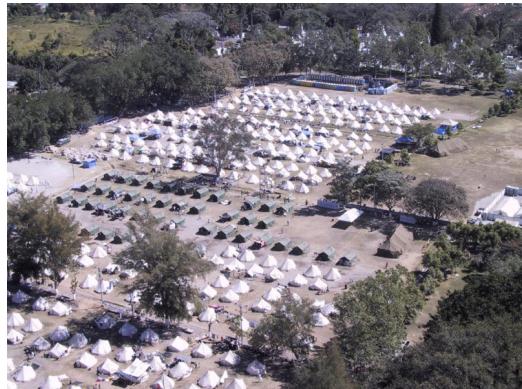
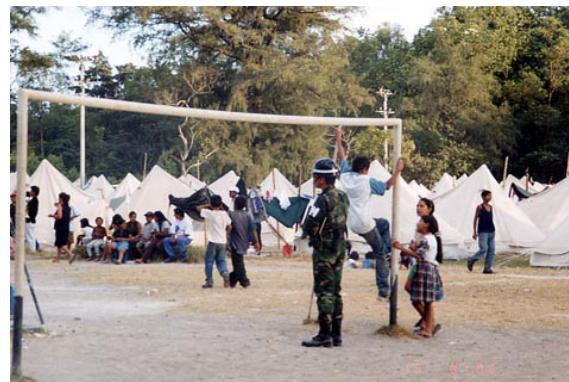
Figure 2.51. Refugees' camp

Extensive cracks remaining along El Balsamo ridge are certainly the serious threat of further slides. The city of Santa Tecla was controlling the potential hazard zones, the red zone with the highest risk and the yellow zone of slightly less danger (**Figure 2.50**). A week after the earthquake, the number of residents evacuated from the zones exposed to the menace of possible landslides reached 14,000, and as of Feb. 3, about 4,000 refugees were still being forced to live in tents (**Figure 2.51**). Since the rainy season starts in April or May, necessary countermeasures should be taken because even flat-lying areas away from sudden changes in slope angle may be still within the possible reach of the soil mass. Recommendations will be given in Section **2.6**.

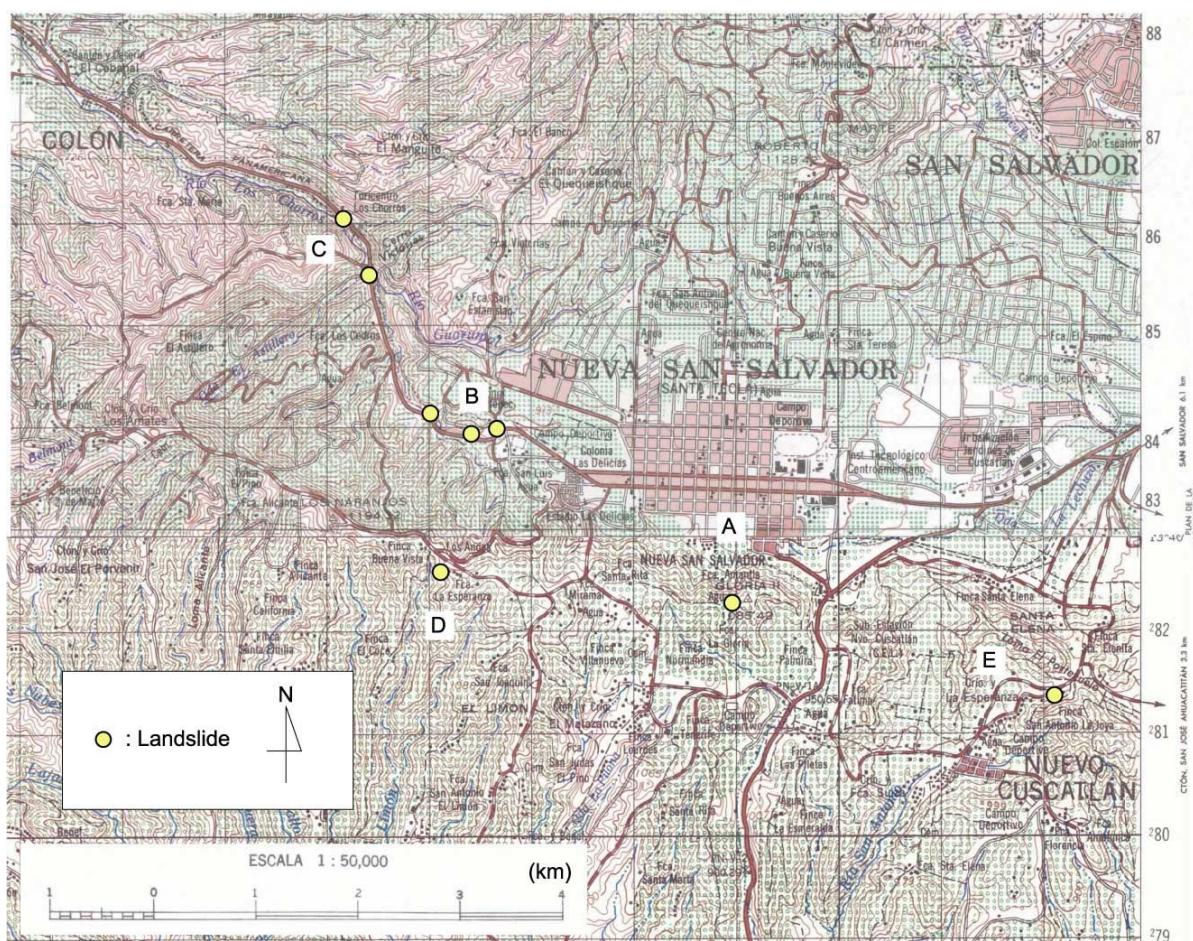
Figure 2.52. Locations of landslides in the vicinity of Nueva San Salvador
(Topographical map: Ministerio de Obras Públicas, 1984)

This section describes the other landslides that the JSCE team investigated. The team had little chance to cover a wide area of the nation during their short stay, and thus they narrowed their target mostly to the slides in the vicinity of Nueva San Salvador (see **Figure 2.52**: Ministerio de Obras Públicas, 1984). They include:
