Strain Induced in Cracked Utility Poles and Damage to Dwellings in the Dec 26, 2003, Bam Earthquake

Kazuo Konagai^{1)*}, Masayuki Yoshimi²⁾, Kimiro Meguro¹⁾, Miho Yoshimura¹⁾, Paola Mayorca¹⁾, Masasuke Takashima¹⁾, Alireza Farahani¹⁾, Hossein Tahghighi¹⁾ and Mohammad Keshavarz³⁾

Abstract

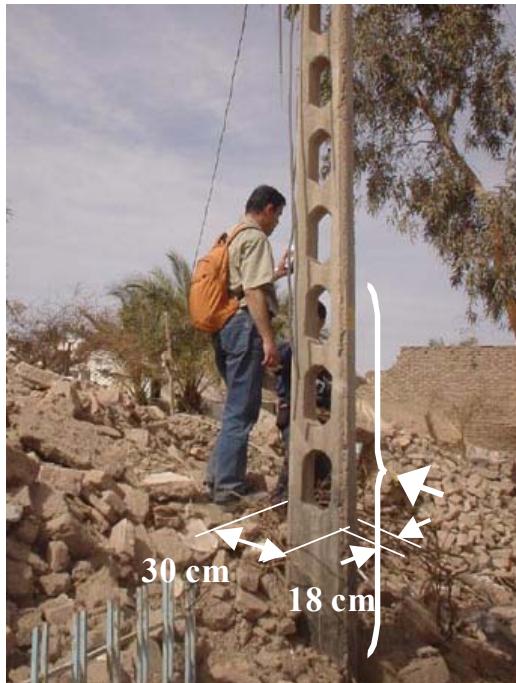
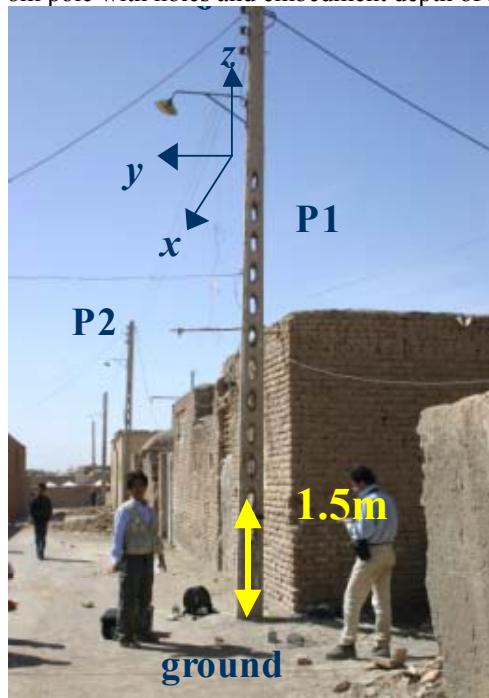
Fig. 4 Poles taken in Bam

In order to examine the dynamic features of this pole type, microtremors were measured at two poles (Fig. 4(b)). Their characteristics are summarized in Table 1. Bottom holes on P-2 pole were filled in to prevent theft.

(a) 8m pole with holes and embedment depth of 2 m

(b) Poles P-1 and P-2

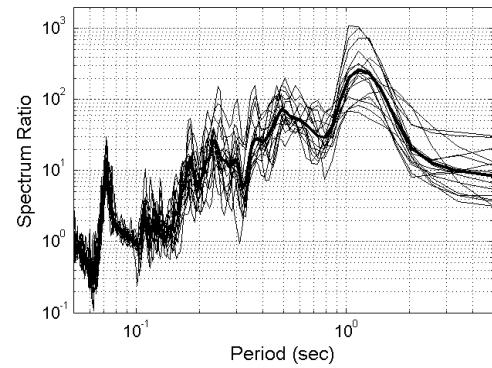
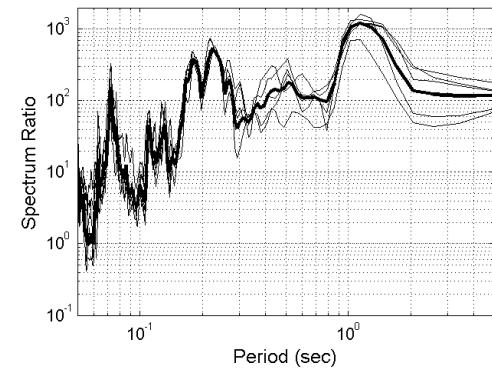
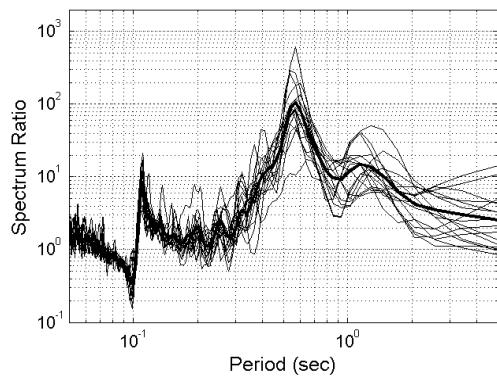
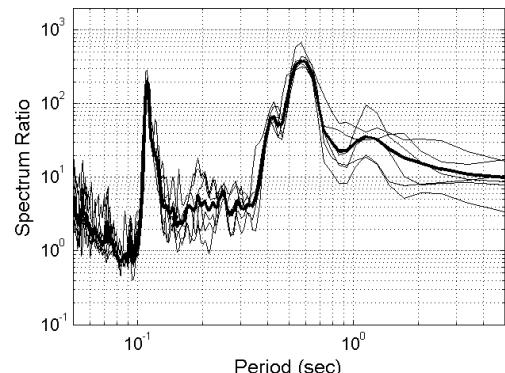
Fig. 5. Transfer functions for pole P-1

Fig. 5 shows the transfer function for P-1. It is clear in Y-direction that there is little change of the predominant periods between the “ambient” and “hit” cases. In both

cases, clear peaks are found at 0.105 and 0.57sec, with the main difference being the peak relative amplitudes. When the structure is hit, the lower period amplitude becomes higher.

Poles exhibits quite different vibration features in X-direction (Compare Figs 5(a) and 5(b) with 5(c) and 5(d)). As for ambient vibration cases, two peaks at 0.07 and 1.10 sec are distinguished among the others at 0.18,

0.21, and 0.6. When the structure is hit, two clear peaks appear at 0.18 and 0.21s in addition to 0.07 and 1.10s, but 0.6s peak is not clearly seen suggesting that this peak is the crosstalk from Y-component of the pole vibration. Fig. 6 shows the transfer functions for P-2 pole. The functions have similar shapes as those for P-1 pole in all cases, suggesting that mortar filled in holes had little effect on the dynamic behavior of the pole. Fig. 7(a), (b) and (c) show X, Y and Z components of the pole vibration spectra. It is noted that the spectra for X and Z components are similar with each other, while Y component exhibits some different shape. Fig. 7(d) shows X/Z and Y/Z spectra ratios to highlight this feature. Assuming that the vertical vibrations of the pole were mainly induced by cable oscillations, it may be concluded that a cable has an important effect on the pole's motion along the cable.
