# **Provisional Report of the May 27, 2006, Mid Java Earthquake, Indonesia**

June 15, 2006

**Advanced Body of the  
“JSCE/AIJ mission for reconstruction  
recommendations for areas devastated by the  
May. 27, 2006, Java earthquake, Indonesia”**

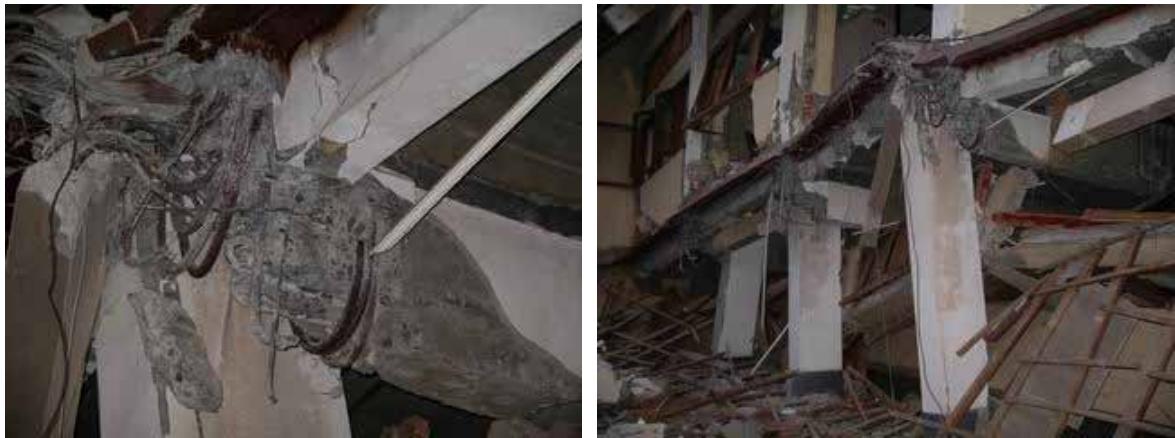
University of Economic Science (STIK Kerja Sama)

5 story building with 4 URM wall frames

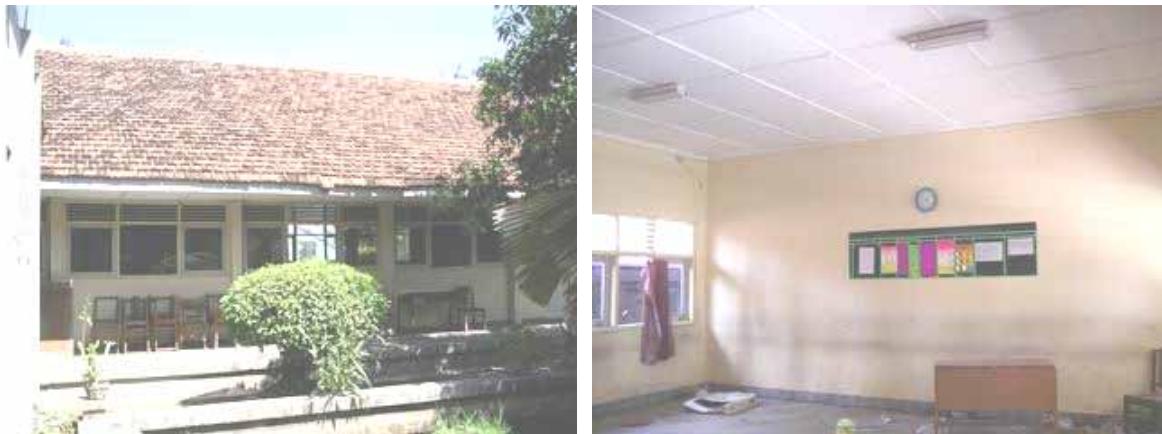
SMP 2 at Bambanglipuro, Kecamatan Baglipuro

Bambanglipuro 2nd Middle School (SMP 2 at Bambanglipuro, Kecamatan Baglipuro / URM+RC column / 1F)

Each class had 3 bays in the longitudinal direction. No major damage was found in the structure.

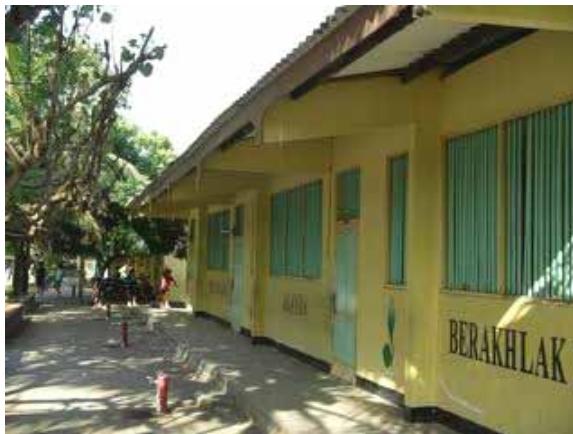
SD2 Parangtritis

Each class had 2 bays in the longitudinal direction. Each bay was 3.5m long and the column

size in the middle was 175mm thick and 350 mm wide. The eaves were supported by  $\Gamma$ -shaped RC columns with cantilever beam. No major damage was found in the structure. Note that less damage was found in the coastal area around Parangtritis (to Opak river) than inland areas.

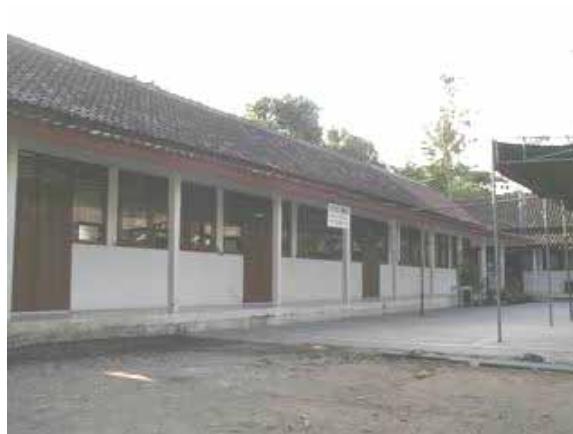
SLB-PGRI Trimulyo

School at Trimulyo (SLB-PGRI Trimulyo, Kecamatan Jetis / URM(+RC column?) / 1F) Each class had 2 bays in the longitudinal direction. Each bay was 3.5m long. Columns had flexural cracks at both ends. The presence of reinforcing bars was not confirmed at the site since the building had minor cracks and rebars were not exposed.

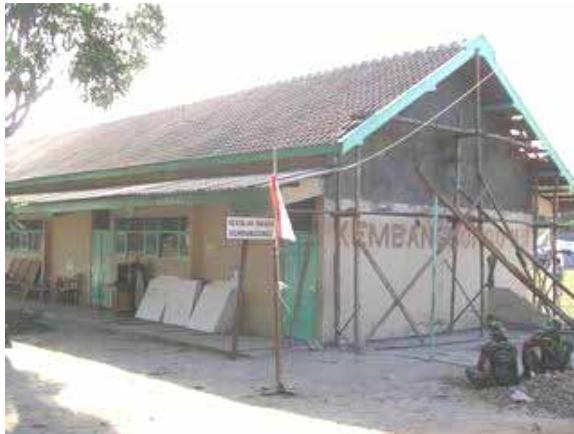
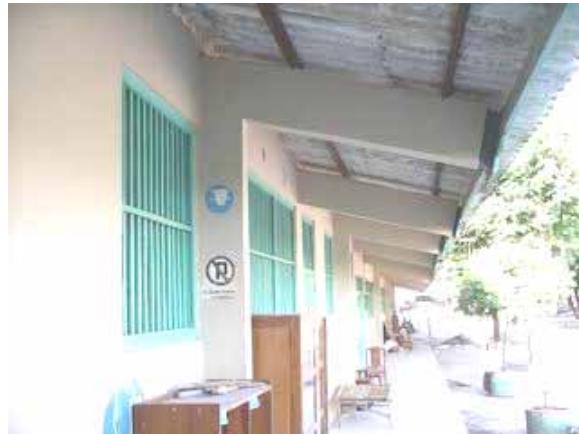
SD 2 at Kembangsongo

Kembangsongo 2nd Elementary School (SD 2 at Kembangsongo / URM+RC column / 1F)

The school was located just north of the school at Trimulyo. The eaves were supported by  $\Gamma$ -shaped RC columns with cantilever beam, which was similar to SD2 Parangtritis. The exterior URM wall was damaged and repaired, but no other major structural damage was

found in the structure.

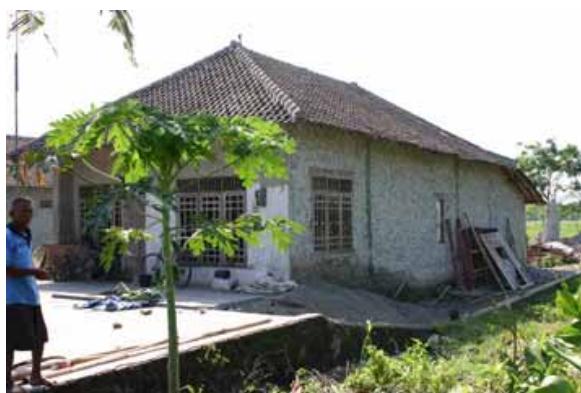
Traditional stone masonry houses in Gantiwarno Sub-Regency had some damage in masonry walls. They had some RC beams on the wall but no RC columns were provided in the house. Although they were heavy, the stone masonry walls were thick and long enough to resist and survive the shaking. Another traditional houses older than the stone masonry construction had minor damage since they had light bamboo-net walls. The bamboo-net house investigated by the reconnaissance team was older than 70 years.

Stone masonry house

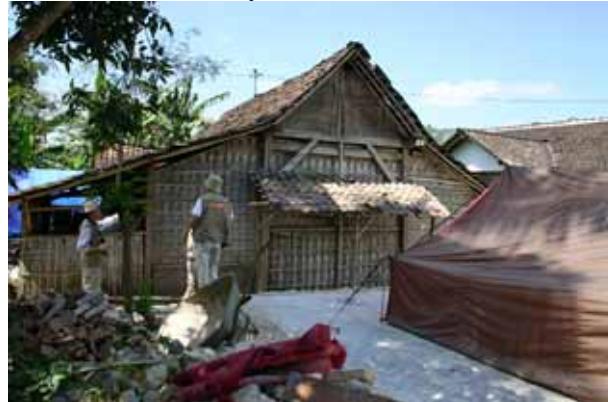
Bamboo-net wall house

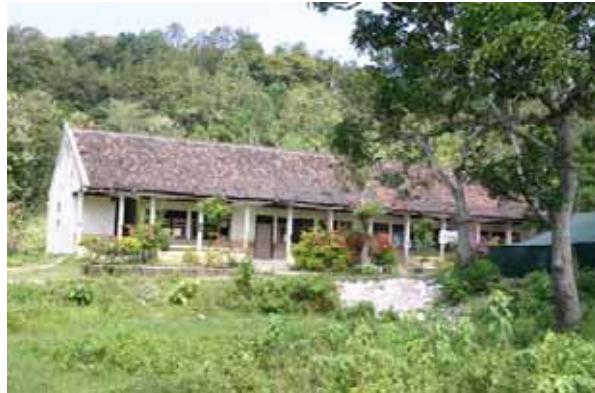
Building #1 : URM with RC columns

The school had 3 buildings, one of them (building #2) were stone masonry structure constructed in the 1970s while the other two buildings (#1 and #3) were URM structure with RC columns. Each classroom of the building #1 had 3 bays, each of which was 3m long. Damage to the roof system and ceiling boards was found in buildings #1 and #3 while cracks in URM stone walls were found in building #2.
