HOKKAIDO, JAPAN, M_w 6.7 EARTHQUAKE OF SEPTEMBER 6, 2018 LIFELINE PERFORMANCE

The Council of Lifeline Earthquake Engineering
TCLEE No. 4

G&E Report R98.23.01 Revision 1, March 18 2019

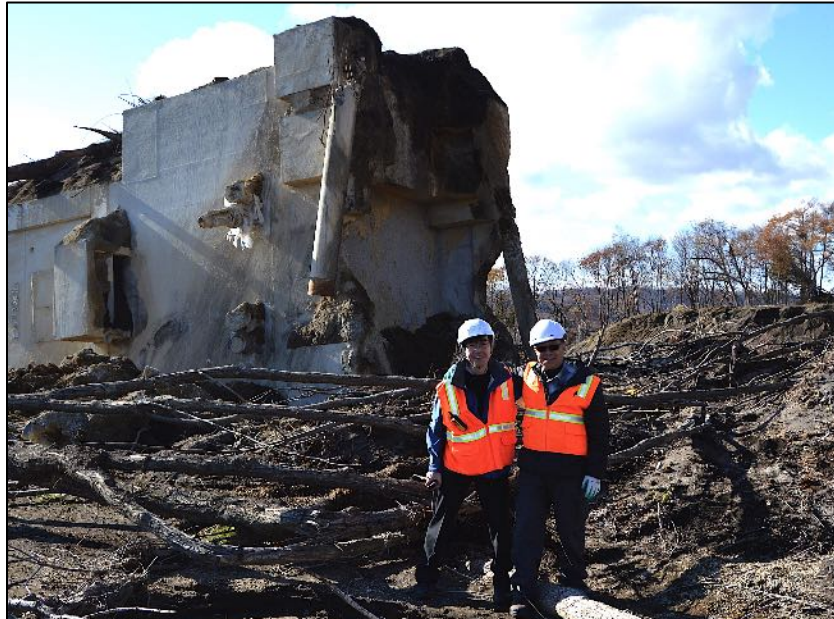
Prof Konagai (Left) and Alex Tang (Right) in front of the destroyed stair column of the Water Treatment Plant (see Chapter 5). The piles were pulled out by the landslide. (Credit: Mr. Ingemansson)

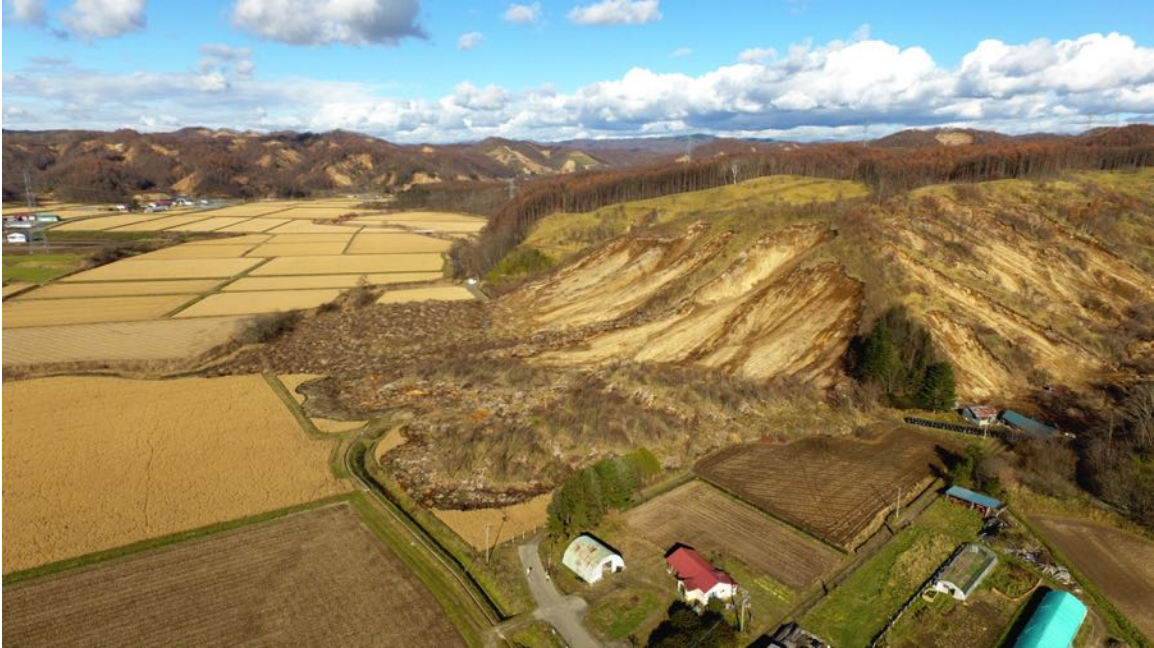
*Figure 2-10. Landslides east of Atsuma
(latitude 42.7596, long 141.9292) (credit: Shiga)*

Figures 2-10 and 2-11 show a landslide zone located east of Atsuma. Several slides initiated on this hill slope. Debris run out was commonly about 100 meters from the base of the slopes. These slopes had been clear cut of trees prior to the earthquake. These photos were taken in mid-November 2018. In the distance of Figure 2-10 are a number of landslides (areas without forest) in the hills.

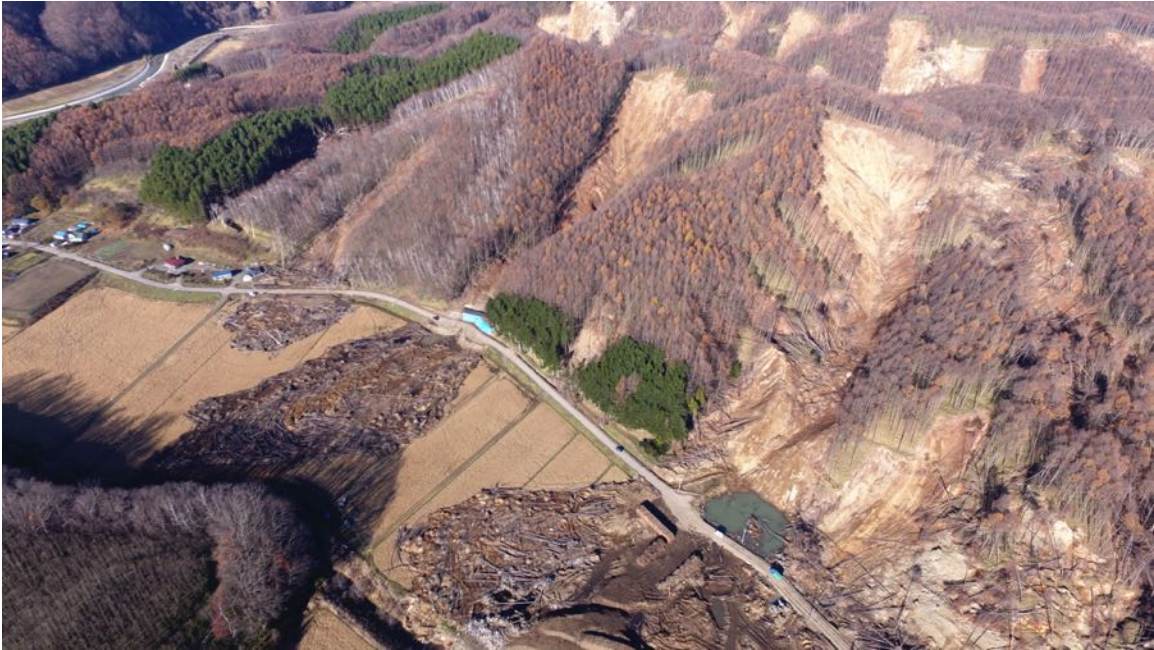
*Figure 2-12. Landslides east of Atsuma
(latitude 42.7510, longitude 141.9856) (Credit: Shiga)*

Figures 2-12 and 2-13 show a landslide zone located east of Atsuma. Several slides initiated on this hill slope. Debris run out was commonly about 100 meters from the base of the slopes. These slopes were entirely forested prior to the earthquake. These photos were taken in mid-November 2018, by which time the road had been cleared of debris.

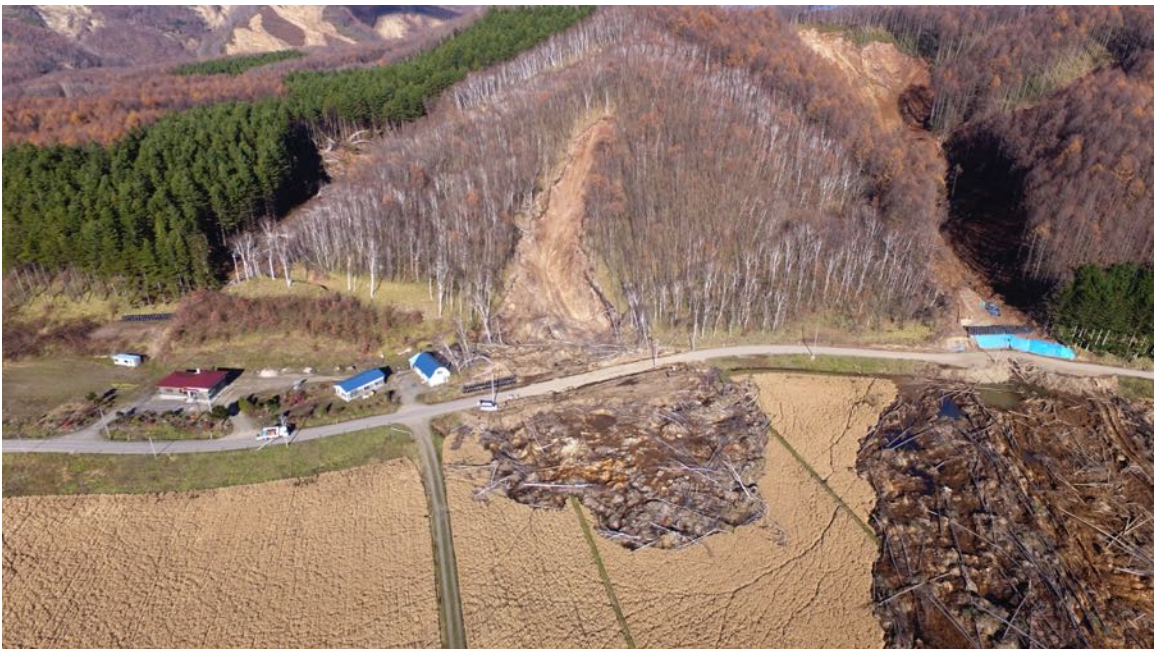
*Figure 2-13. Landslides east of Atsuma
(latitude 42.7510, longitude 141.9856) (Credit: Shiga)*

The slides in Figure 2-13 are a close-up view on the left-most (western-most) slides in Figure 2-12.

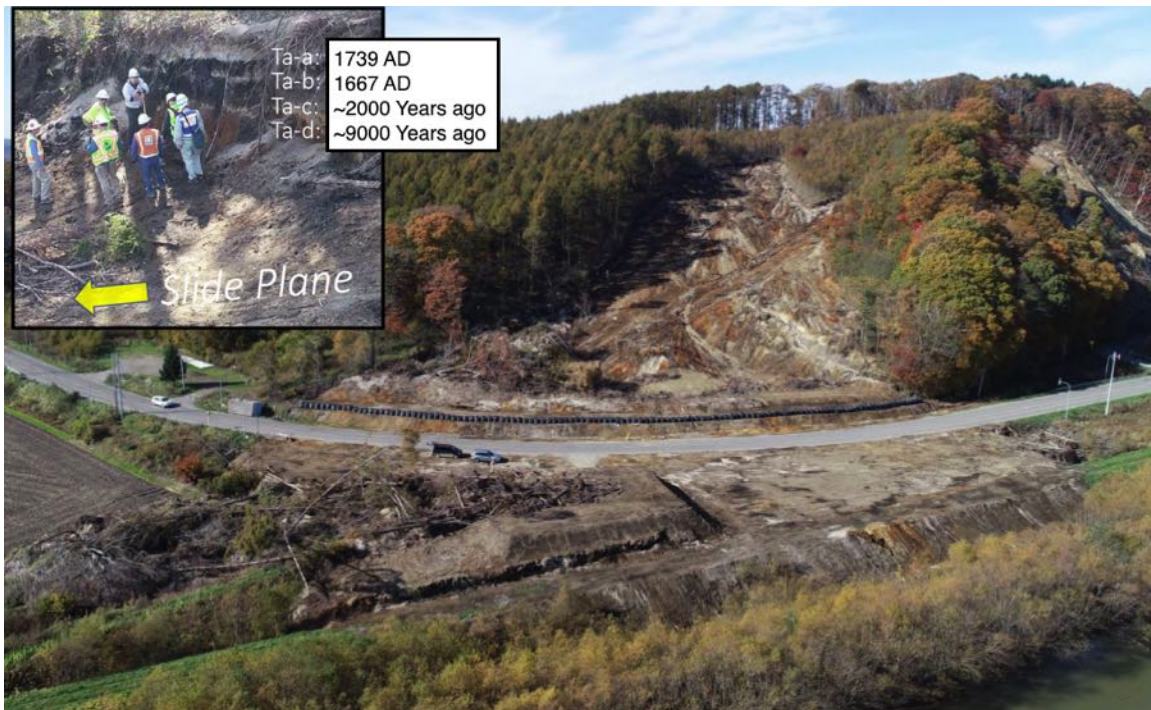
*Figure 2-14. Landslide zone east of Atsuma latitude 42.7371, longitude 141.9016)
(Credit: Madugo)*

The slide in Figure 2-14 is located just east of Atsuma. The inset shows 7 geologists and geotechnical engineers examining the soil layering at the edge of the slide. Four layers of volcanic tuff (also called Tephra, unit Ta) are exposed, labeled Ta-a, Ta-b, Ta-c, Ta-d, with estimated ages of 9000 years ago (Ta-d), ~2000 years ago (Ta-c); 1667 AD (Ta-b) and 1739 AD (Ta-a). Tephra is a material that falls out of the air during a volcanic eruption. The term "Lapilli" is used to describe the size of the particles, from 2 mm to 64 mm in diameter. The term "ash" is used to describe particles that are smaller than 2 mm in diameter.

The Lapilli ash fall from the Shikotsu-Ko volcano was laid here by eruptions of these ages; but possibly the higher layers reflect prior landslides at this location, and not independent volcanic eruptions. Lake Shikotsu is the large caldera lake in the southwest portion of Figure 2-3. This caldera was formed 40 to 50 thousand years ago, and the present-day caldera was formed some 31 to 34 thousand years ago by one of Hokkaido's largest quaternary eruptions. The present-day volcanoes Mount Tarumae, Mount Eniwa and Mount Fuppushi are located on this rim of this caldera.

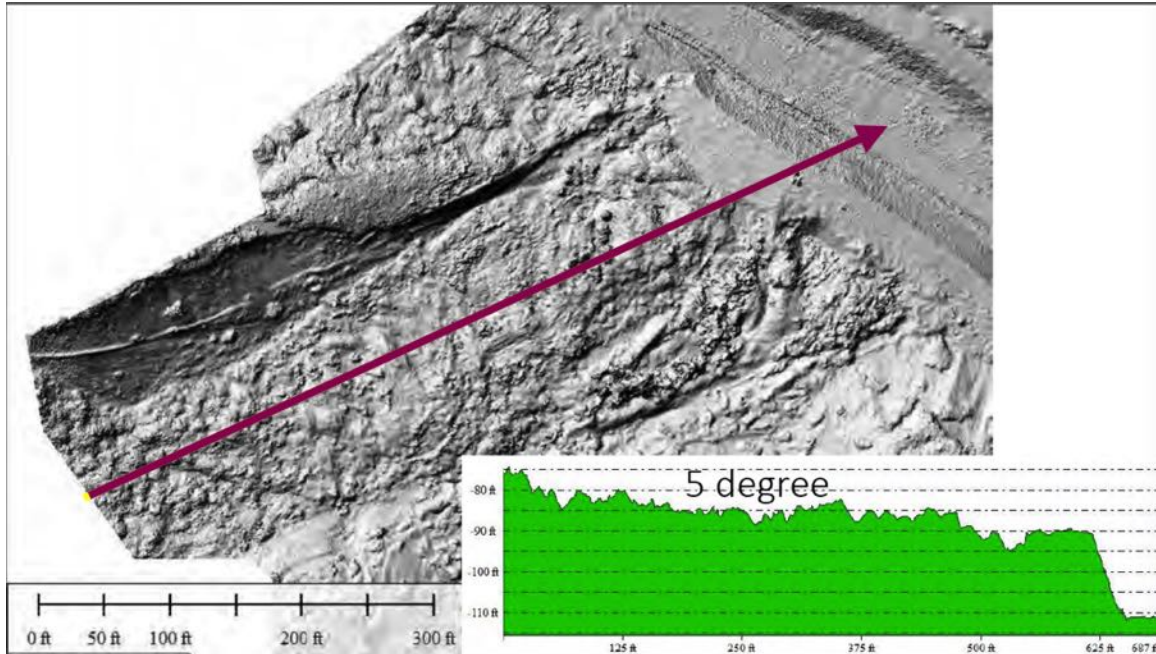
Figure 2-15. Landslide zone east of Atsuma (latitude 42.7549, longitude 141.8636) (Credit: Madugo)

While most of the landslides in the mapped area in Figure 2-8 occurred on moderately steep slopes (30° to 40° slopes common), some of the landslides occurred on very shallow slopes. Figure 2-15 shows a digital elevation model created by a drone over flight, using photogrammetric methods. The developed cross section shows the head scarp at about 40 feet higher elevation than the near-toe of the slide, with a horizontal distance of about 640 feet, or an average 4° slope.

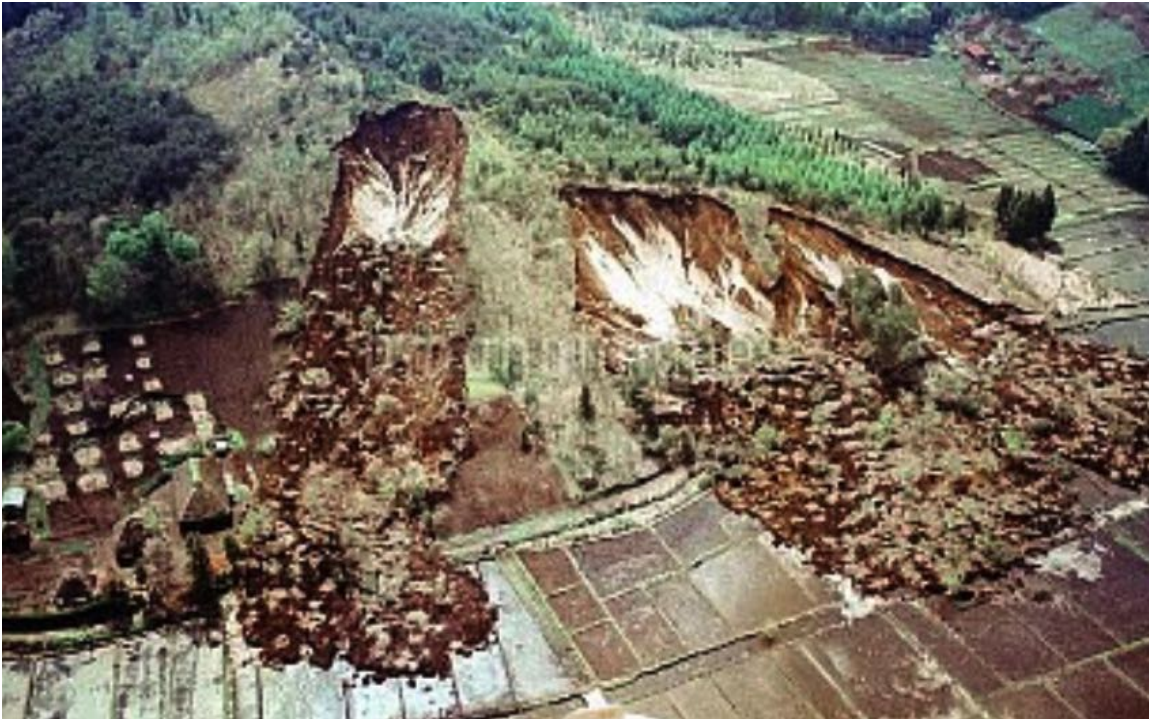
*Figure 2-17. Triggered Landslides due to the 1968 M 8.3 Offshore Earthquake
(credit: Konagai)*

Figure 2-17 shows an aerial photograph of landslides triggered by the 1968 Offshore Tokachi M 8.3 earthquake. This area was also draped in wet pumice-rich volcanic materials. The level of ground shaking at this location is uncertain, but thought to be in the $PGA = 0.10g$ to $0.20g$ range. The general trend of these slide masses is very similar to those that occurred in 2018:

- Slide zone is 10s of meters wide; slope is moderately steep (20° to 30°); depth of slide mass is ~ 5 to 10 meters; slide mass moves downwards and then horizontally into adjacent agriculture fields.

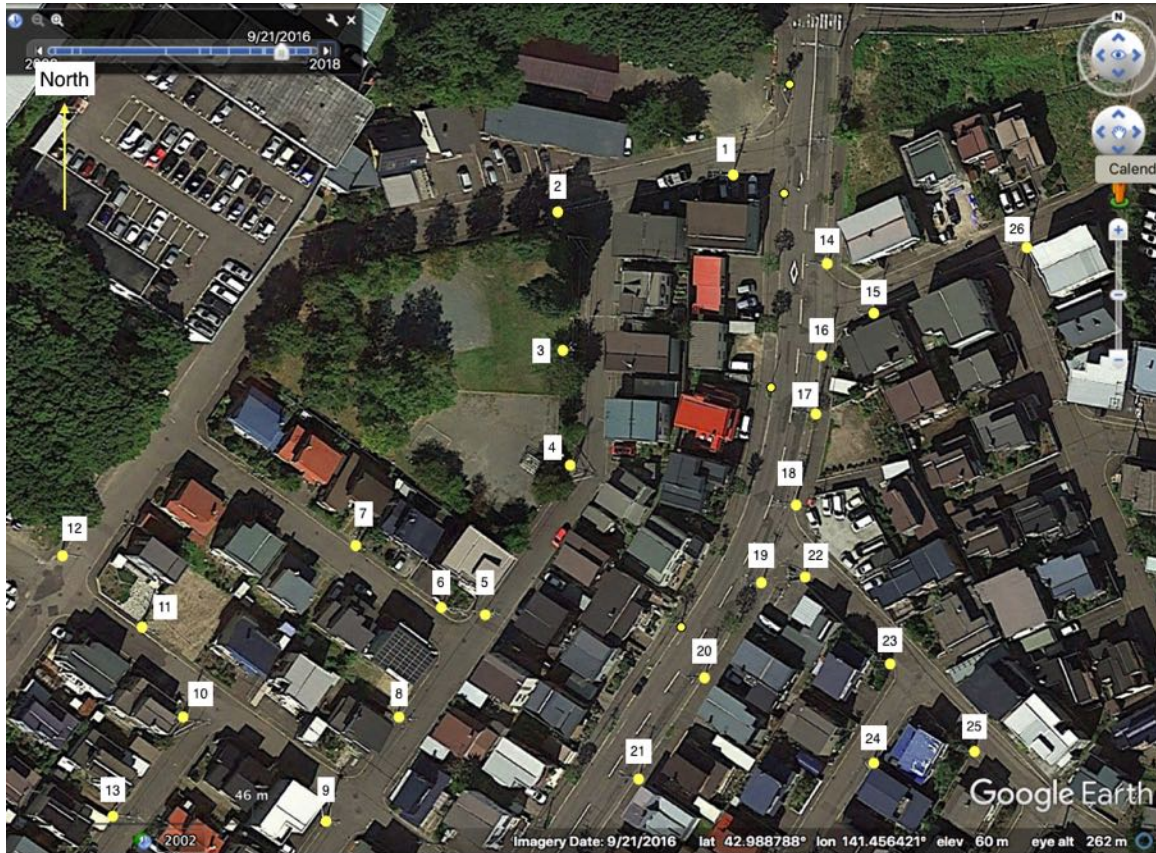
Figure 2-19. Location of Concrete Power Poles in Liquefaction zone in Kiyota-Ward (latitude 42.9888 long 141.4564)

Figure 2-19 shows the locations of 26 power poles (yellow dots) that were subjected to PGDs in excess of 0.5 meters in the liquefaction PGD zone. None of these poles collapsed, but several were tilted and one sunk downwards as much as a meter. Maximum PGD was on the order of 2 meters. From a functionality point of view, these poles might all have to be reset to be vertical once this community is re-built.

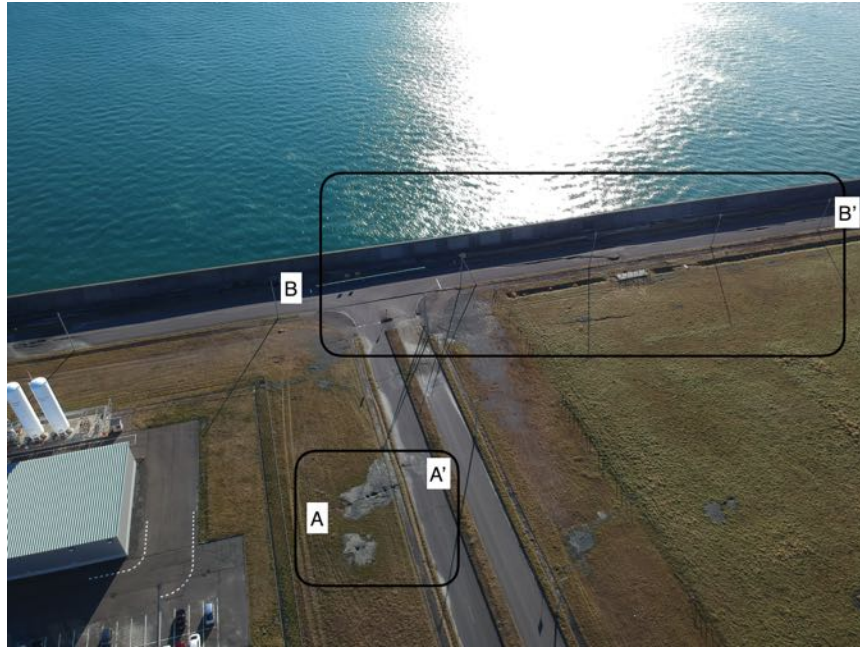
Figure 2-20 shows the sea wall near the Tomatoh-Atsuma power plant. Figure 2-21 shows the ejected sand along line A-A'. Figure 2-22 shows the effects of liquefaction along the sea wall along line B-B'. Figure 2-23 highlights the scale of PGDs.

Figure 2-20. Liquefaction at Sea Wall (looking south) (lat 42.6042, long 141.7969)

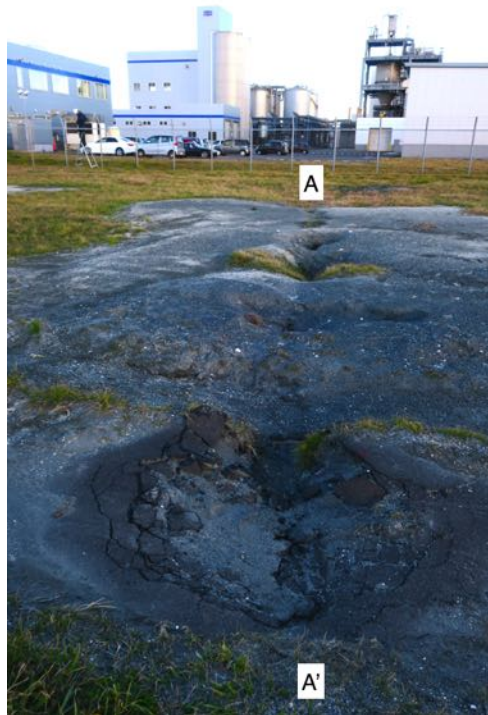
Figure 2-21. Ejected Sand, Line A-A'

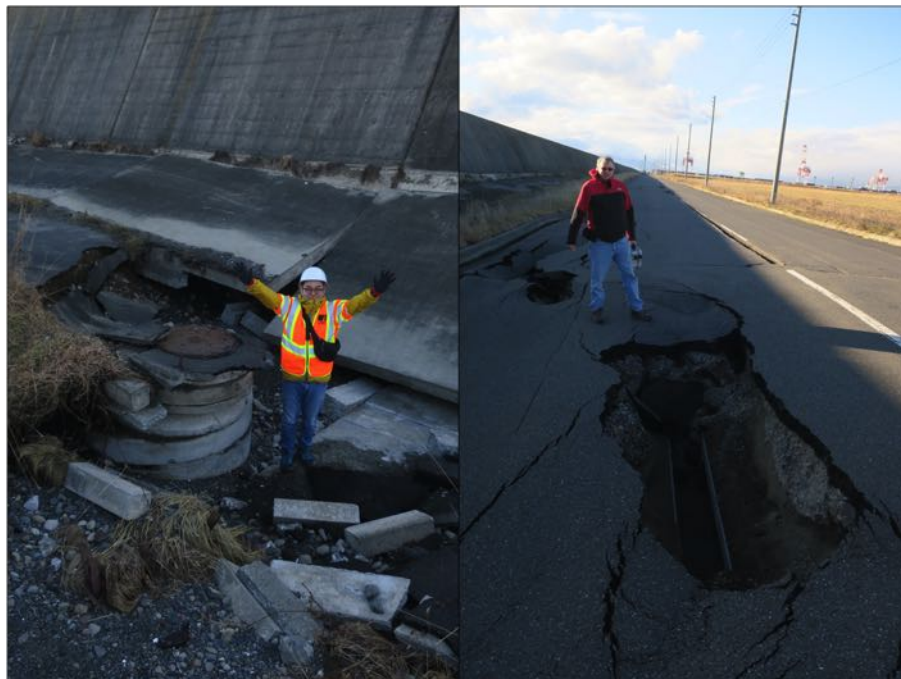
Figure 2-23. Left: Settlement at Storm Drain (Shiga). Right: Road failure (Eidinger)

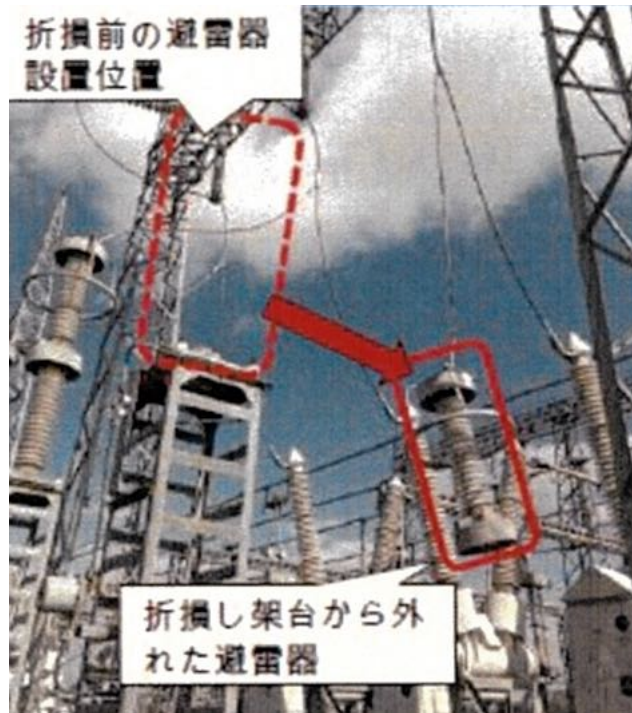
Figure 3-12a,b shows the position where one of the 187 kV lighting arrestors collapsed. This surge arrester in one of three serving the right-most transformer in Figure 3-9. Inspection of the attached conductors suggests that the failure was not due to the conductors having insufficient slack; rather, it was an inertial overload. During the earthquake, the surge arrester broke at its base, and swung sideways (towards the right in this photo, see Figure 3-12b). Fortunately, the arrester did not impact anything (it was more than 10 meters away from the 187 kV transformer bushings), so the net result was at most a temporary line fault that could be cleared once repair men could de-energize and safely cut away the broken surge arrester. The photo in Figure 3-12a was taken on November 14 2018, more than 2 months after the earthquake, and a replacement surge arrester has not yet been installed.

Figure 3-12b. Eniwa 187 kV Substation. Damaged Surge Arrester (credit: HEPCO)

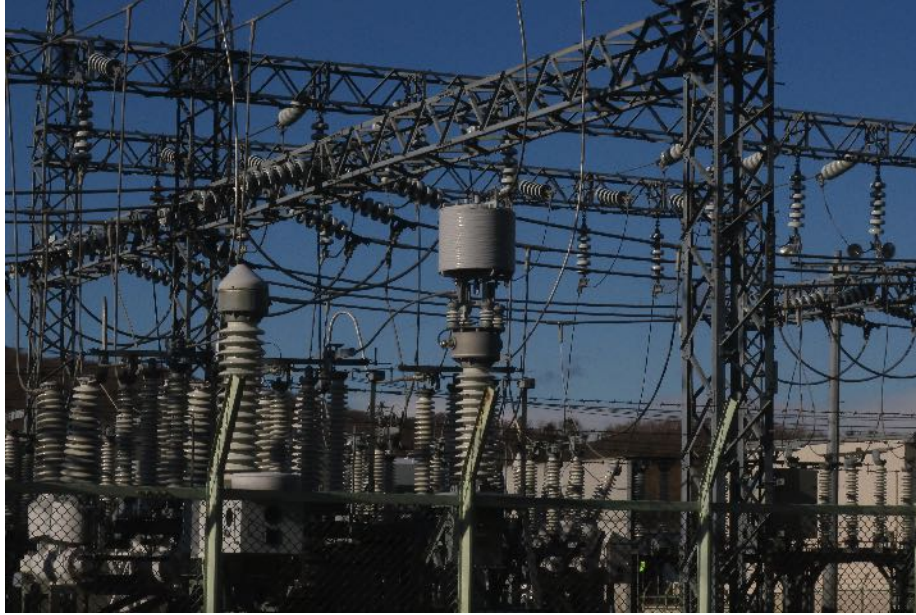
Figure 3-15 shows a wave trap atop a CCVT for one of the 66 kV lines at this yard. This type of detail would not normally be found at substations in the west coast of the USA; wave traps are heavy, and in this configuration, apply extra weight and extra bending moment to the CCVT below. Nevertheless, the equipment did not fail in this earthquake, suggesting that at 66 kV, this CCVT (as well as the electrical standoffs under the Wave Trap) were suitably strong.

Figure 3-15. Hayakita 66 kV SF6 Wave Trap

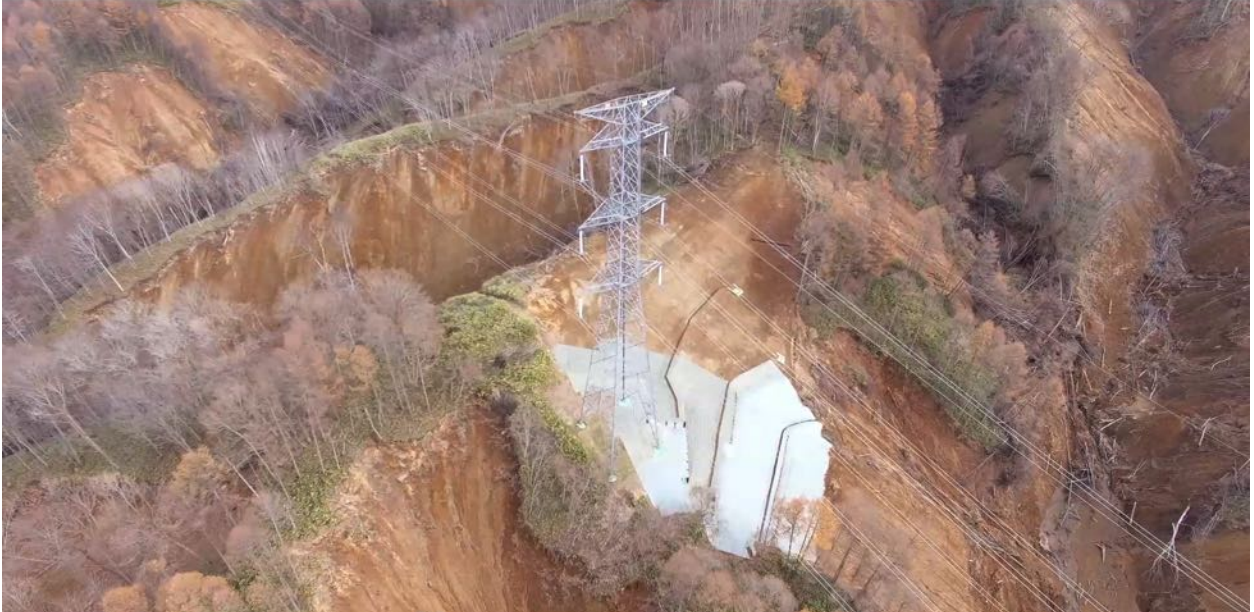
Figures 3-21 and 3-22 show aerial views of the repaired tower and surrounding landslides. The denuded slopes are all areas that had landslides that were commonly 2 to 3 meters deep and with downslope movements as much as 50 meters or more.

Figure 3-21. Aerial View looking Southwest (credit: Shiga)

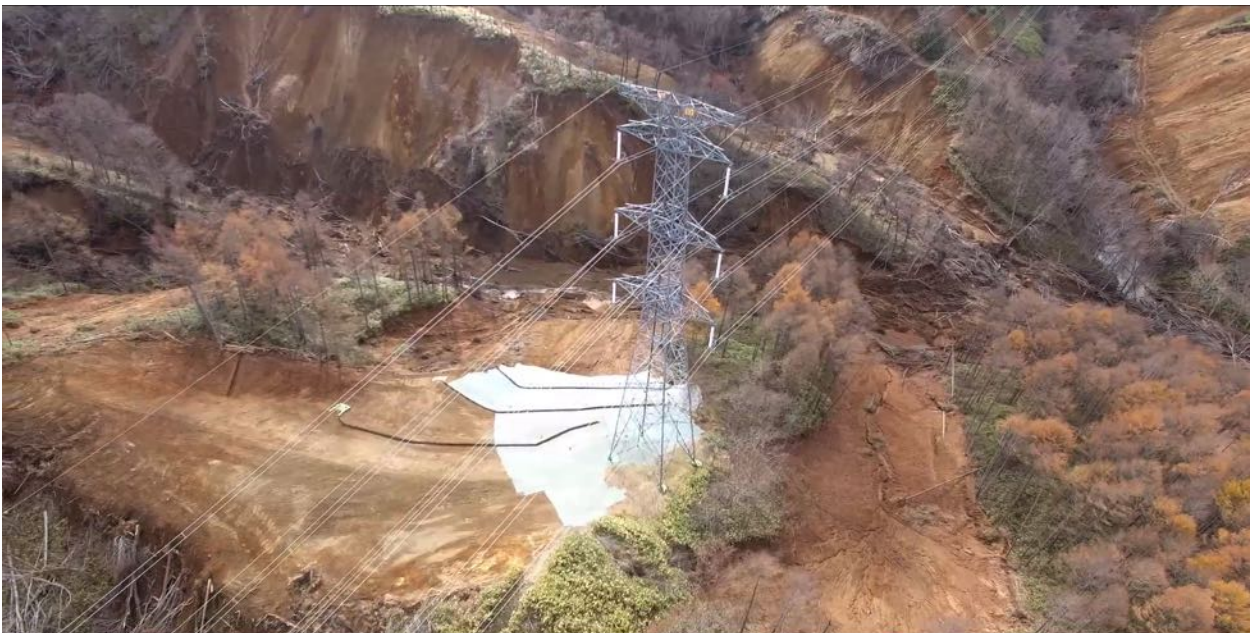
Figure 3-22. Aerial View looking Southeast (credit: Shiga)

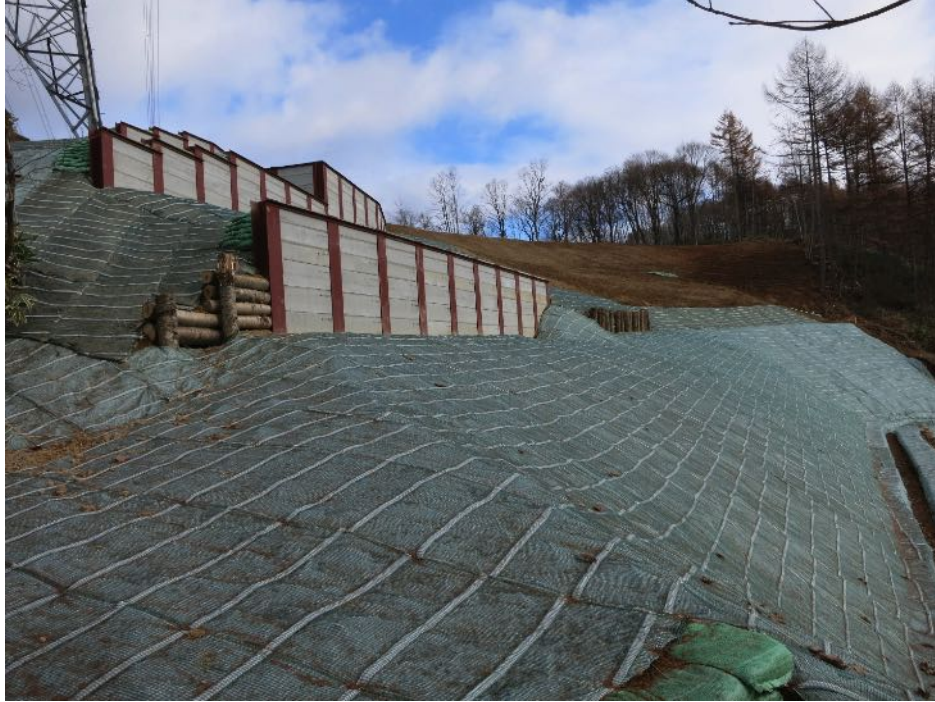
Figure 3-23. Benched Retaining Wall

The slope immediately surrounding and downslope of the tower was stabilized with stepped retaining walls constructed of steel wide flange soldier piles with precast concrete lagging, see Figure 3-23. The shoulders of the soldier pile wall were

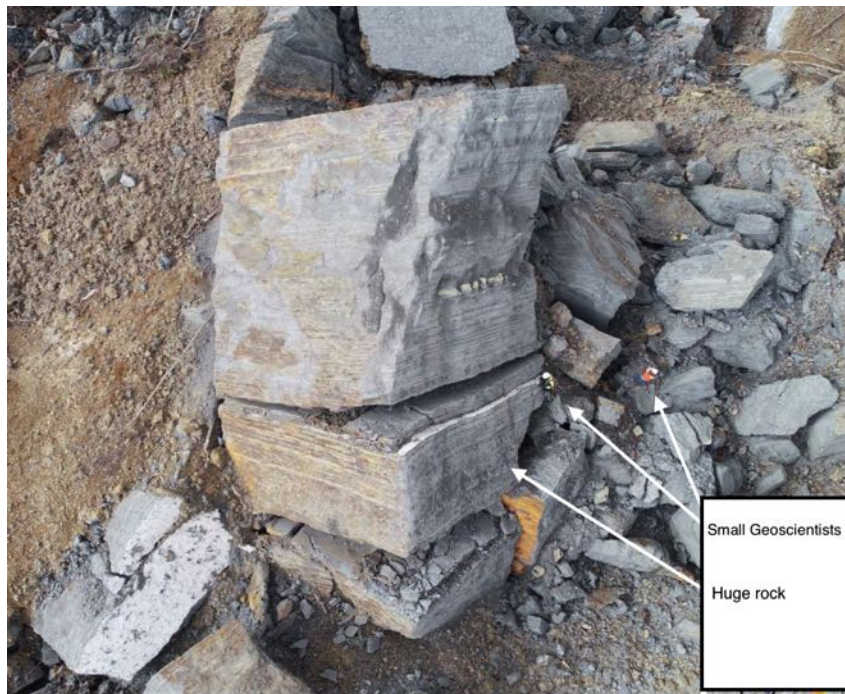
Figure 3-28 shows two geoscientists examining the strata within the head scarp in Figure 3-27. This photo shows size of the head scarp and massive nature of the layered strata.

Figure 3-28. Size of blocks in the head scarp of the landslide at Tower 107

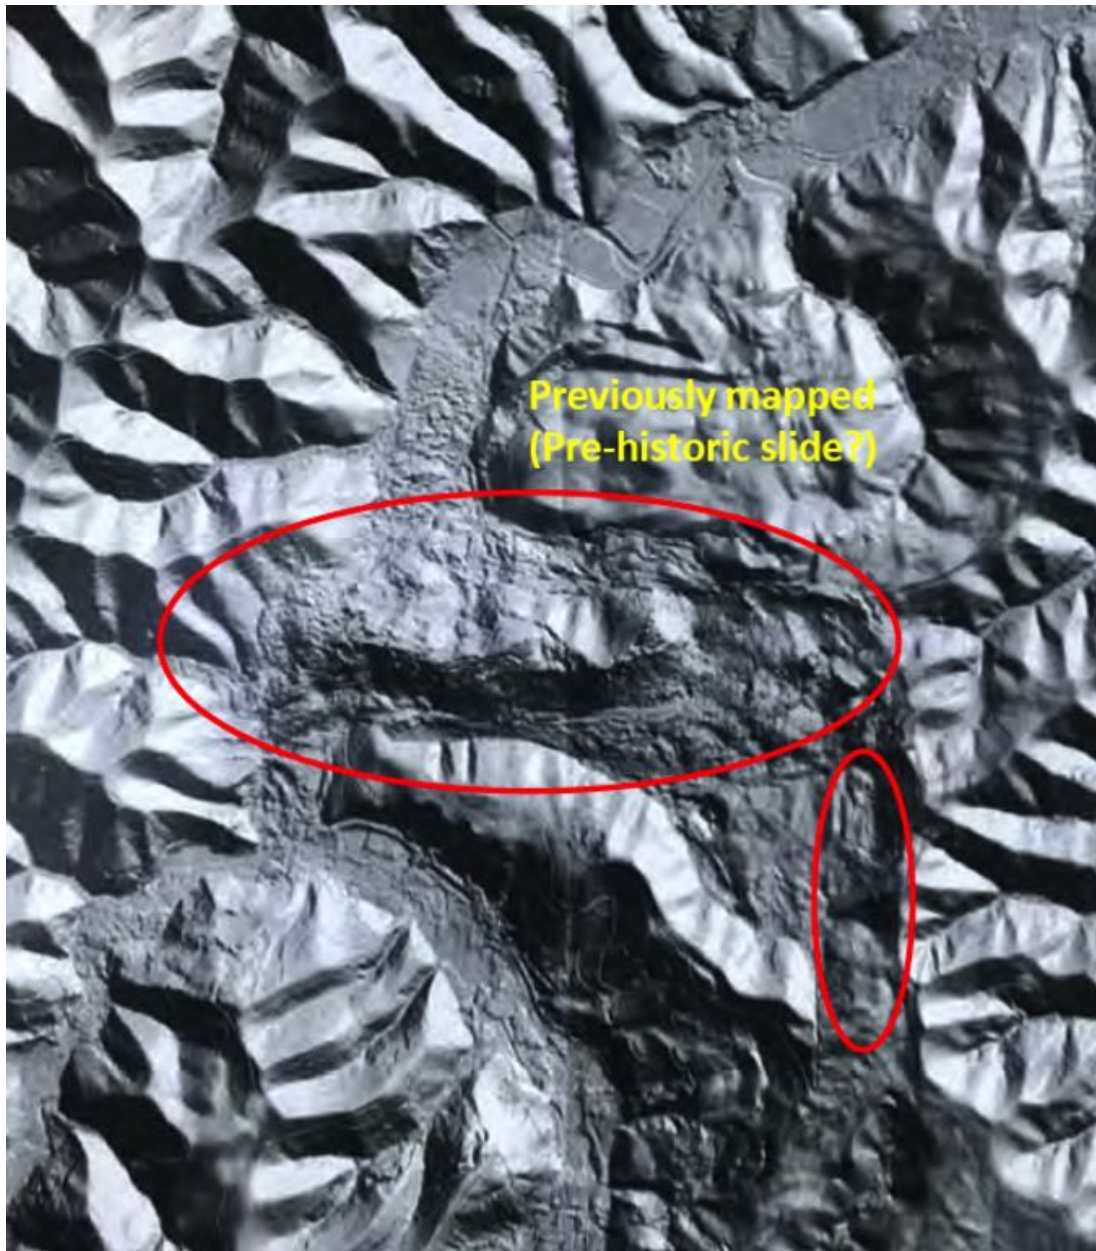
Figure 3-31 shows a digital elevation map produced by LiDAR survey completed after the earthquake. The major slide in this earthquake is indicated by the red ovals, with the location of the tower in the larger red circle. To the top (west), labeled Previously mapped (Pre-historic slide) one can see morphology that suggests another massive landslide had previously occurred in the adjacent valley, possibly triggered by another prior earthquake. This suggests that if the slopes and geology are similar, that terrain that has not shown evidence of recent prior landslides can still undergo massive landslide movements in future earthquakes.

Figure 3-31. Post-earthquake LiDAR-based digital elevation map, Tower 71

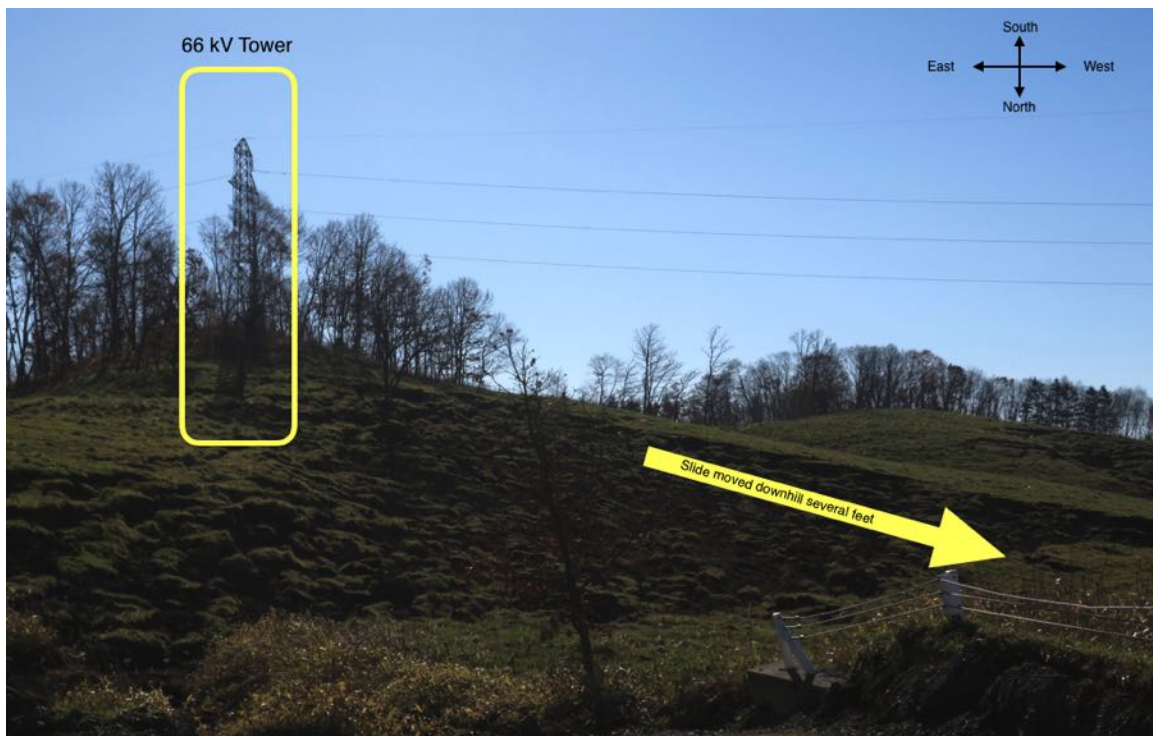
Figure 3-32 shows a landslide that occurred beneath a 66 kV suspension tower. The slide has moved a few meters downslope. The base of the tower is about 55 meters above sea level; the toe of the slide is about 30 meters above sea level. The distance from the tower (point C3 in Figure 3-34) to the toe (point C4 in Figure 3-34) is about 130 meters. The average angle of the slope is about 10.6° ($= \text{ATAN}(25 / 130)$). At the crest of the hill, the head scarp of the slide has gone between three of the four legs of this tower, exposing the concrete piers, Figure 3-33. This tower was visited twice, on October 10 2018 and November 14 2018; and could observe no discernable ongoing movement of the four legs of the tower. We inspected the braces and found no visible distortions of either the primary or secondary braces. We concluded that the bottom depth of the landslide is above the base of the concrete piers. A long term effort to repair the landslide from further undermining this tower may be suitable.

Figure 3-32. Landslide beneath 66 kV Suspension Tower (Lat 42.7560, long 141.8695)

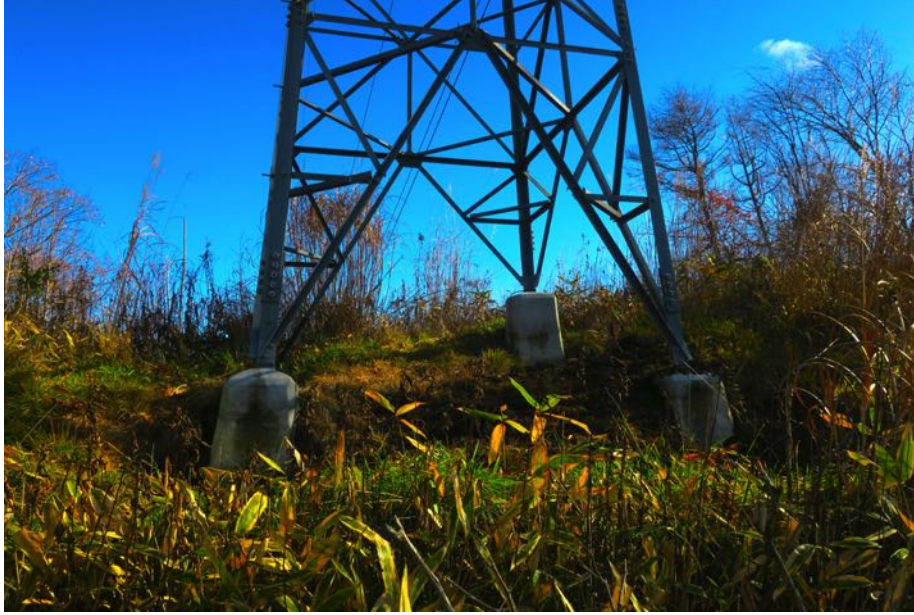
Figure 3-33. Head scarp beneath the tower in Figure 3-32 has exposed three of the four concrete piers

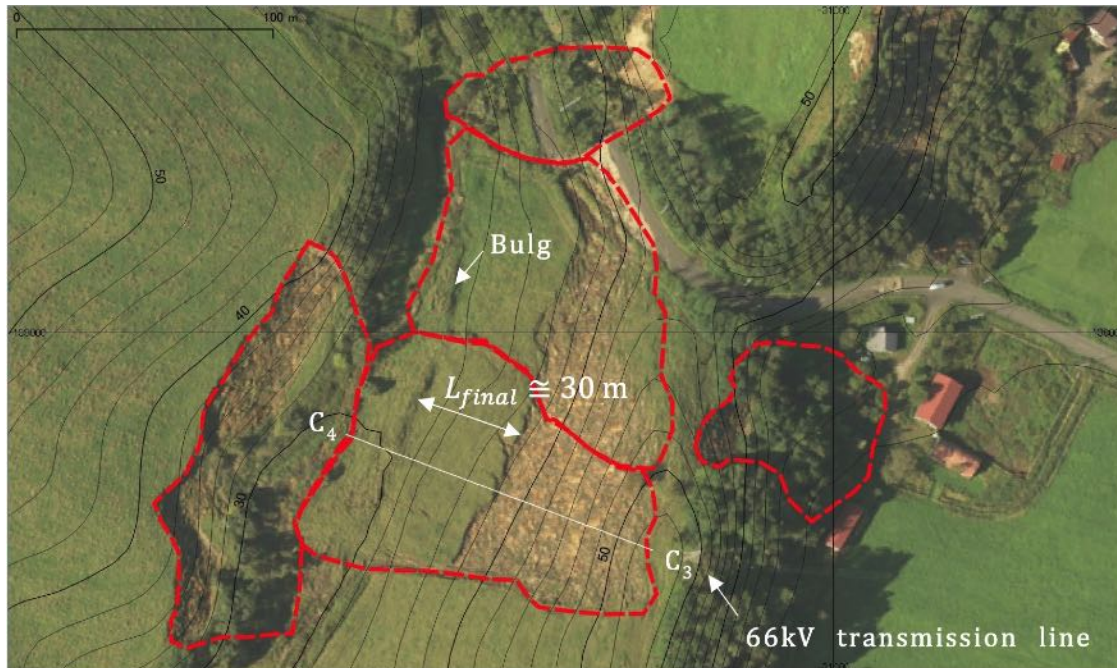
Coherent landslide mass compressed against the other side wall of valley¹⁾

Figure 3-34. Map of Landslide Area. The location of the tower in Figures 3-32 and 3-33 is indicated by the white arrow. (Ref: Konagai et al, 2018).

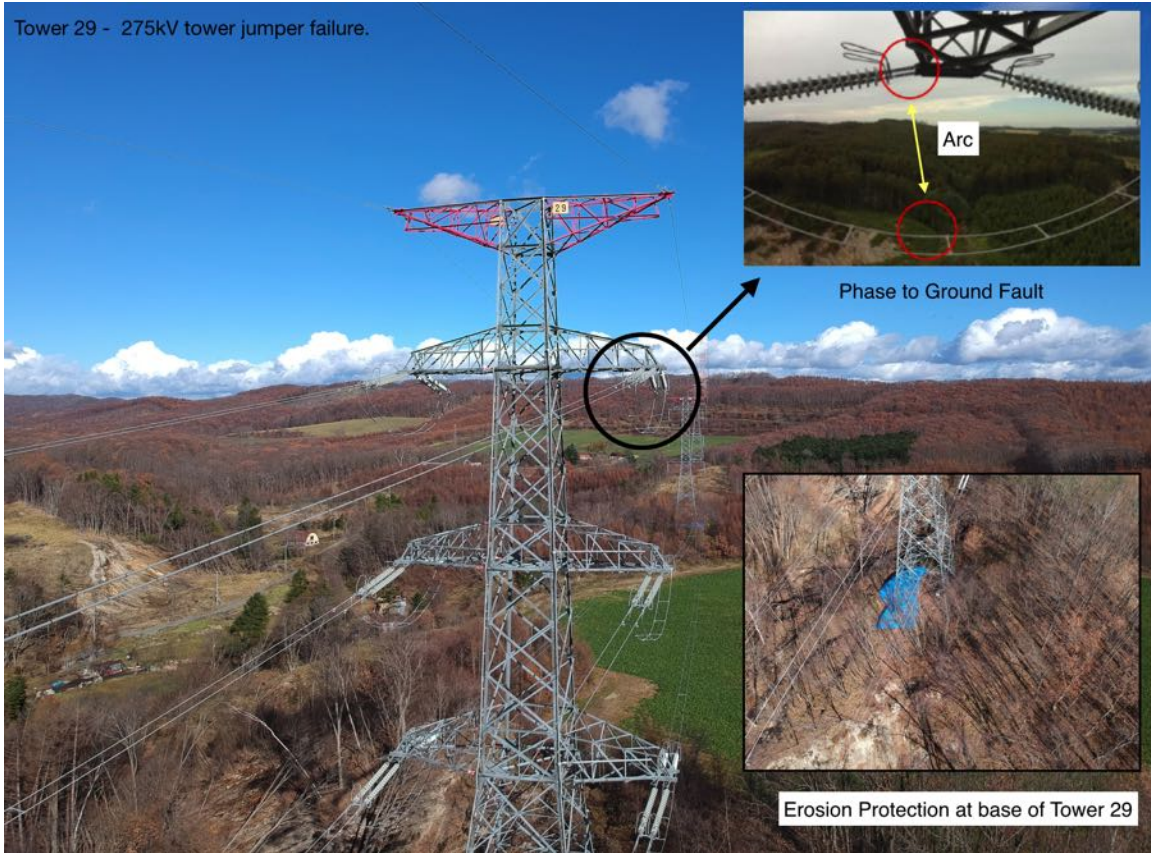
Figures 3-35 and 3-36 show Towers 26 and 29 on the 275 kV Karikatsu lines (see Figure 3-17 for location). The line jumpers and string insulators in the black circles moved during sufficiently during the earthquake to cause phase-to-ground faults.

Figure 3-36. Tower 29, Line Fault

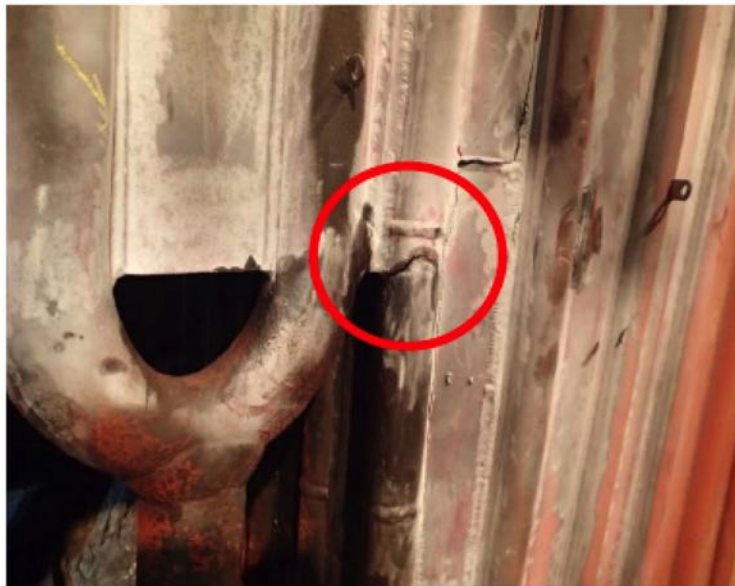
Unit 1: Boiler tube damage situation

Figure 3-39. Damage of Boiler Tubes Tomatoh-Atsuma Units 1, 2 (photos: HEPCO)

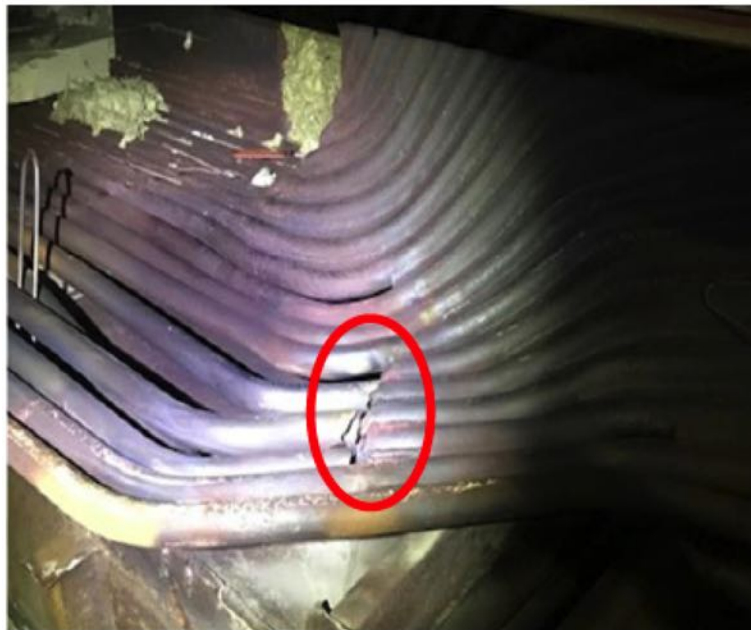
Unit 2: Boiler tube damage situation. ①

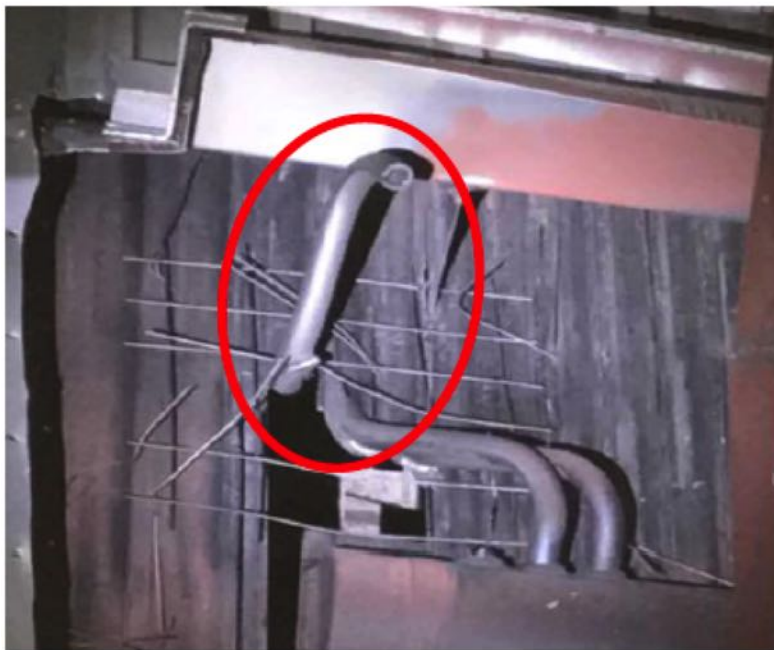
Unit 2: Boiler tube damage situation ②

Figure 3-40. Damage of Boiler Tubes Tomatoh-Atsuma Units 1, 2 (photos: HEPCO)

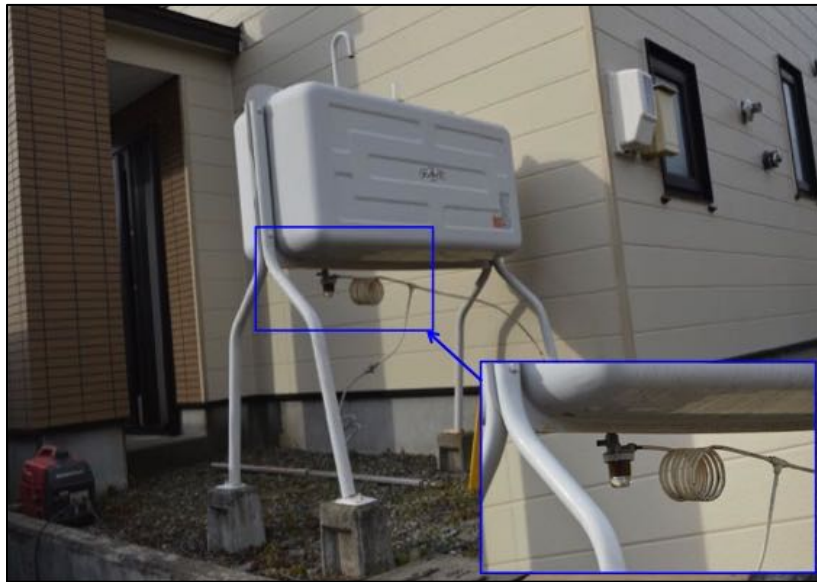
Figure 4-8. Kerosene tank outside of most residential buildings

areas with very strong shaking ($PGA > 0.5g$), we did not observe complete toppling of these tanks; but we did not inspect every building, so this failure mode cannot be ruled out. There were reports of broken lines connected to some of these tanks, and we did observe tilting of these tanks in areas subjected to liquefaction PGDs. The typical tank has a shut off valve installed. Some (but not all) tanks were observed to have a pig-tail pipe arrangement to allow for differential movements, see Figure 4-8. Figure 4-9 shows a typical installation of propane tanks for a residential building.

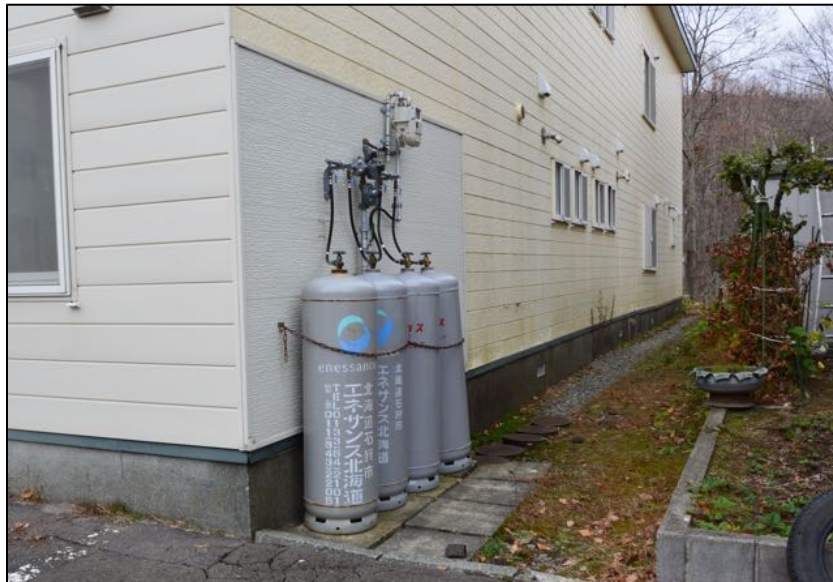
Figure 4-9. Propane tanks strapped to wall anchors. This household uses both gas and propane

For the most part, household propane tanks are vertically-standing tanks, generally up to 1.5 meters tall by up to 0.5 meters in diameter, strapped to anchors on the adjacent building wall, see Figure 4-9. If the building remained standing, there was little damage to the propane tanks. All the tanks we observed were chained, as in Figure 4-9; we did not see instances where the tank had both top- and bottom-level chains.

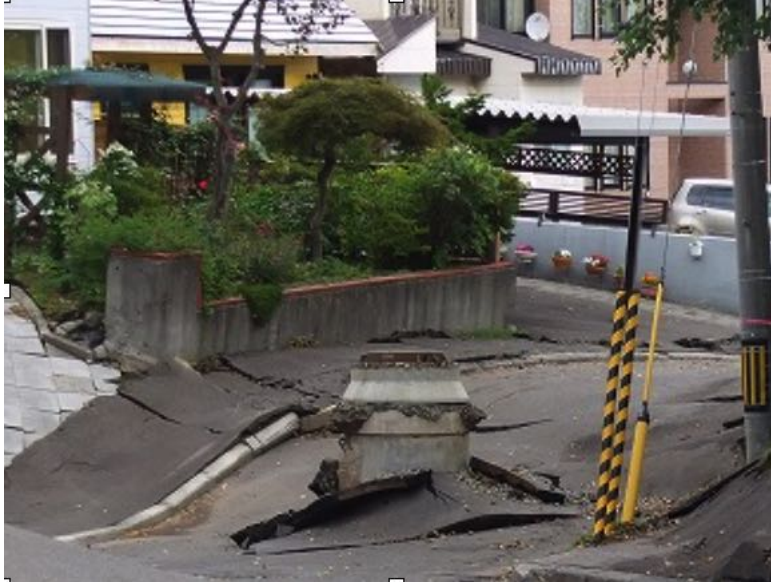
Figure 5-10. Manhole in Liquefaction Zone (credit: Kubota)

Figure 5-10 shows the relative vertical movements of a sewer manhole with the major settlement of the surrounding street. At depth, these relative movements will damage the sewer-to-manhole connection. In this area, inspection of the sewers showed major inundation by sand and debris.

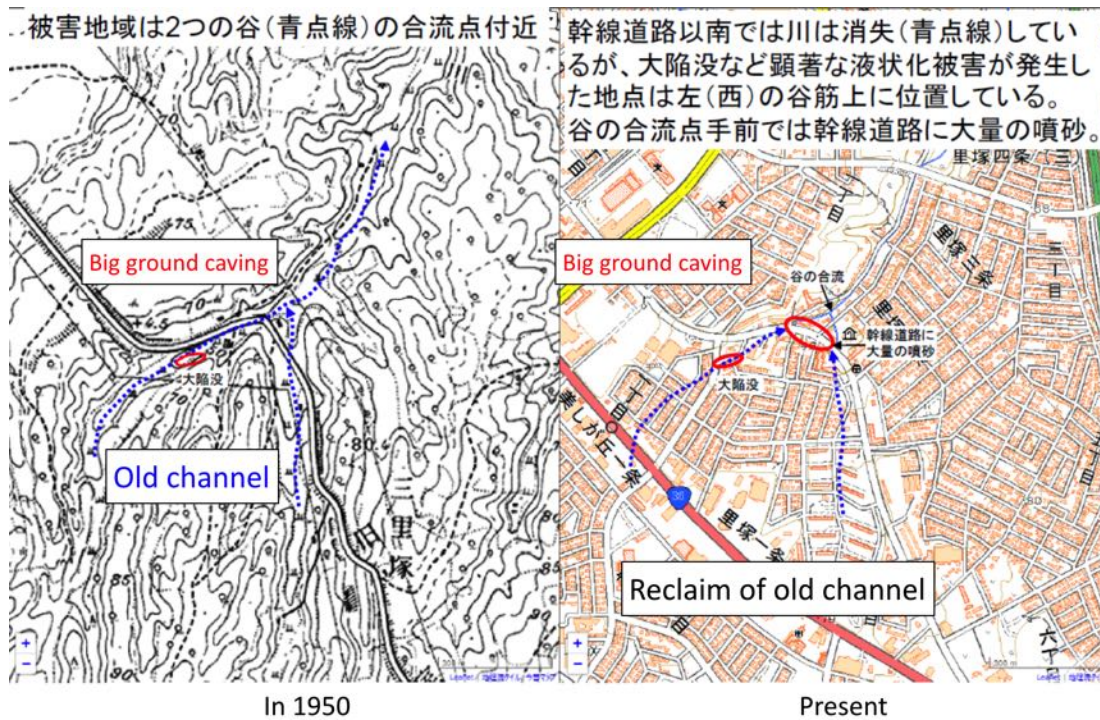
Figure 5-12. Historical Location of Drainage Channels (from [http://home.kanto-gakuin.ac.jp/~wakamatu/wakamatsu/reports/satozuka_report.pdf\(2018.9.28\)](http://home.kanto-gakuin.ac.jp/~wakamatu/wakamatsu/reports/satozuka_report.pdf(2018.9.28)))

Figure 5-12 shows historical (1950) and present day (2018) topographical maps of the area. The blue dashed lines are the historical drainage channels. The small red oval is at the same location as the black oval in Figure 5-9.
