HOKKAIDO, JAPAN, M_w 6.7 EARTHQUAKE OF SEPTEMBER 6, 2018 LIFELINE PERFORMANCE

The Council of Lifeline Earthquake Engineering
TCLEE No. 4

G&E Report R98.23.01 Revision 1, March 18 2019

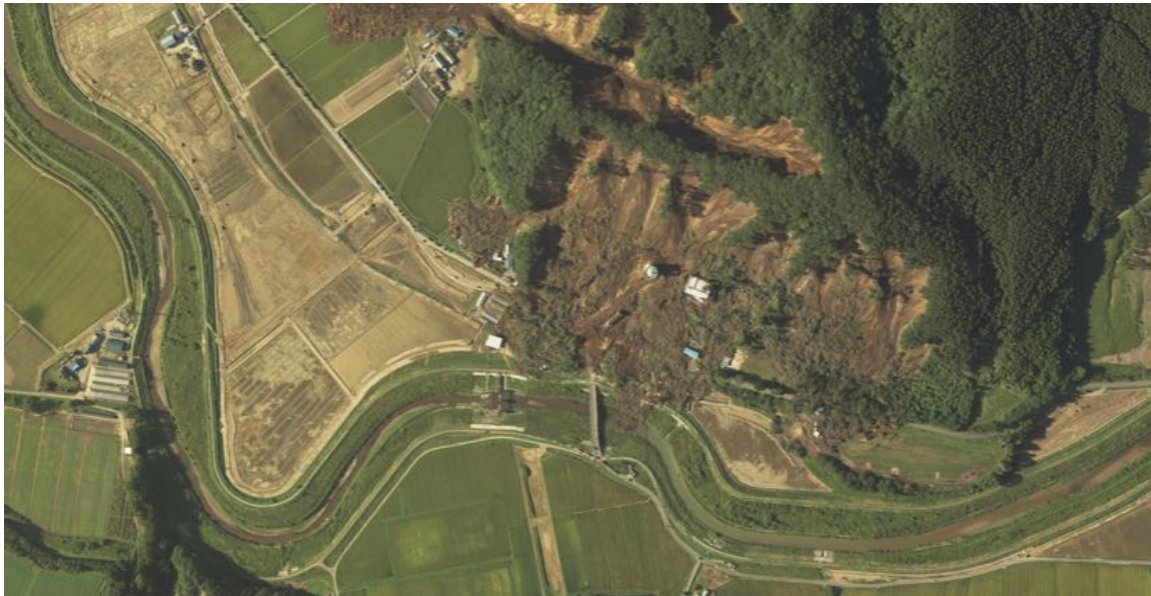
Figure 5-15. Landslide Impact on Atsuma WTP (credit: Google)

The earthquake triggered a landslide just behind (and to the north) of the WTP. The hillside to the immediate north of the WTP ranges in elevation from about 56 to 145 meters above sea level over a horizontal distance of about 100 meters, making the average slope about 40°. The landslide debris moved nearly horizontal about 200 meters, dropping over that elevation by about 10 meters, until it inundated the river to the south of the plant.

The landslide inundated the WTP. The debris of the slide impacted each of the structures. On the west (left side of Figure 5-14), debris hit the tank, forming a high debris scar on the up-hill side; the tank stayed in place. The debris hit the "stair building" used to access the roof of the tank; the building was pushed over 50 feet to the southwest, uprooting its pile foundation. The debris hit the water treatment plant building (filters, offices, etc.), inundating the building.

After the earthquake, the town of Atsuma restarted its older Shinmachi water treatment plant.

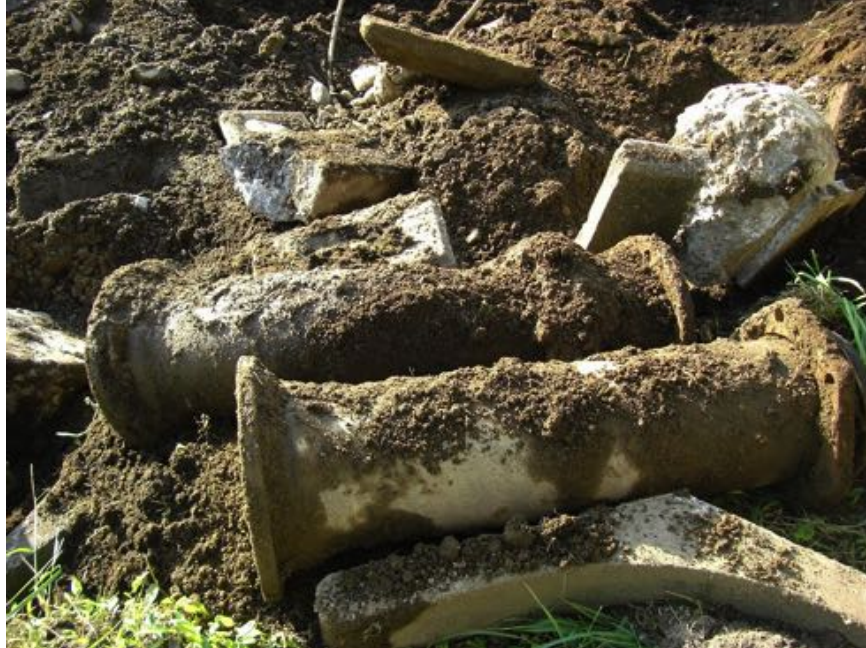
Figure 5-17. Removed Elbows of 200 mm DIP (credit: Kubota)

Within the town of Atsuma, there was also damage to buried water pipes. Figure 5-17 shows two removed 200 mm DIP pipe elbows (A-Type). Figures 5-18 and 5-19 show the location of a damaged 150 mm PVC pipe. The roadway failed (possibly an embankment slump), leading to the damaged pipe. Repairs were made using GX-type ER-DIP.

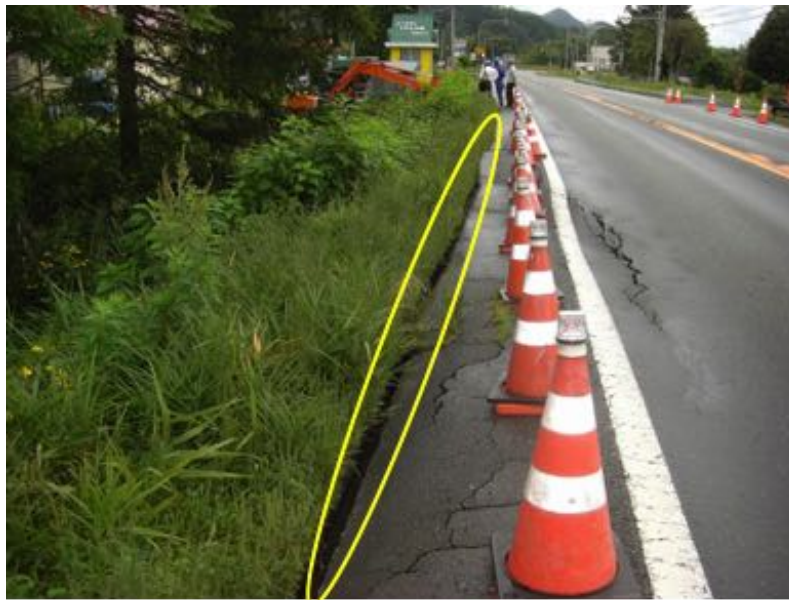
Figure 5-20. Slump of roadside embankment in Biratori-town (separation at edge of asphalt is about 5 inches) (credit: Kubota)

Figures 5-20 and 5-21 show the damage to a 150 mm K-type joint DIP in the town of Biratori.

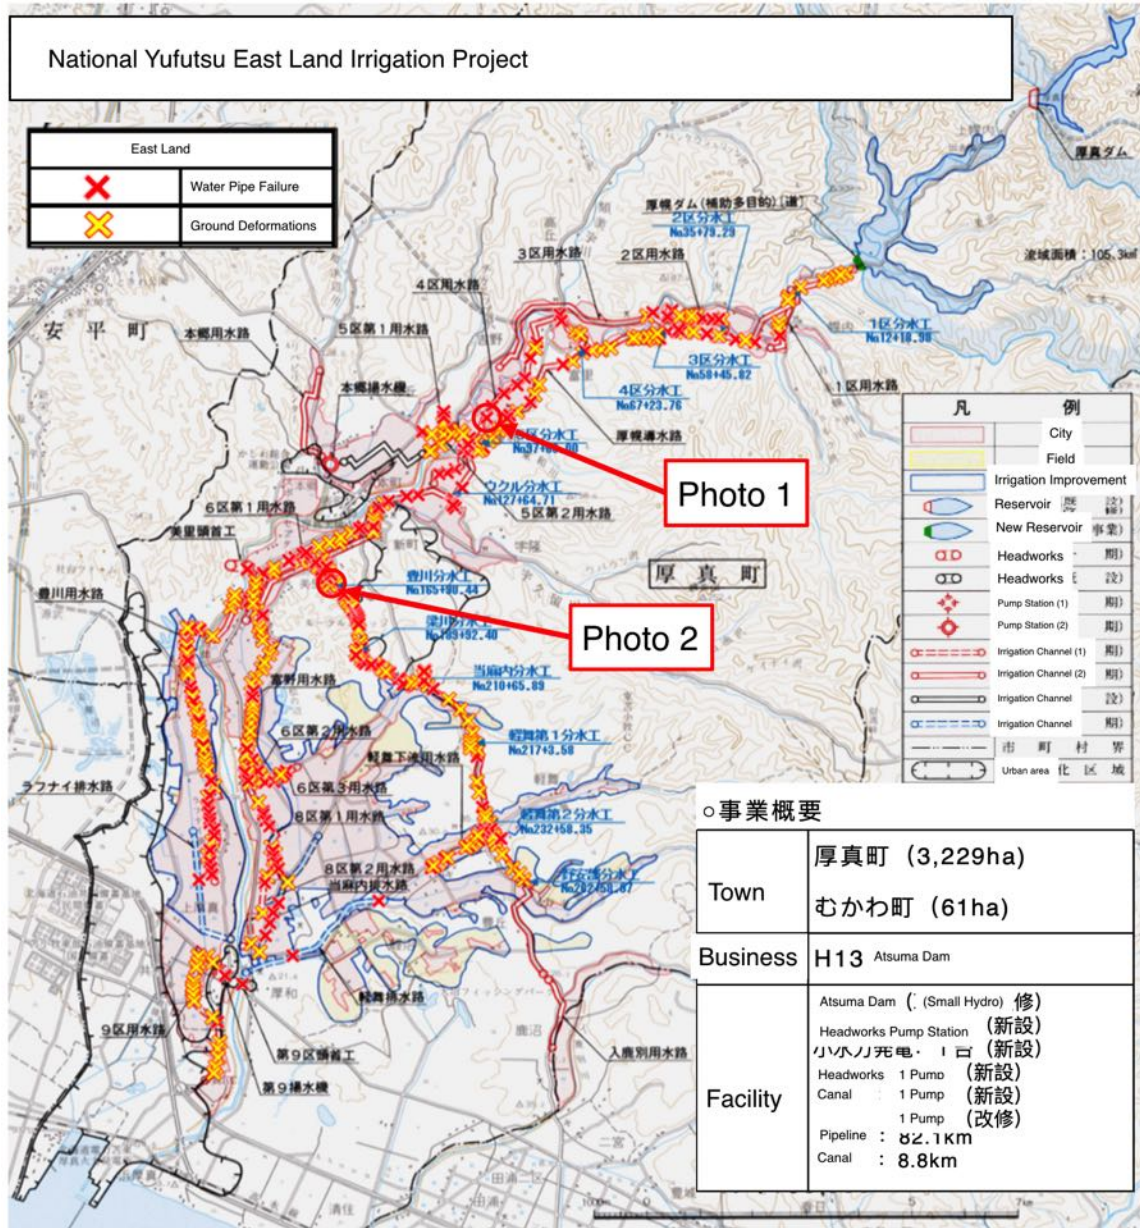
Figure 5-22. Atsuma Irrigation Project (Credit: MILT)

Figure 5-22 shows a map of the upper Atsuma and lower Apporo reservoirs (top right) and the downstream pipelines. The red "X" locations show where the pipelines were

damaged. The yellow "X" locations show where there was ground deformations observed at the surface. The estimated cost to make all the repairs is about \$185 million USD (20,500,000,000 Yen). Figures 5-23 and 5-24 show the ground deformations at the locations called "Photo 1" and "Photo 2" in Figure 5-22.

The total number of repair locations was about 100. The repair rate is about $100 / 90.7 \text{ km} = 1.1$ per km. Assuming that 25% of the area underwent 2 inches of settlements, then the forecast number of repairs would be (using the backbone fragility model for rubber gasketed pipe, $k_2 = 1.0$): $RR = 1.06 * (2)^{0.319} = 1.32$ repairs per 1,000 feet. This suggests that about $(100 / 1.32) * 1000 = 76,000$ feet (23 km of the 82.1 km) of the alignment underwent some type of ground deformation. Given the widespread observations of some surface manifestation of PGDs (large number of yellow "X"s in Figure 5-14), it might be suggested that k_2 for rubber gasketed GRP is less than 1.0. Alternatively, if the pipes were buoyant (the pipes are under gravity flow and not entirely filled with water), then the liquefaction in the area would have tried to float the pipes, which also would result in a great amount of damage, as clearly the pipe joints are unable to sustain much differential movements.

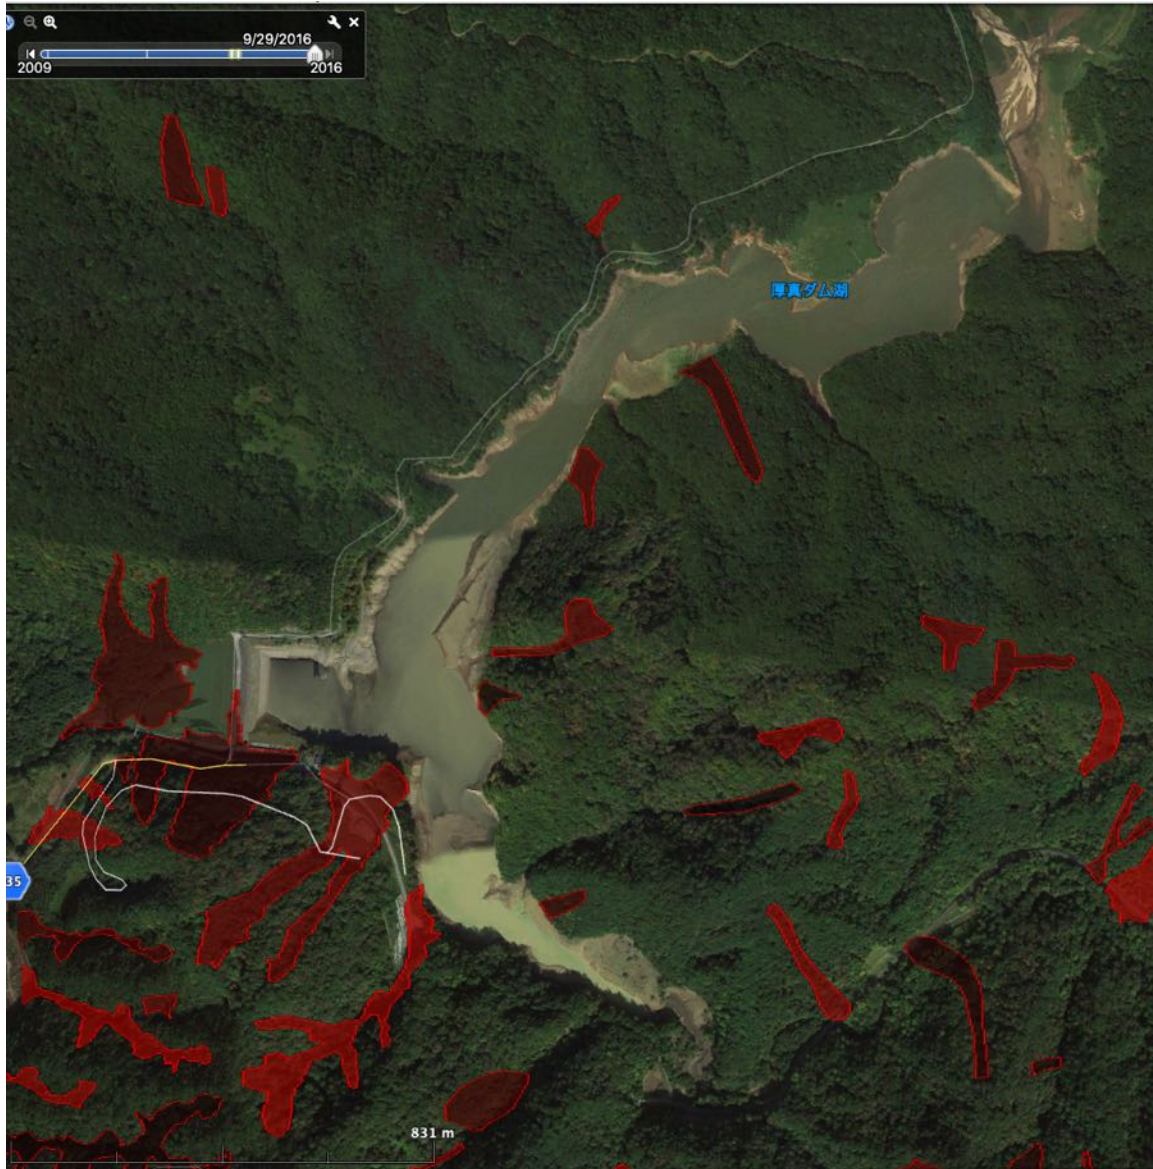
Figure 5-25. Landslides (Red highlighted areas) Near Upper Atsuma Reservoir

Figure 5-25 shows the extent of landslides around Atsuma Upper Reservoir. Three landslides (red zones) were mapped directly adjacent to the waters of the reservoir. A large landslide at the south abutment of the earthen dam deposited a lot of debris into the concrete-lined spillway. Removal of this debris was a priority of the MILT TEC force teams in the days immediately after the earthquake, Figure 5-26.

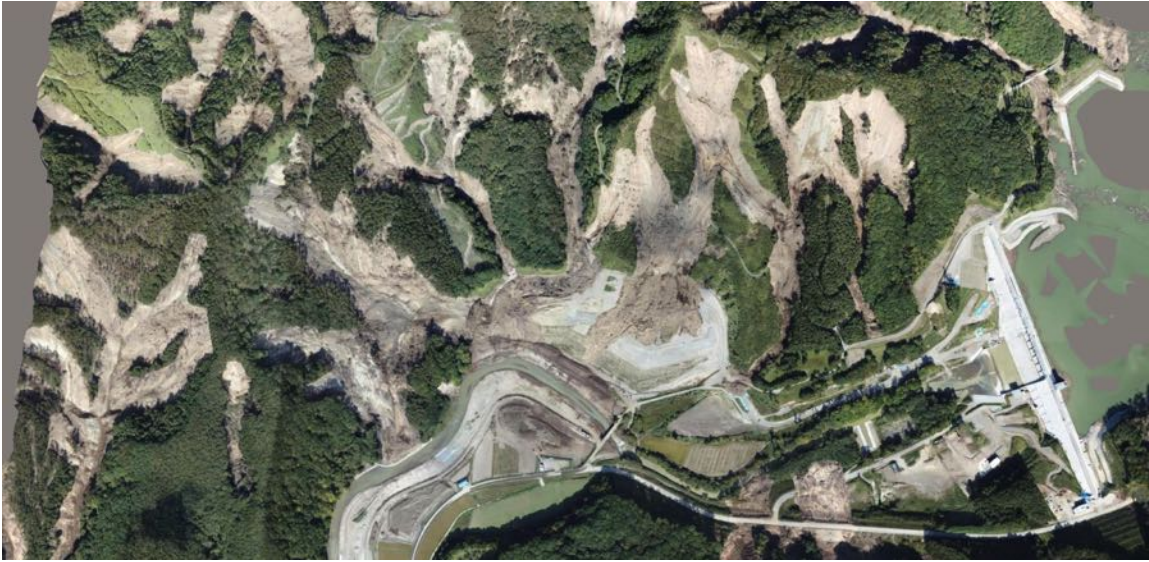
Figure 5-27. Landslides (Scar Areas) Below Lower Atsuma Reservoir (Credit: GEER)

Figure 5-27 shows an aerial view of the area immediately downstream of the Apporo Lower Reservoir (see Figure 3-19 shows a GIS-based map of these landslides). The light areas show the scars on the hillsides from earthquake-induced landslides. The water in the reservoir (right of the concrete gravity dam) is turbid. About 50% of the hillsides slid in this area.

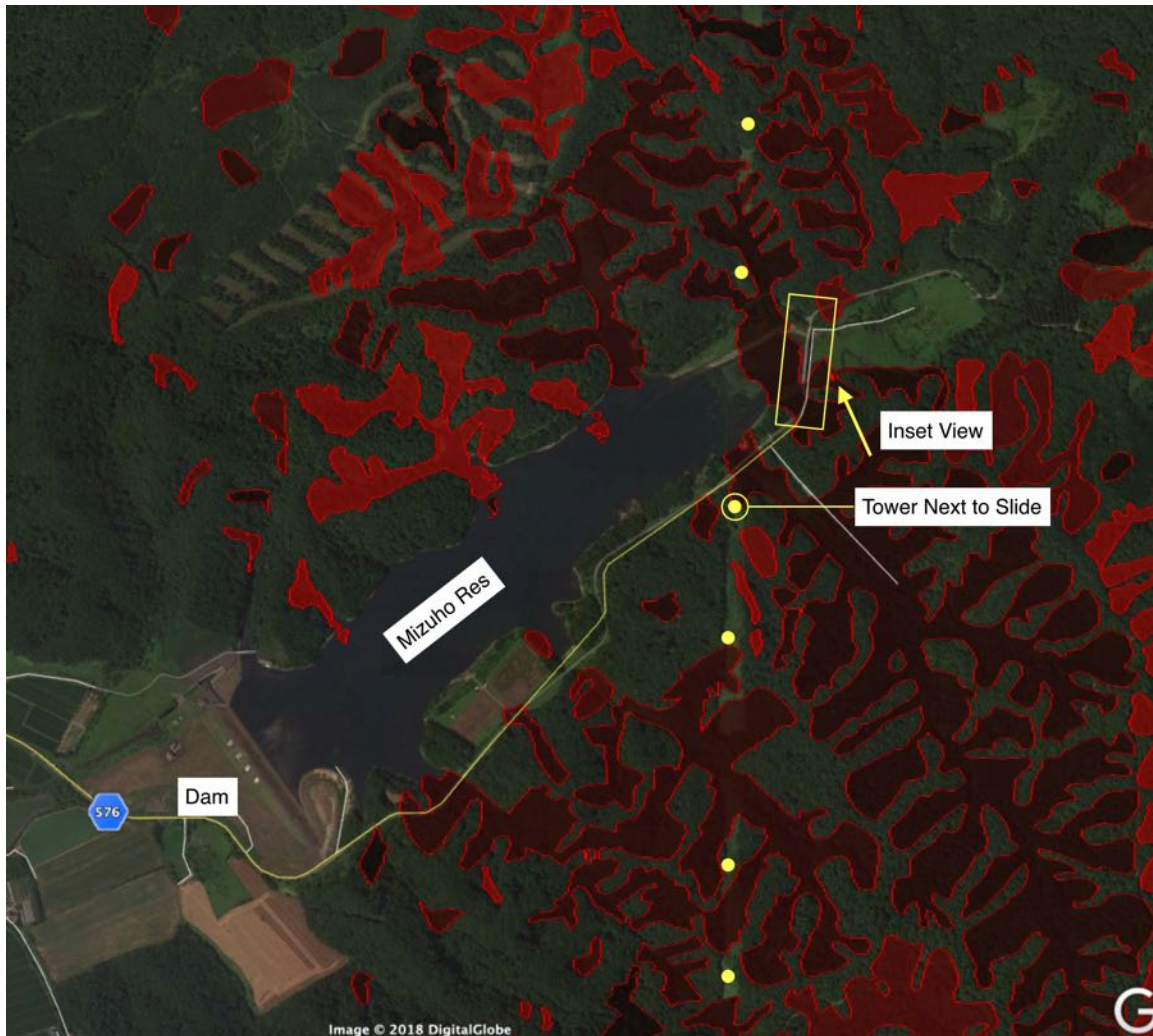
Figure 5-28. Landslides (Scar Areas) Near Mizuho Reservoir (latitude 42.8469, longitude 141.9123)

Figure 5-28 shows landslides near Mizuho Reservoir. The yellow dots are the locations of towers supporting twin 275 kV transmission lines, and the circled dot is the location of a tower that is immediately adjacent to a landslide. Red polygons show locations with major earthquake-induced landslides, of which 8 separate slides inundated the reservoir. The yellow rectangle shows the location of the bridge seen in Figure 5-29. The two yellow dots above and to the left of the rectangle are transmission towers with bases *outside* the mapped landslides, as seen in Figure 5-29.

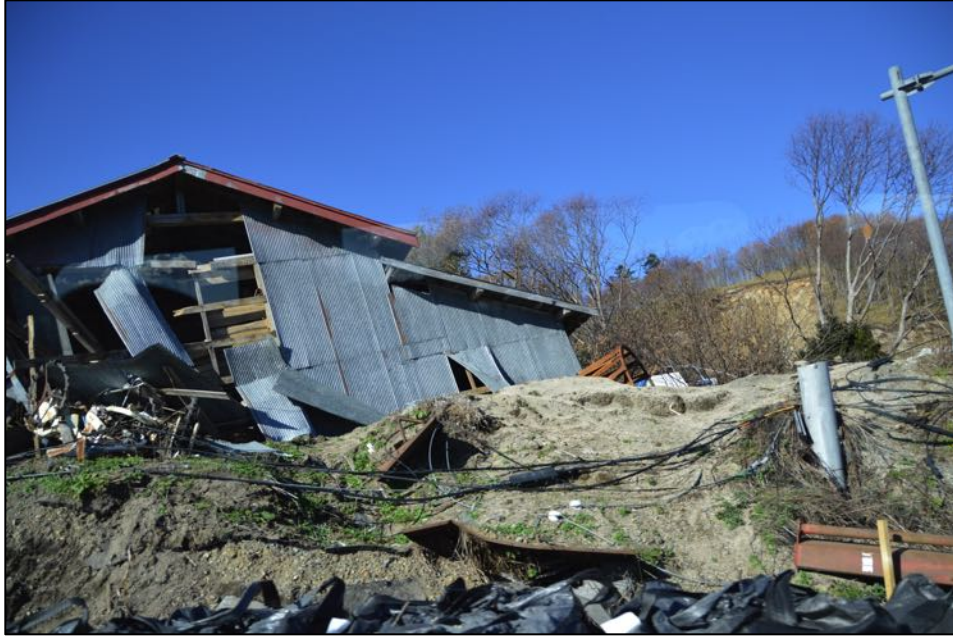
The landline network sustained significant damage in this earthquake due to the extensive landslides that destroyed the utility poles burying both copper and optical fiber cables with mud, sand and debris. Figure 6-2 shows one of the many examples of landslide that destroy the cable links.

Figure 6-2. Telecom poles and cables (metal and fiber) destroyed by debris

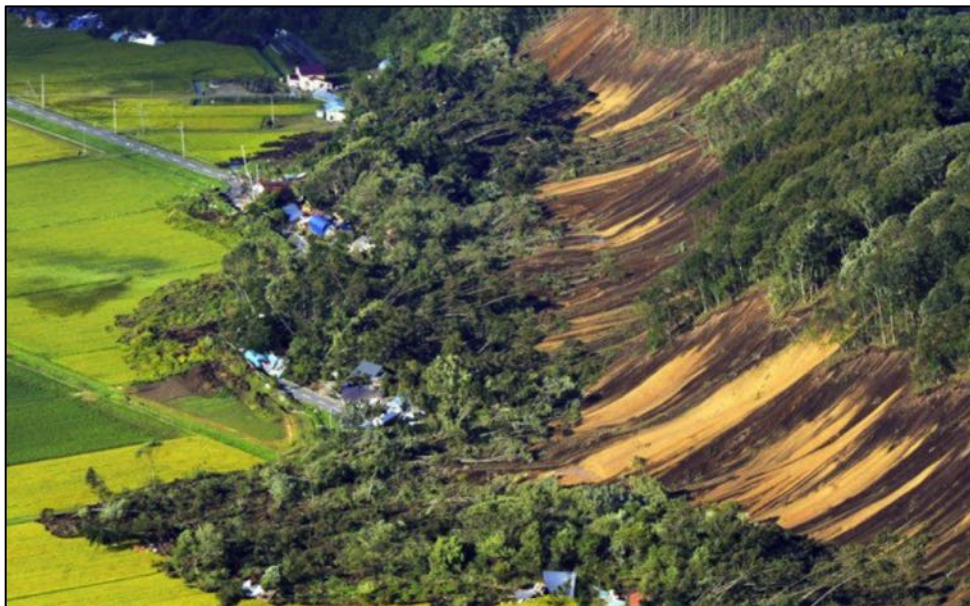
Figure 6-3. The massive landslide destroyed the road and the utility poles for both power and telecom connections. (Credit: Masataka Shiga)

Figure 6-3 shows the link was discontinued by one of the large landslides. This is just one of many landslide locations in this area where there was considerable destruction of poles that carry the links needed to provide connectivity to Remote Offices and Exchange Offices, which process calls.

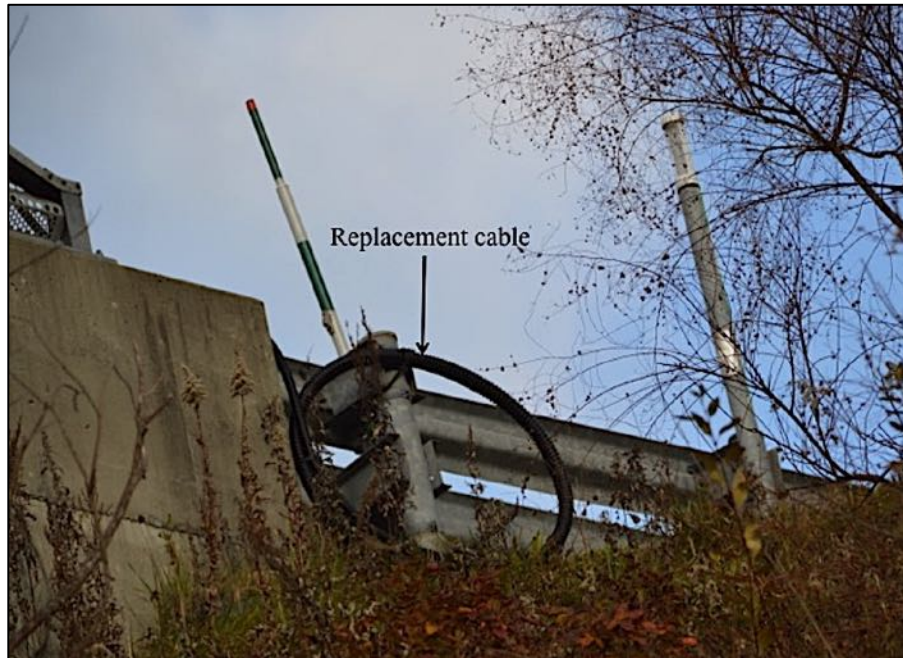
There was a report of an optical fiber cable damaged at the abutment of a bridge on the Hokkaido Expressway. The location of this bridge is N42.9143°, E141.9212°. The expressway was open to traffic during our visit and there was no safe place to stop for close up inspection. A photo was taken with the apparent replacement cable on the bridge. Figure 6-4 shows the cable bundle, the loop radius suggested that the cable is optical fiber. There was evidence of ground deformation at this location, Figure 6-5.

Figure 6-4. Replaced cable temporarily strapped to the guard rail of the expressway

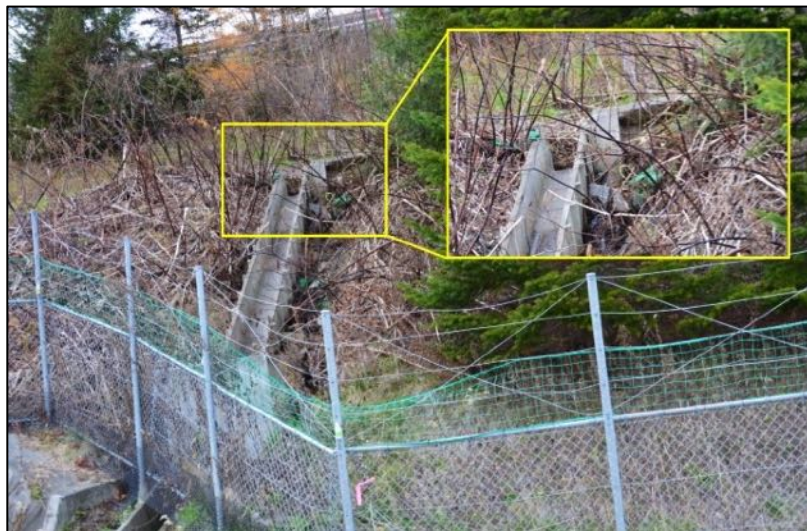
Figure 6-5. Evidence of ground deformation at the abutment area, ~ 30 cm displacement of the drainage channel.

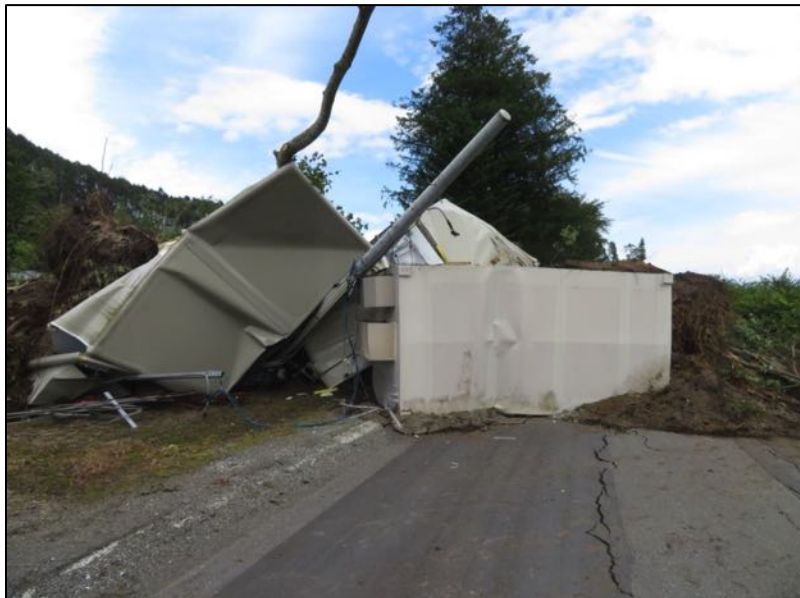
Chapter 5 for details of the water treatment plant). This is one of the key nodes that link the telecom landlines to the network. Figure 6-6 shows the original Remote Office structure prior to the earthquake. Figure 6-7 shows the office that was destroyed by the landslide.

Figure 6-7. Remote Office destroyed by landslide. (Source: Prof Suzuki of Toyo University)

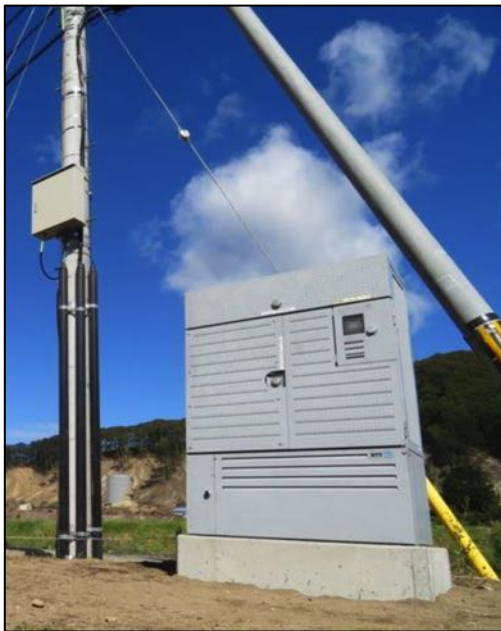
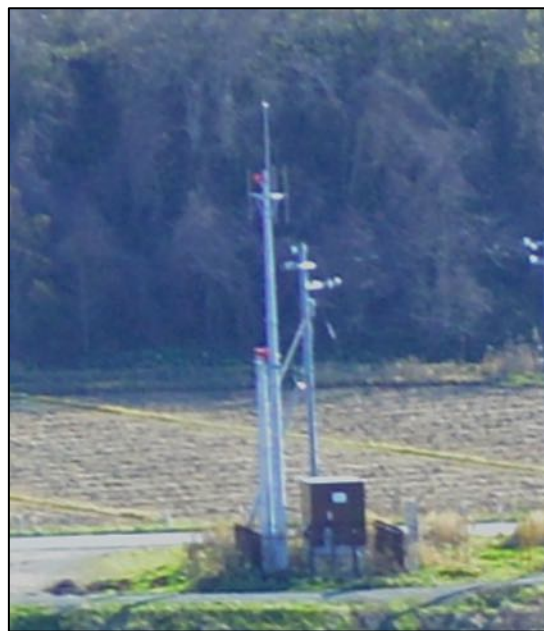
Figure 6-8. The new DLC cabinet, note the water tank of the WTP after the landslide (Source: Prof Suzuki of Toyo University)

Figure 6-9. View of the cabinet from the ruins of the WTP, note fence was added

As a temporary service restoration NTT East installed a DLC (Digital Loop Carrier) cabinet, which used both copper and fiber to connect the area to the network, Figures 6-8 and 6-9. This was also the approach used after the Great East Japan Earthquake and

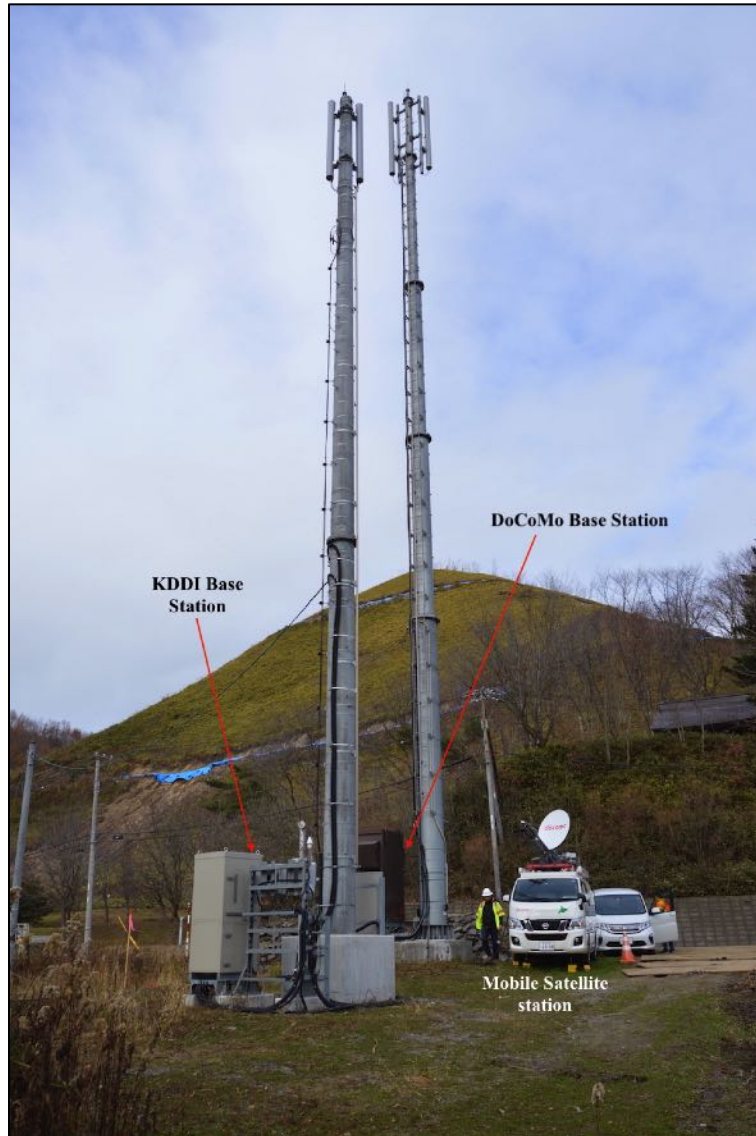
Due to landline damage at one of the Base Stations in Atsuma, a mobile satellite unit was deployed to connect the Base Station to the network, Figure 6-11. This photo was taken after power was restored; therefore the NTT mobile generator unit was no longer on site. The DoCoMo Base Station was installed in 2010, while the KDDI Base Station was installed in 2017.

Figure 6-11. Mobile Satellite station was used to link this Base Station to the network

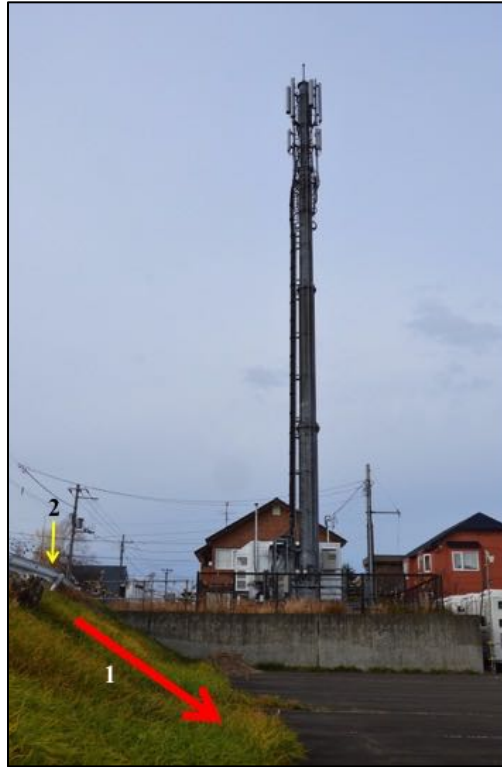
We visited one Base Station site (Figure 6-13) in Sapporo close to Kiyota Ward, which had major liquefaction problem (see Chapter 5 for a description of the liquefaction issues in Kiyota Ward). The Base Station in Figure 6-13 belongs to DoCoMo and is on the edge of small hill. The retaining wall built around the Base Station did not have any sign of failure. The slope next to the Base Station was not protected. It showed a small amount soil spreading down at the lower edge by the parking lot. The guard rail along the top of the slope (Figure 6-14) indicated some ground movement causing the guard rail deformed and twisted with one bracket bolted to the retaining pole broken (Figures 6-15 and 6-16). The Base Station was not affected. Based on the size of the Base Station housing, batteries might have been used to power the equipment for short duration power outage.

Figure 6-13. This site shows a slight slide (1) of surface soil covering part of the parking lot. The guard rail pole (2) was rotated.

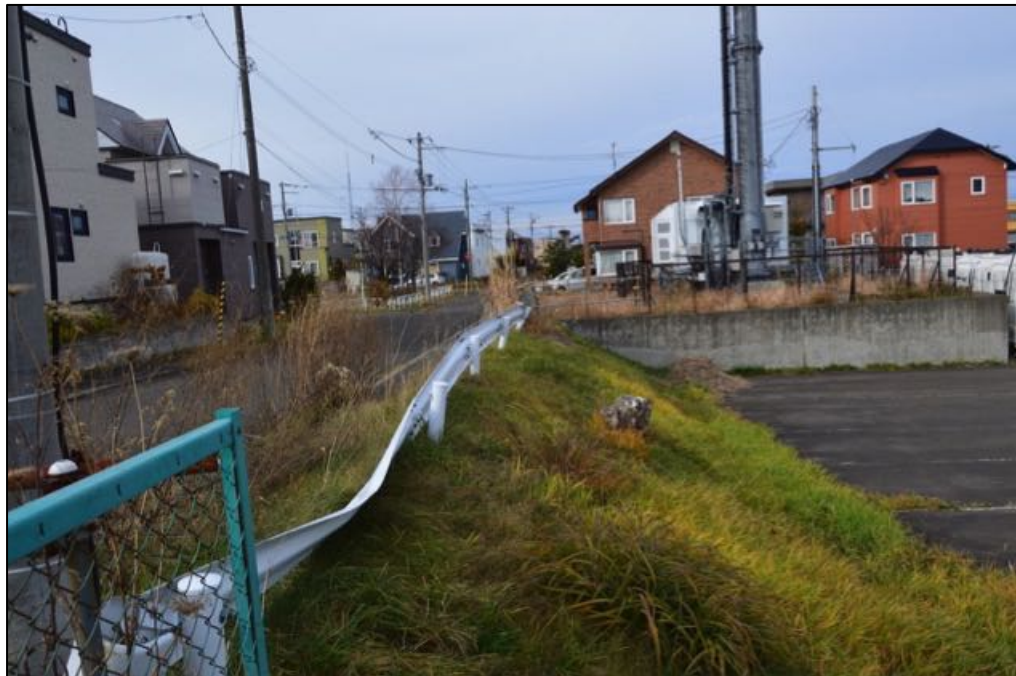
Figure 6-14. Guard Rail twisted and support poles rotated

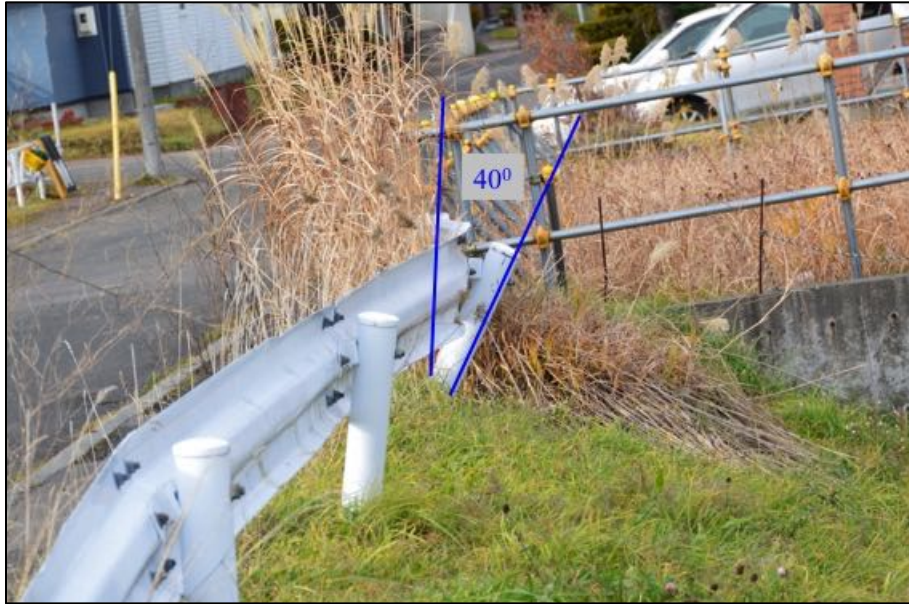
Figure 6-15. The support pole rotated about 40° .

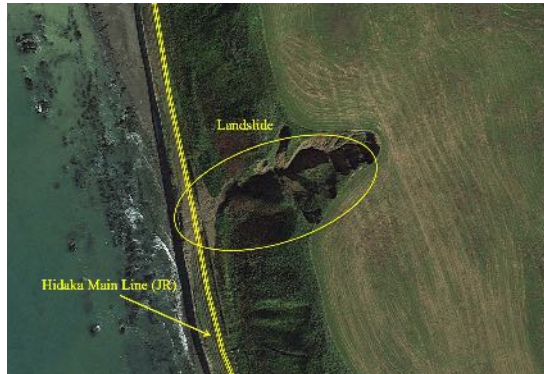
*Figure 7-5. Landslide damaged the Track.
(Source: Google Earth)*

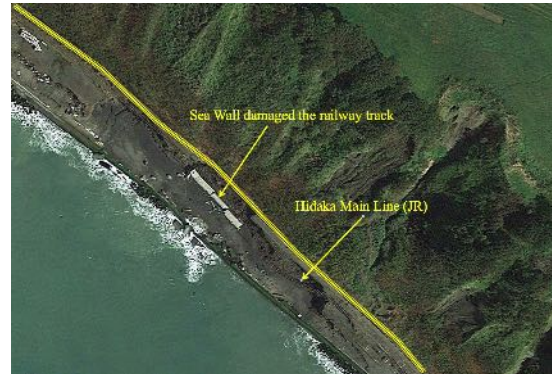
*Figure 7-6. Wave damaged the sea wall,
then the sea wall damaged the track.
(Google Earth)*

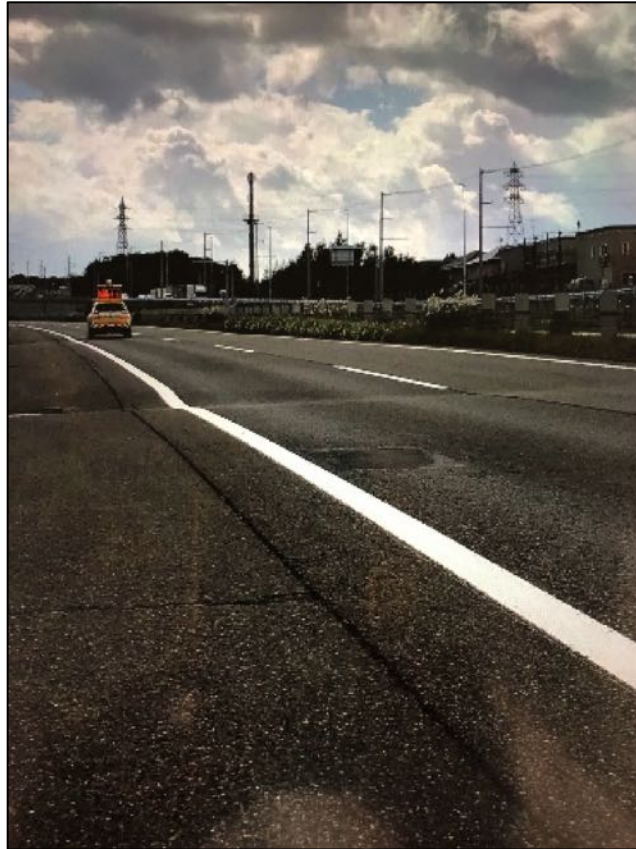
Figure 7-18 shows the damage sustained by the expressway, which was quite minor. The major damage to the expressways was road surface cracks and road subsidence. The damage to bridge was confined to one bridge where the abutment settled and the movement damaged an optical fiber cable (Figure 7-19) that was co-located with the bridge deck. The location of the Kita-Hiroshima IC was 42.9885° , 141.4704° . The location of the optical fiber damage was 42.91428° , 141.9212° .

*Figure 7-18. Road surface crack close to toll booth at Kita-Hiroshima Interchange.
(Credit: Prof Maruyama)*

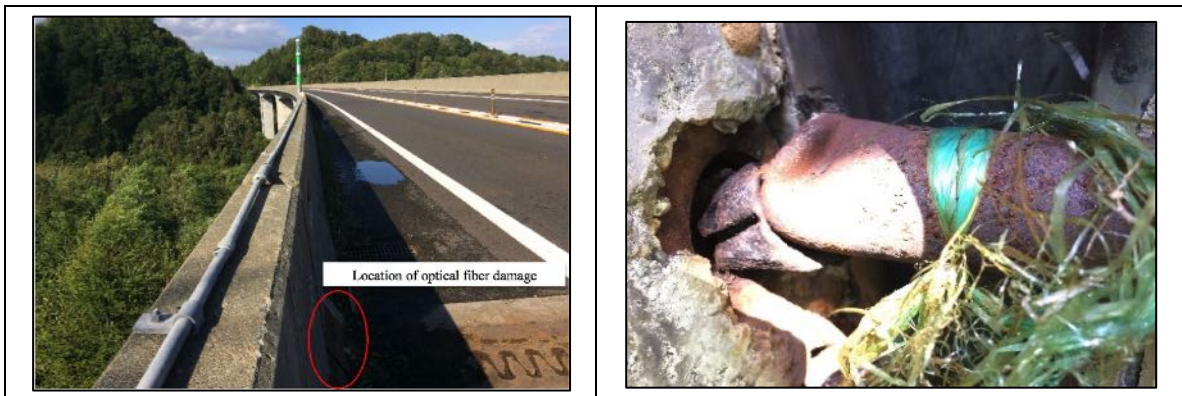
The major damage to the expressways were road surface cracks and road subsidence. One bridge was damaged where the abutment settled and the movement damaged an optical fiber cable that was co-located with the bridge deck.

Figure 7-19. The photo on the left shows the location of the optical fiber damaged on this bridge, the left photo shows the close up view the damage conduit. The location is west of Chitose-higashi. (Credit: Prof Maruyama)

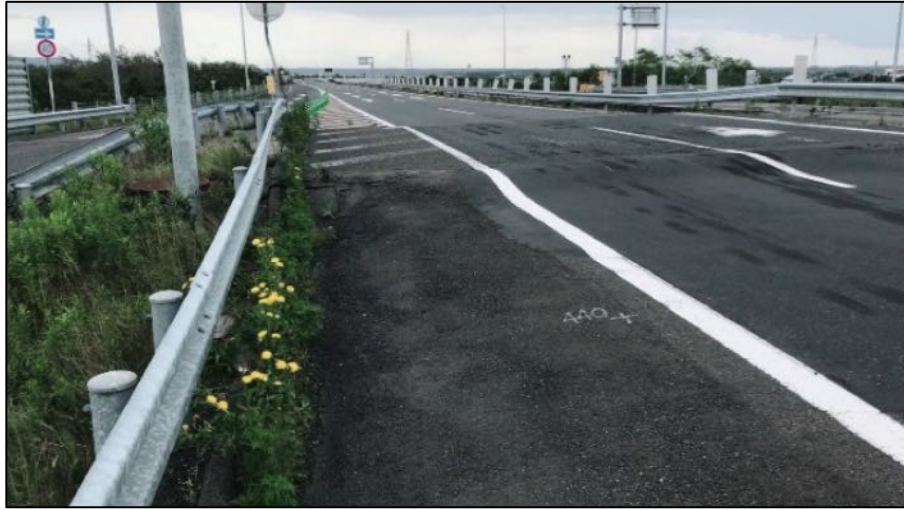
Figure 7-21. Mukawa Interchange area road surface damage. (Credit: MLIT)

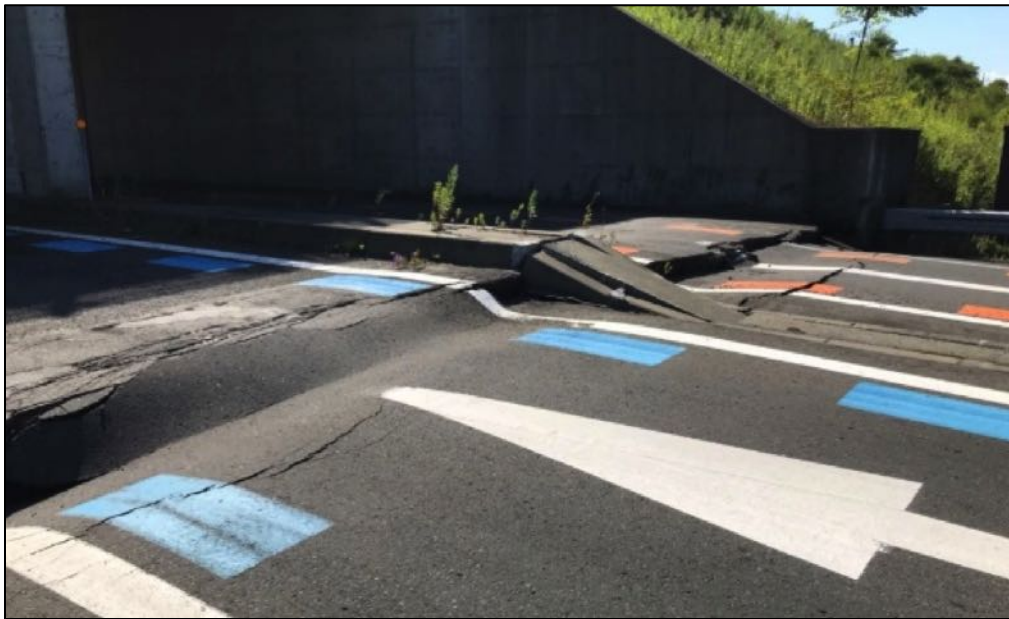
The damage of the road surfaces is shown in Figures 7-21 and 7-22.

Figure 7-22. Mukawa Interchange road surface just beneath the overpass (Credit: MLIT)

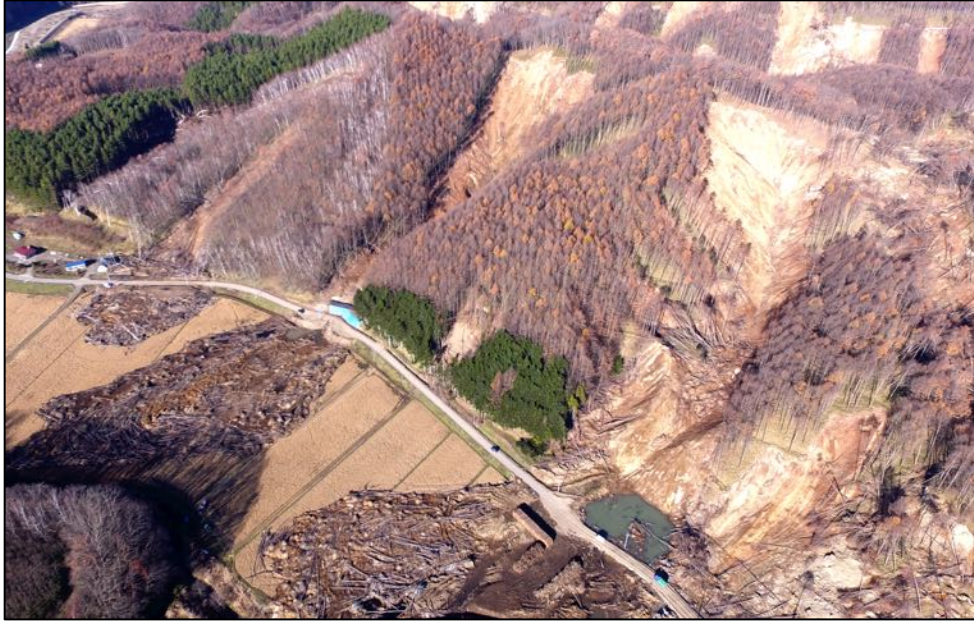
In the major landslide areas west of Atsuma, road damage was caused mainly by debris covering the road or mud carrying trees and other large objects pushed the road over. The repair to open these roads were very labor intensive. Figures 7-23 to 7-24 give a general idea of the intensity of the material covering the roads and the number of locations.

*Figure 7-23. Three locations on this secondary road were covered by landslide. The one on the right is the largest. The road surface was not repaved as of mid-November 2018.
(Source: Masataka Shiga)*

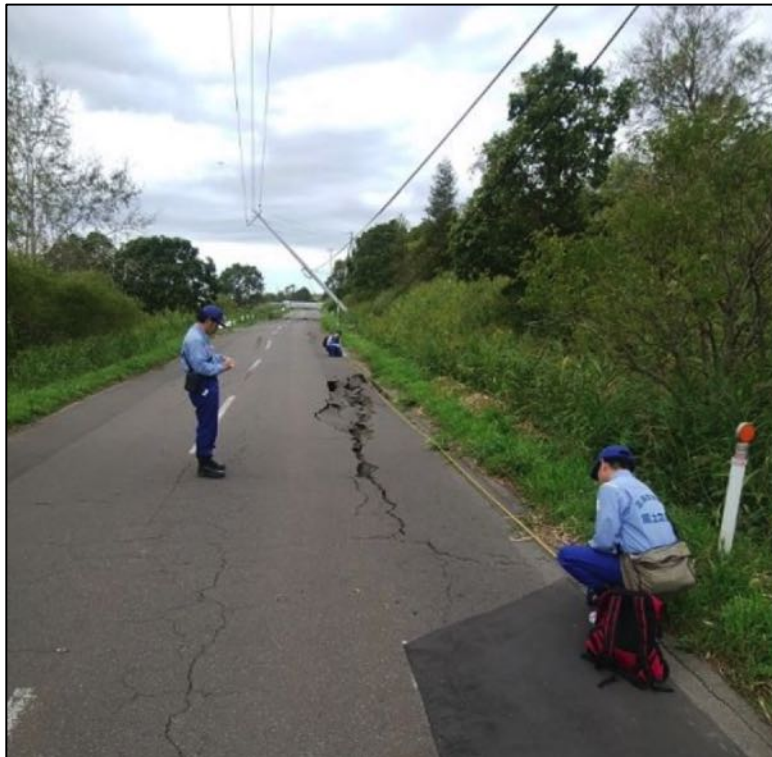
Figure 7-26. TEC-Force at damaged sites performing a quick evaluation to plan the recovery. (Credit: MLIT)

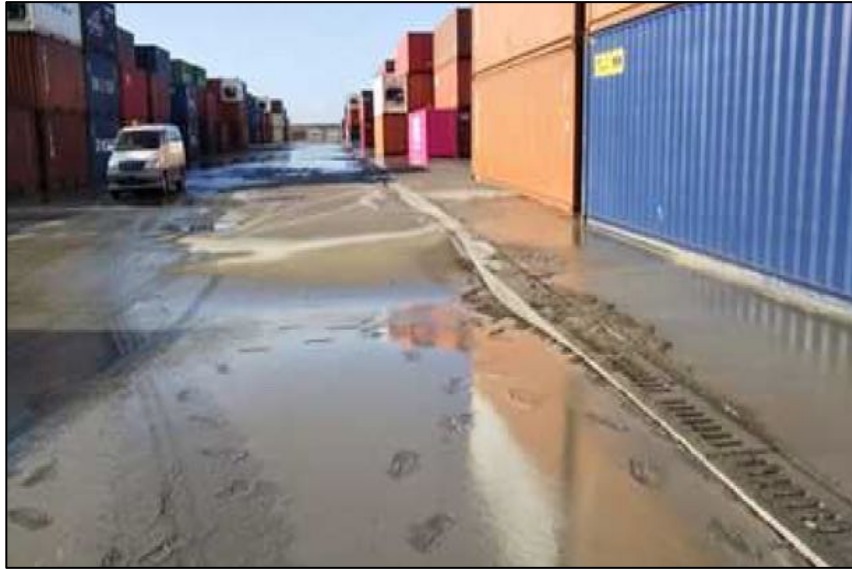
Figure 8-5. Liquefaction at the International Container Port (Source: MLIT)

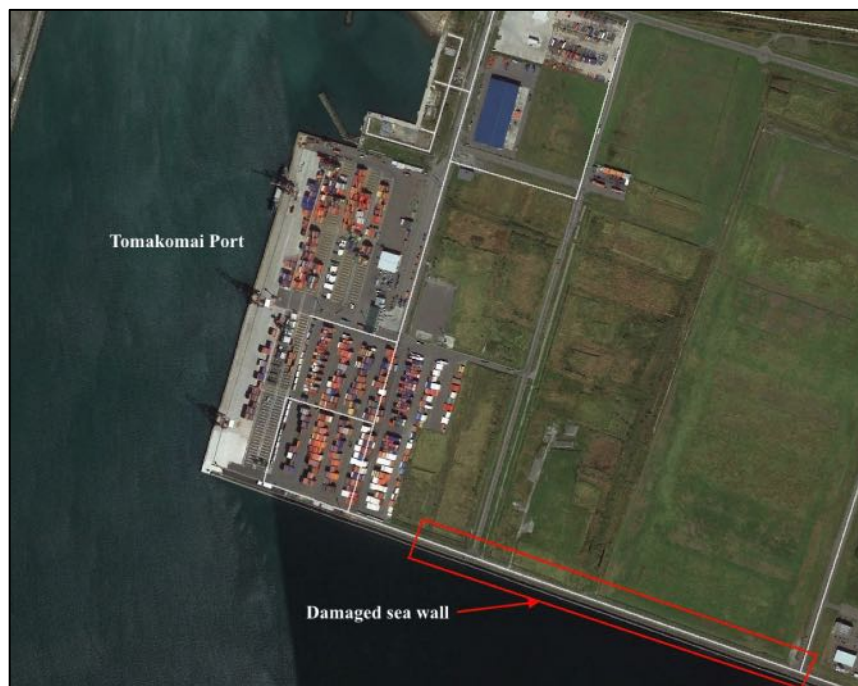
Figure 8-6. Tomakomai-Atsuma International Container Port. (Source: Google Earth)

The International Container Port is very close to the seawall that sustained extensive damage due to permanent ground deformation) and liquefaction. Figure 8-6 shows the location of the seawall with respect to the port. Figure 8-10 shows the aerial view of damage. Figure 8-11 shows damage to the quay wall for the pier at the power plant.

The sea wall shown in Figure 8-6 did not perform well. The primary function of this wall is to deflect potential incoming tsunami (there were no tsunamis caused by this onshore crustal earthquake). There was substantial liquefaction in the area immediately north of this sea wall, as evidenced by many widespread sand boils. The land at an industrial factory located immediately north of this sea wall suffered differential settlements, possibly aggravated by the movement of the sea wall.

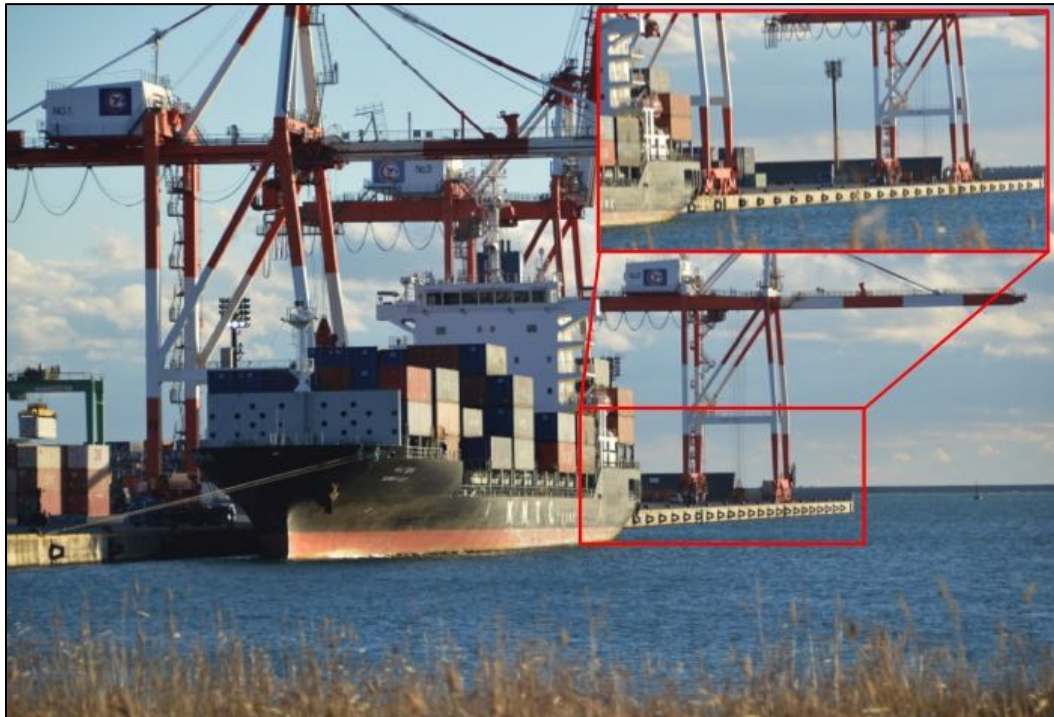
There was no report of significant Ports damage. The largest port that is closest to the epicenter is Tomakomai-Atsuma East Port, about 15 km south-west of the epicenter ($PGA \sim 0.25g$); there was no sign of quay damage (Figure 8-9) and it was in full operation by mid-November. The Tomakomai-Atsuma West Port ($PGA \sim 0.25g$) did not sustain structural damage from this earthquake; there were two places at the Container Ports that had liquefaction in the container storage areas. The sea wall to the south-east of the Tomakomai-Atsuma power plant (Figure 2-18) sustained significant damage due to liquefaction ($PGA \sim 0.35g$). A pier serving the Tomakomai-Atsuma power plant ($PGA \sim 0.35g$) sustained some damage (Figure 8-12), as evidenced by some lateral offset of the pier; as of the time of writing this report, under-pier investigations had not been performed to ascertain the cause(s) of this damage. The Ishikari and Otaru ports west of Sapporo ($PGA < 0.05g$) suffered no damage.

Figure 8-9 shows the port pier at Tomakomai; it was not damaged and a container ship is unloading container at the time. The cranes did not sustain any damage.

Figure 8-9. Tomakomai-Atsuma East Port

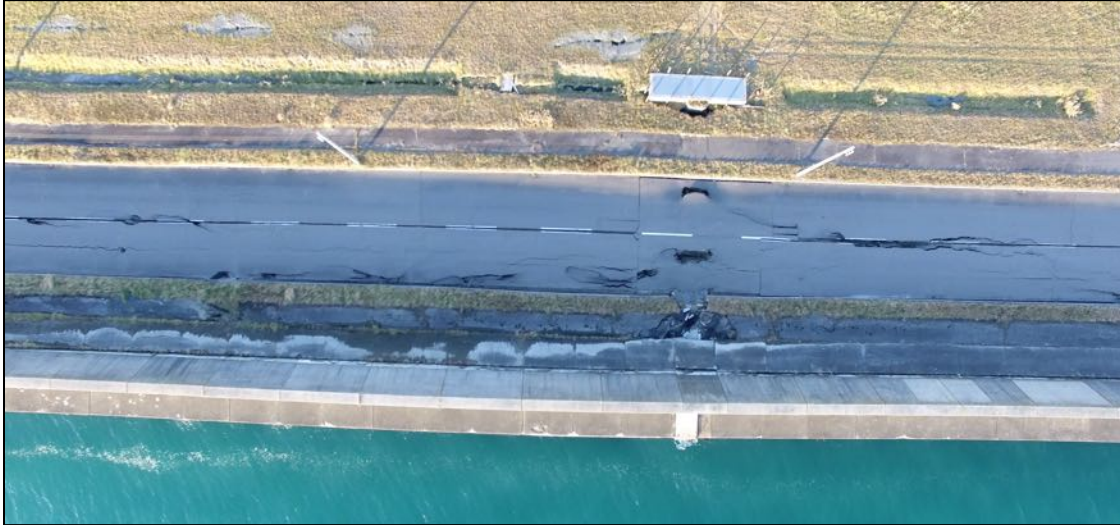
Figure 8-10. Aerial view of damage to the road and part of the seawall. (Source: Masataka Shiga)

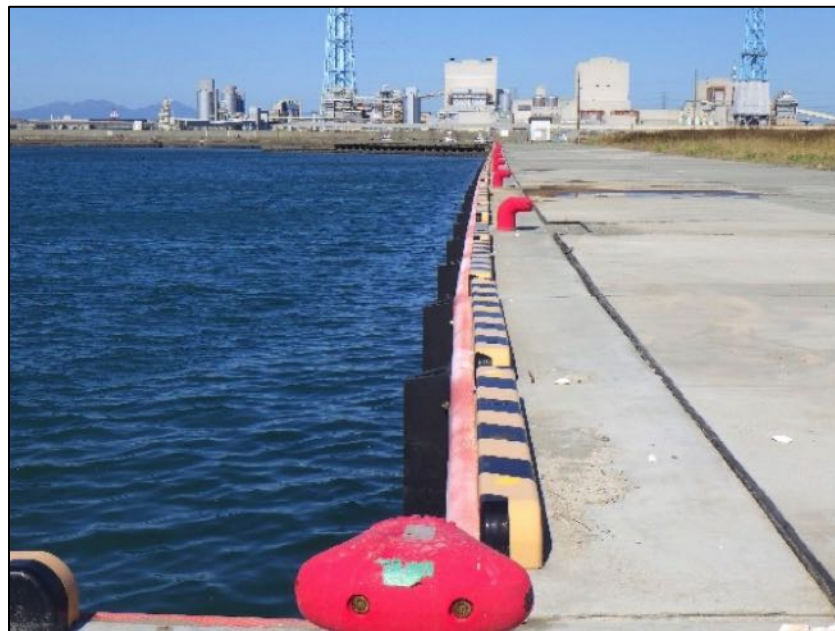
Figure 8-11. Bulging of the quay wall at Tomakomai-Atsuma Power Plant
