HOKKAIDO, JAPAN, M_w 6.7 EARTHQUAKE OF SEPTEMBER 6, 2018 LIFELINE PERFORMANCE

The Council of Lifeline Earthquake Engineering
TCLEE No. 4

G&E Report R98.23.01 Revision 1, March 18 2019

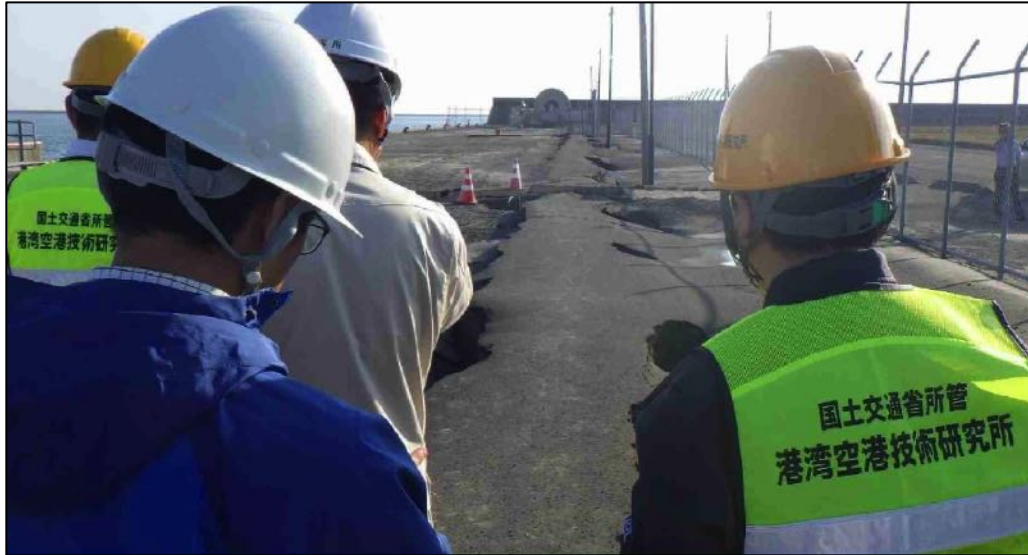
The pier at the Tomakomai Ferry Port had liquefaction, Figure 8-12 shows the liquefaction damage. The location of the Ferry Port is shown in Figure 8-13 (42.6095°, 141.8209°).

Figure 8-12. Tomakomai Port pier liquefaction damage. (Credit: Hokkaido MLIT)

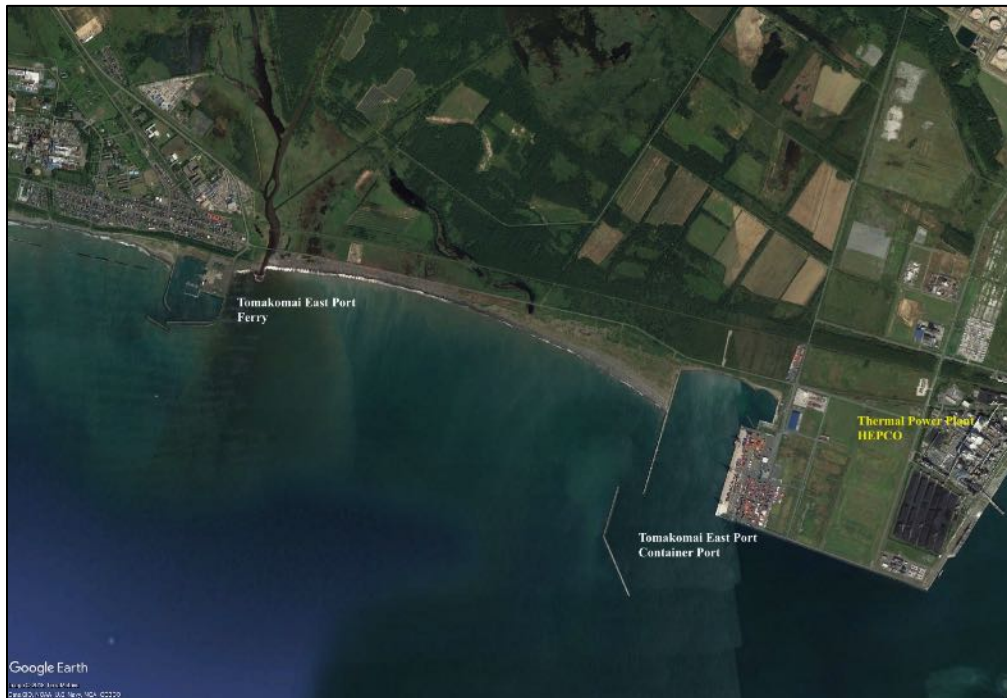
Figure 8-13 The liquefaction damage in Figure 8-12 was at the Ferry port on the right hand side of the figure. (Source: Google Earth)

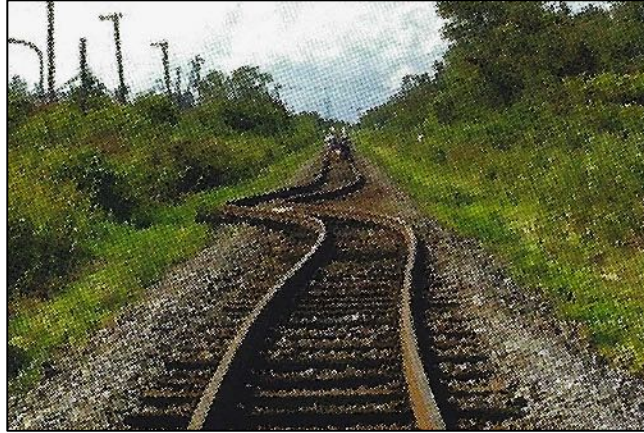
Both JR and the light rail system sustained service interruption mainly due to power outage. Sapporo City and Iburi Sub-prefecture suffered long duration of service interruption to public transportation services. A section of the track between Tomakomai and Samani was buckled (Figure 9-2) due to permanent ground movement that forced the steel rails into compression. This section of rail service took about three weeks to repair and return to partial service; about six weeks to restore entirely to normal service.

Figure 9-2. Buckled JR track on Hidaka Line. (Source: JR)
